June 30, 2015

Reference No. 1214280022-018-L-Rev0-11000

**RESPONSE TO MINISTRY OF ENERGY AND MINES MEMORANDUM DATED FEBRUARY 3, 2015  
REGARDING THE BEAVERDELL TAILINGS FACILITIES**

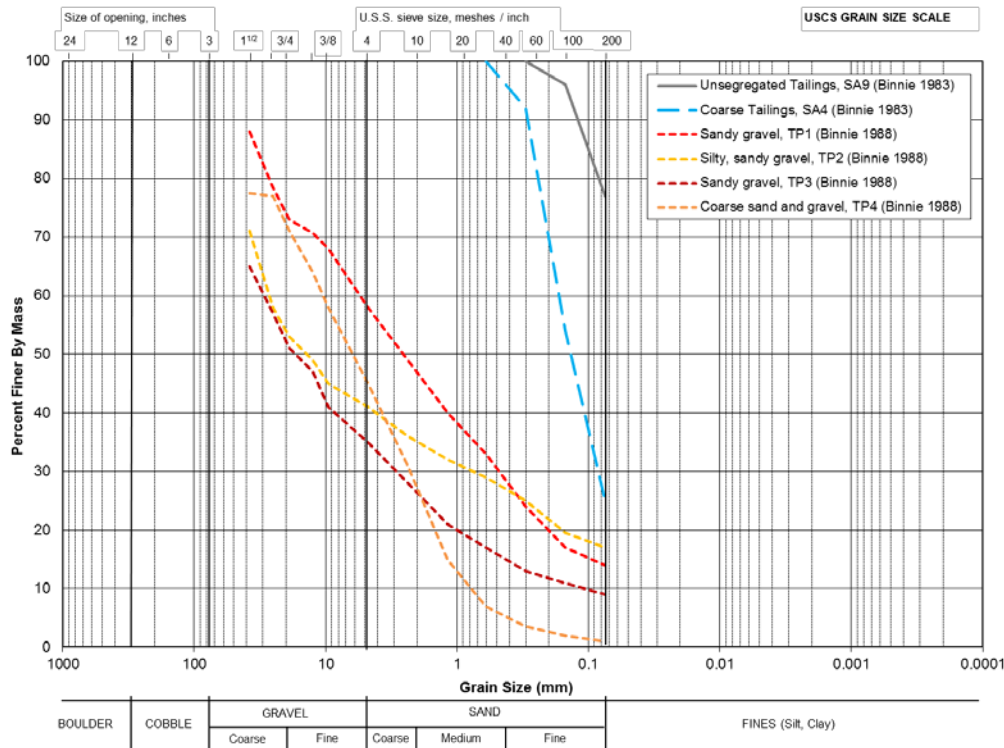
Chart 4: Pond 7 Foundation/Dam Section Gradations and Pond 6 Tailings Gradations for Filter Compatibility Comparison

Gradations of the coarse tailings (beach) are filter compatible with the gradations of the slimes for samples taken in Ponds 4, 5, 6, and 7.

Gradations of the coarse tailings (beach) are filter compatible with the gradations of the sand and gravel dam for all samples taken except for the coarse sand and gravel from test pit (TP) 4 in Pond 7. However, Pond 7 was never filled with tailings, so this gap represents a low risk for piping failure.
