**Wetland Assessment Report**  
**Montague Gold Mines, Nova Scotia**  
**Final Report**

Project #: TV183013

May 2021

**Intrinsik Corporation on Behalf of Nova Scotia Lands**

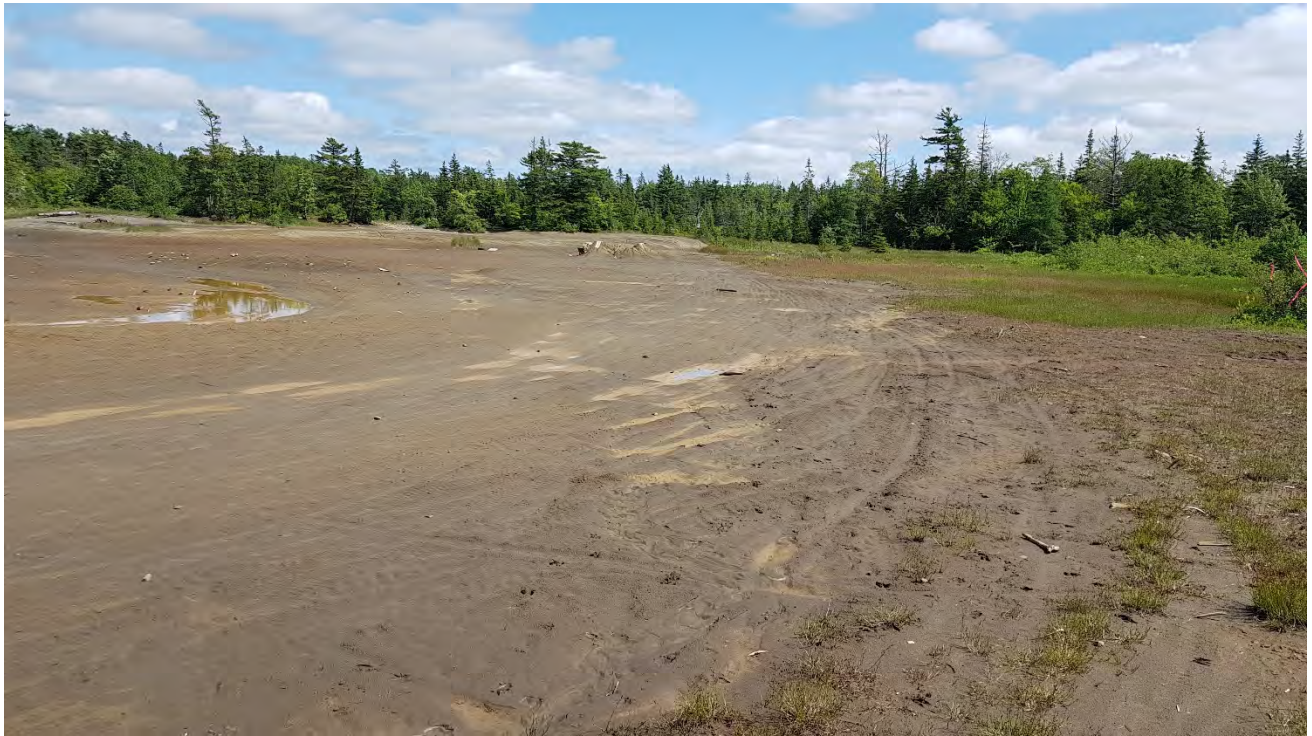
Photo 1. Area 1A – Looking west across the main tailings deposit; edge of wetland at right.

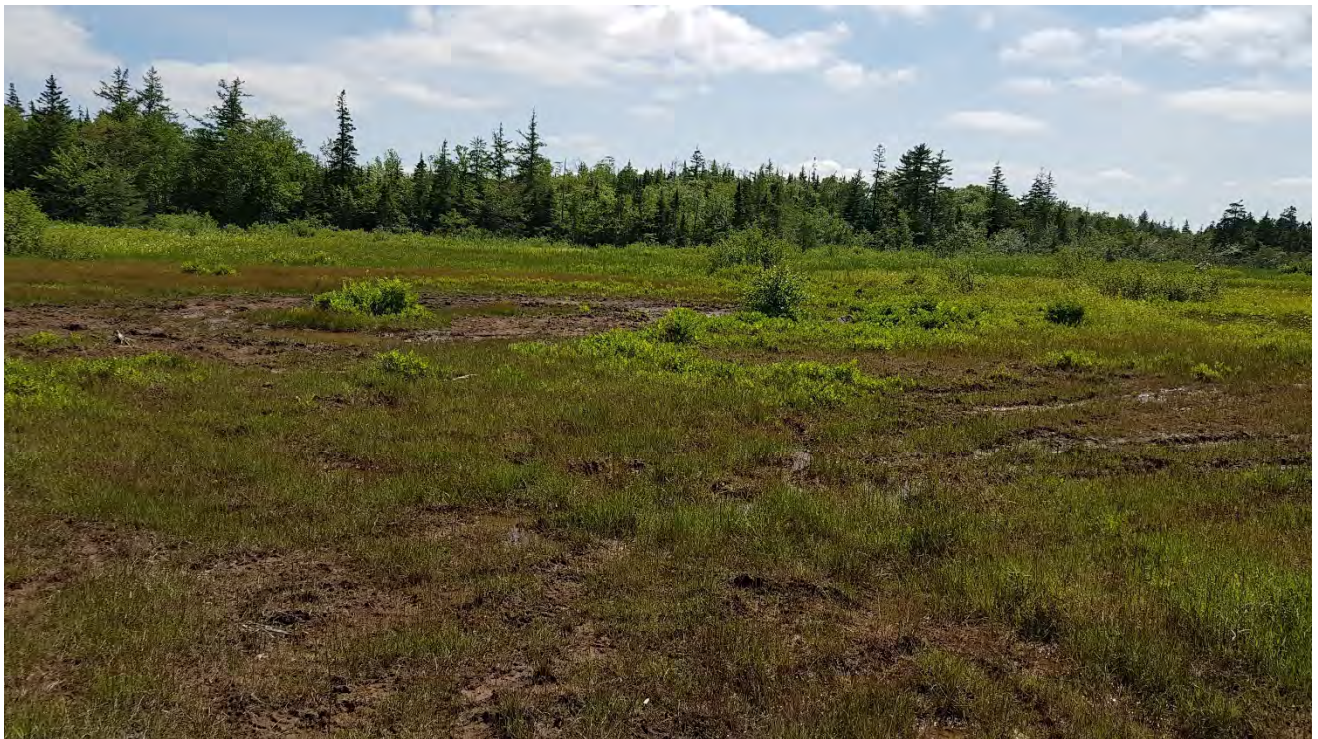
Photo 2. Area 1A – Looking south from the location above, toward Area 1C. There is significant rutting by off-road vehicles. In the distance, Mitchell Brook flows from left to right from the treeline into the shrubby meadow.

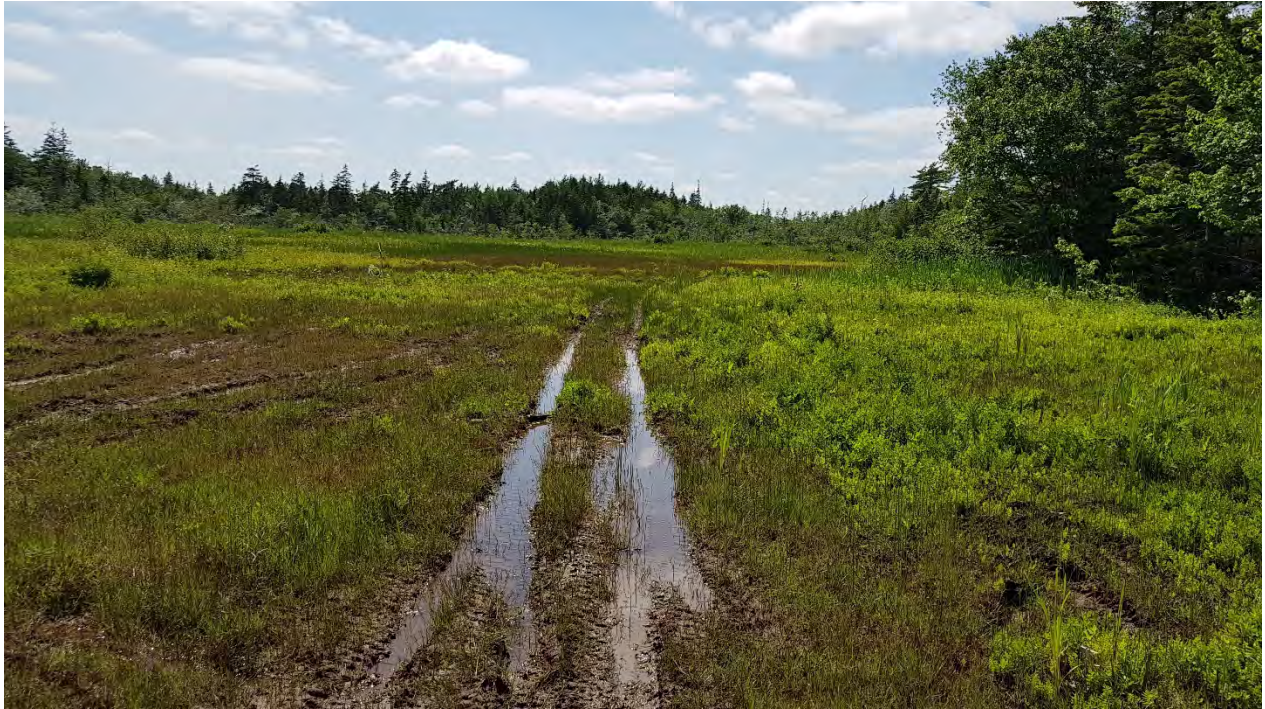
Photo 3. Area 1A – Looking southwest from the location above toward Area 1E.

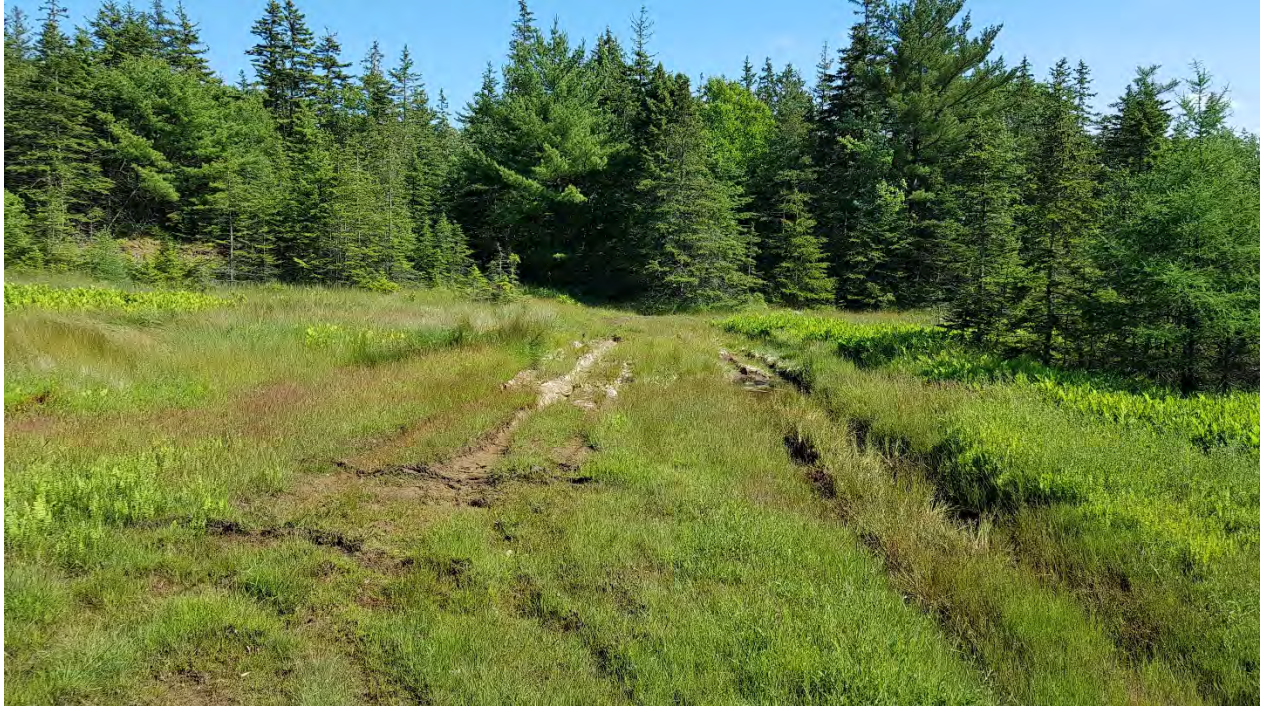
Photo 4. Area 1A – At the east end of Area 1A, recreational vehicles access the site through the wetland.

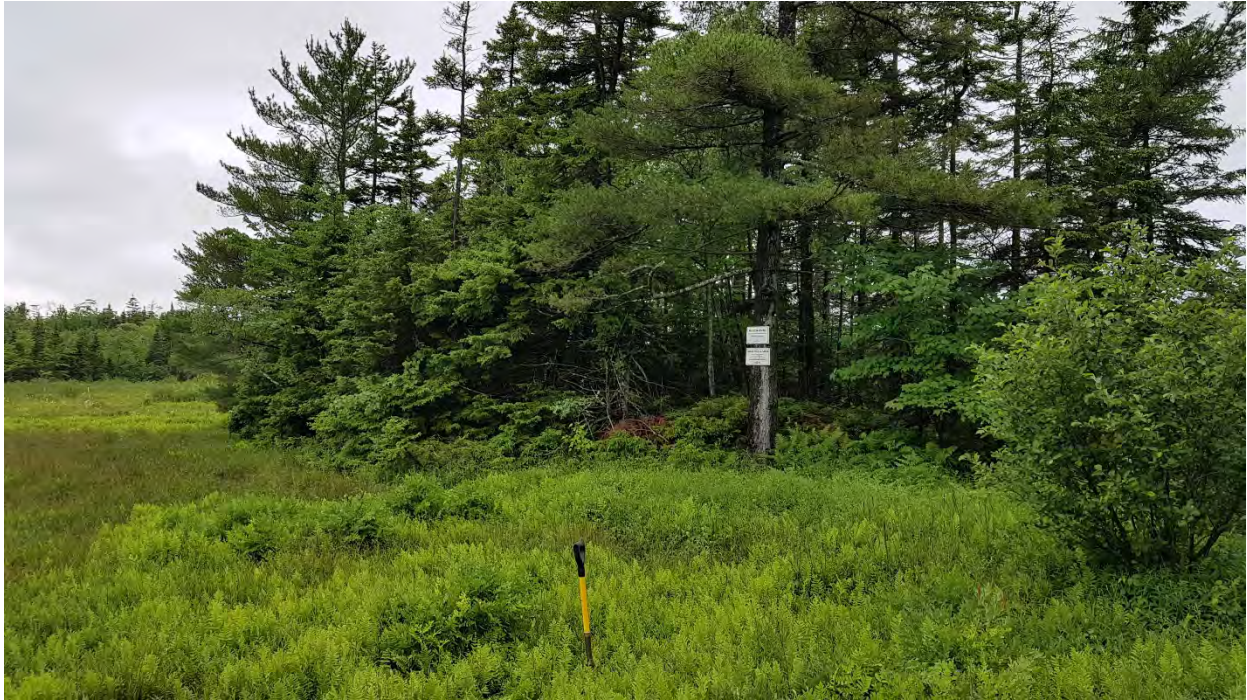
Photo 5. Area 1C – Typical “low” vegetation structure in the impacted wetland. Warning signs about the contamination are visible on the tree.

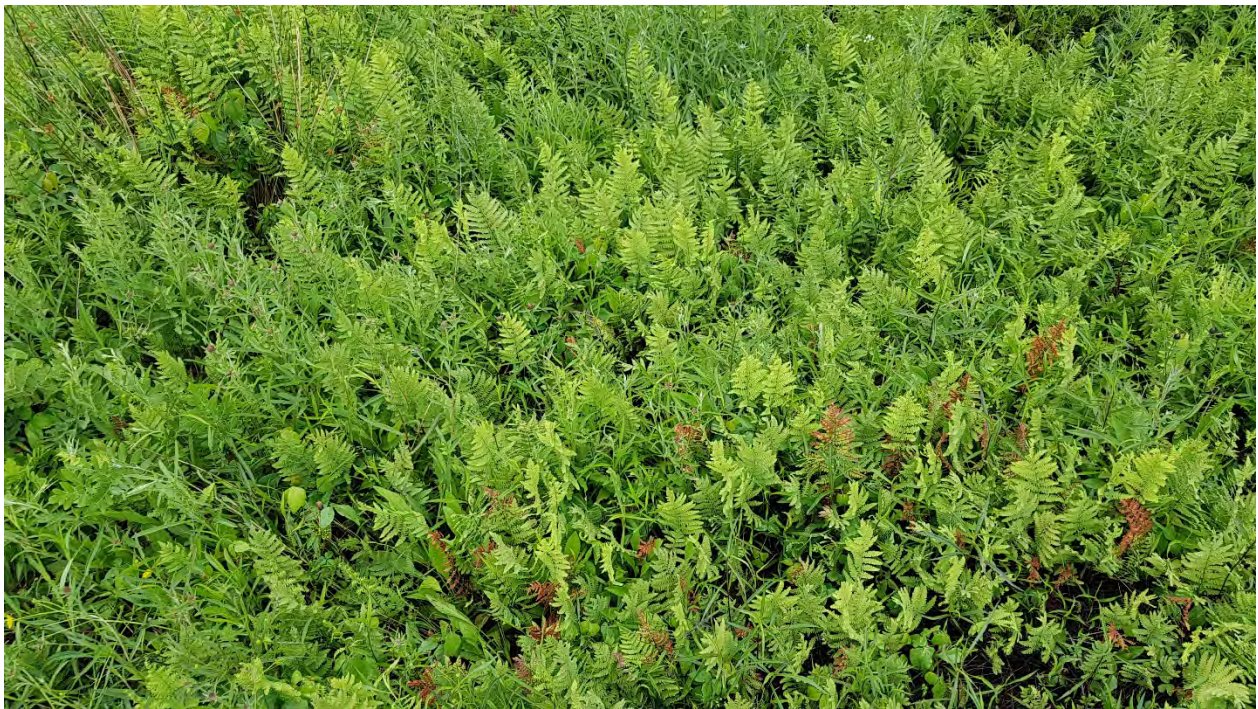
Photo 6. Area 1C – Common ground cover includes marsh fern (*Thelypteris palustris*), Canada rush (*Juncus canadensis*), water horsetail (*Equisetum fluviatile*), and red-top (*Agrostis stolonifera*).

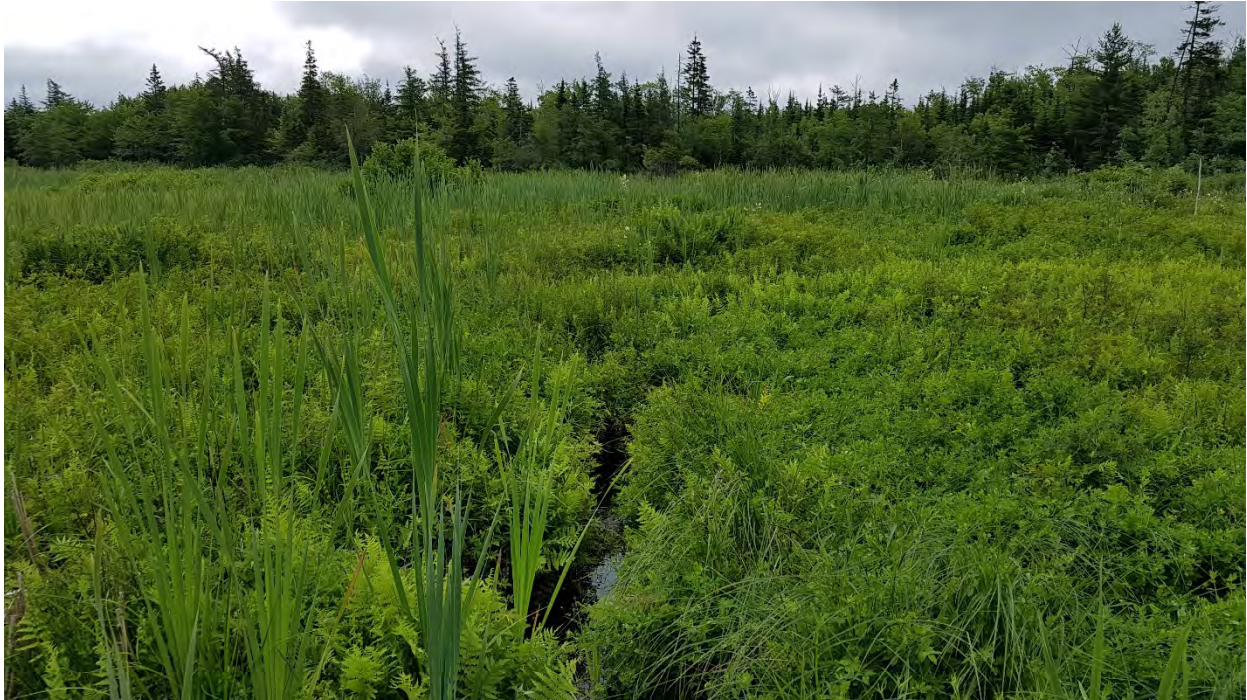
Photo 7. Area 1C – Looking southeast along Mitchell Brook in Area 1C. Vegetation is similar to 1A but somewhat higher and more diverse.

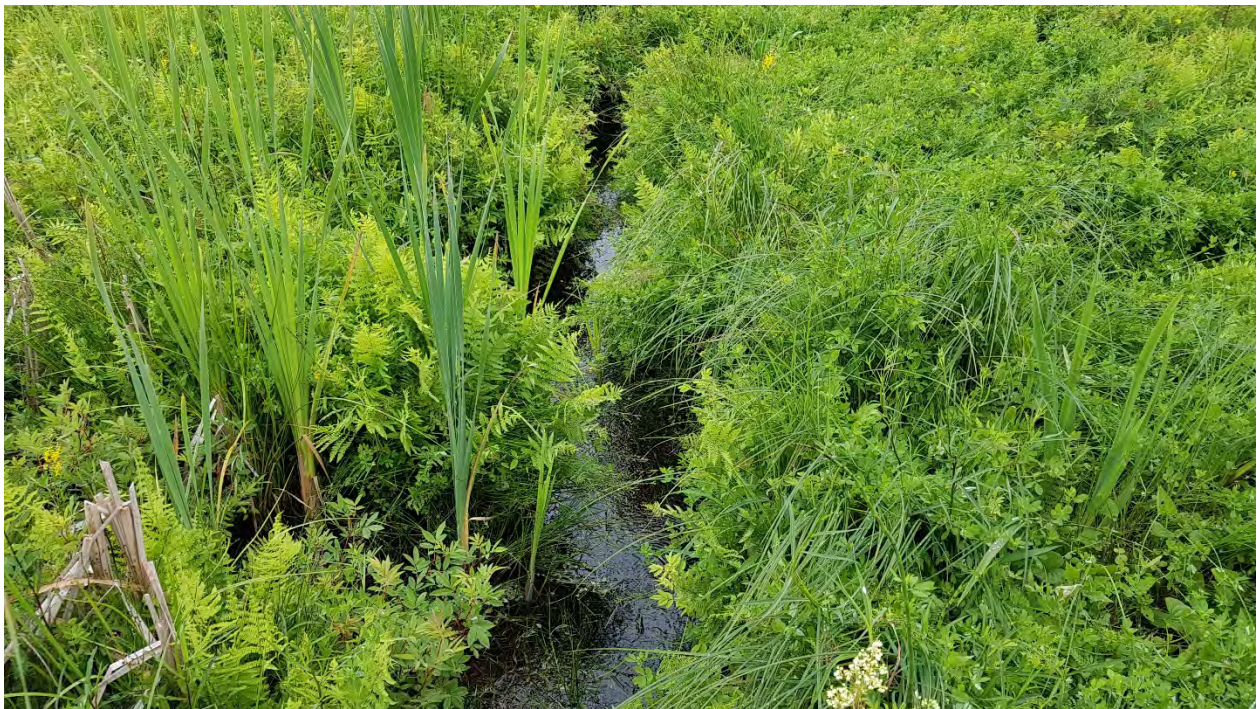
Photo 8. Area 1C – Mitchell Brook is approximately 1 m wide at this point and 50 – 100 cm deep. Cattails are scattered throughout Area 1C.

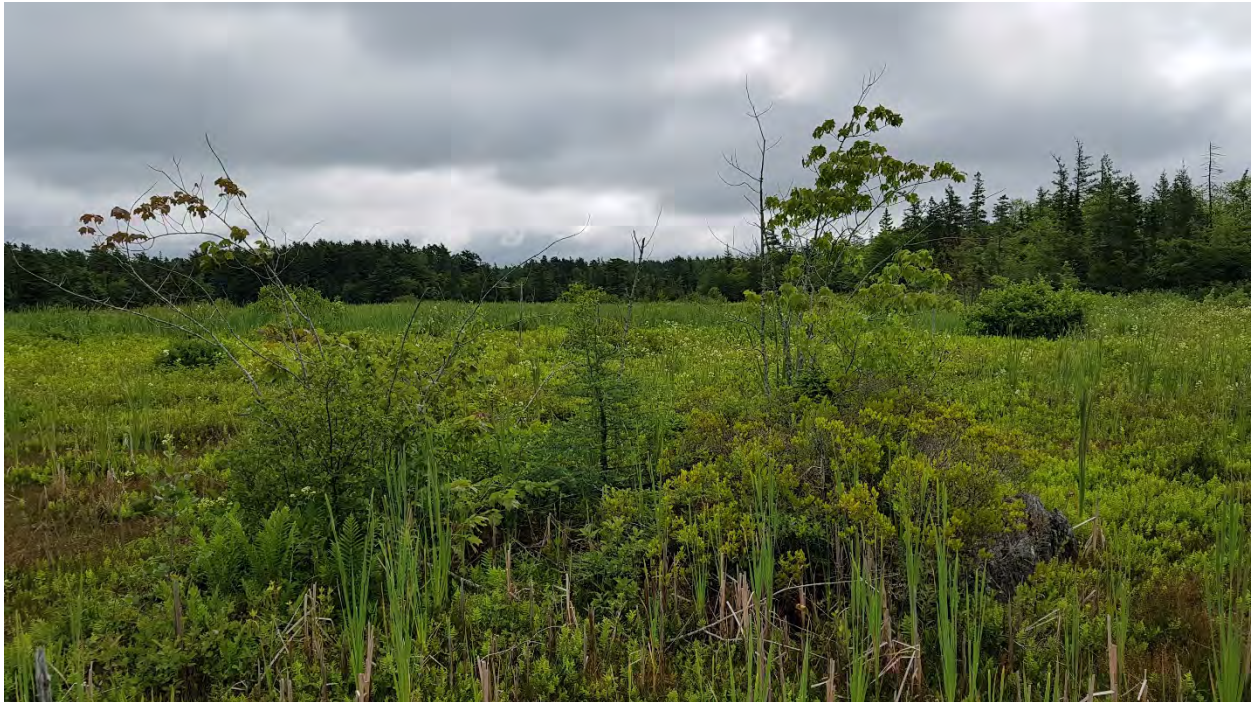
Photo 9. Area 1C – Looking south in Area 1C. The wetland includes more diverse structure including tall shrubs, tree saplings. The topsoil has a much higher organic content than Area 1A

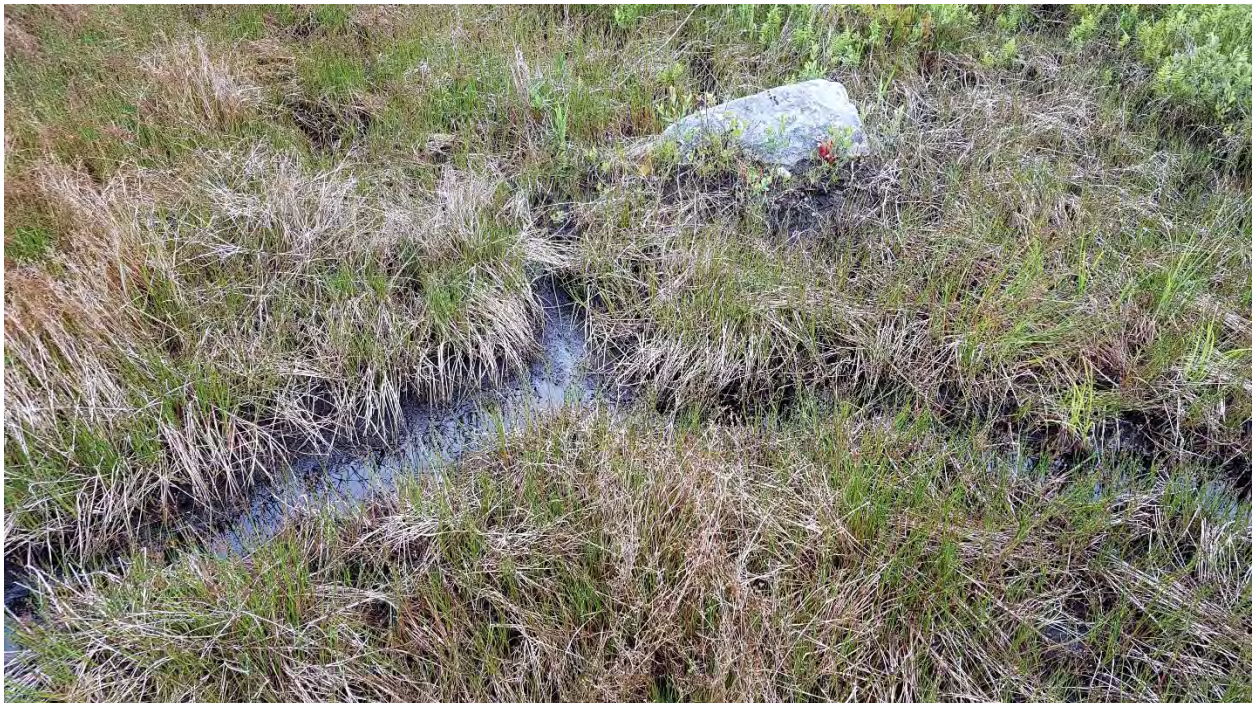
Photo 10. Area 1C – Intermittent drainage channels have formed in Area 1C that appear to flow toward the highway (Culvert 1A). Possibly this indicates that Mitchell Brook does not effectively drain the wetland during high flow events

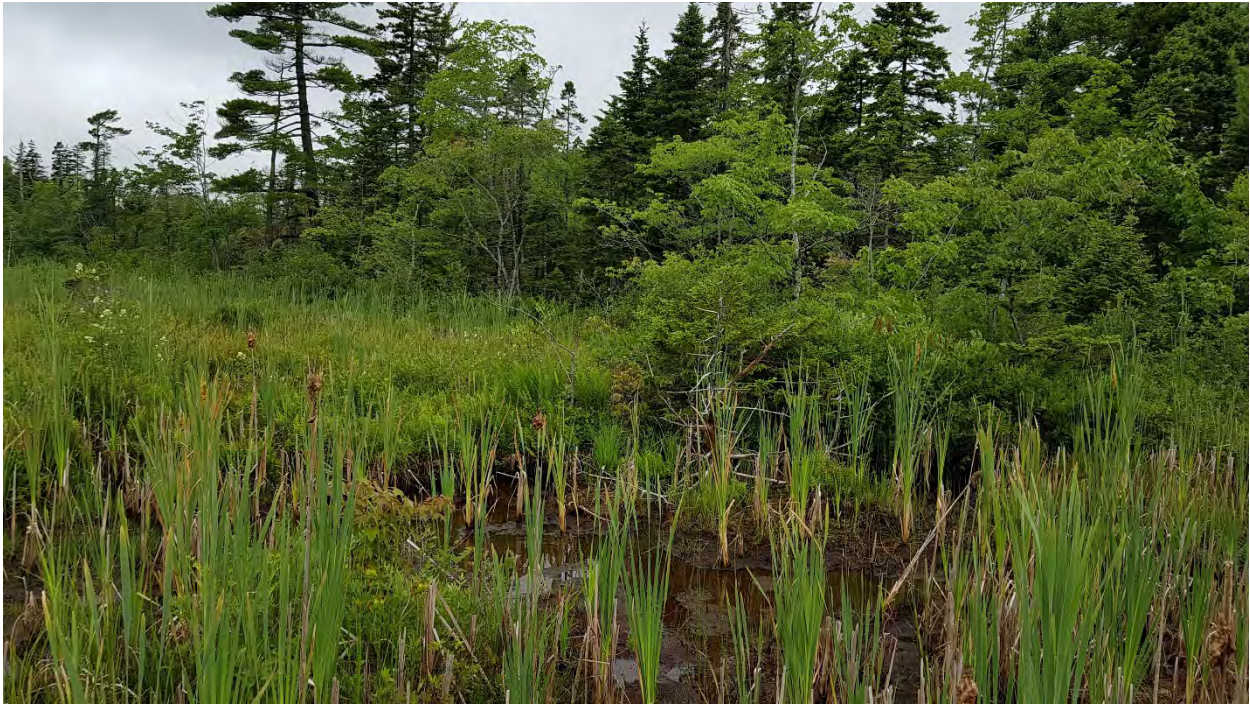
Photo 11. Area 1E – Wetland area appears to increase in wetness going west along Mitchell Brook. Area 1E showed visible small pools and more dense cattails.

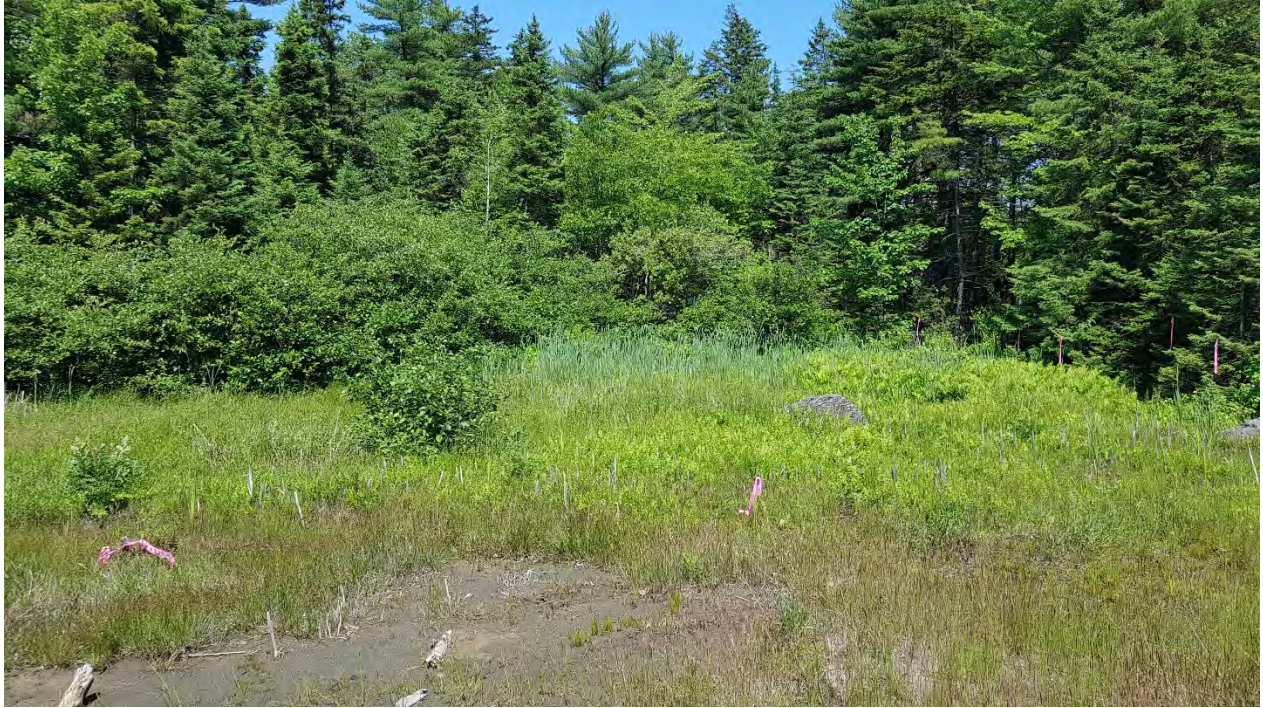
Photo 13. Area 1A (extremity) – There is a small extremity of Wetland 1A that is adjacent to the north edge of the core tailings deposit. It is connected to the rest of the wetland along a narrow drainage path (below).

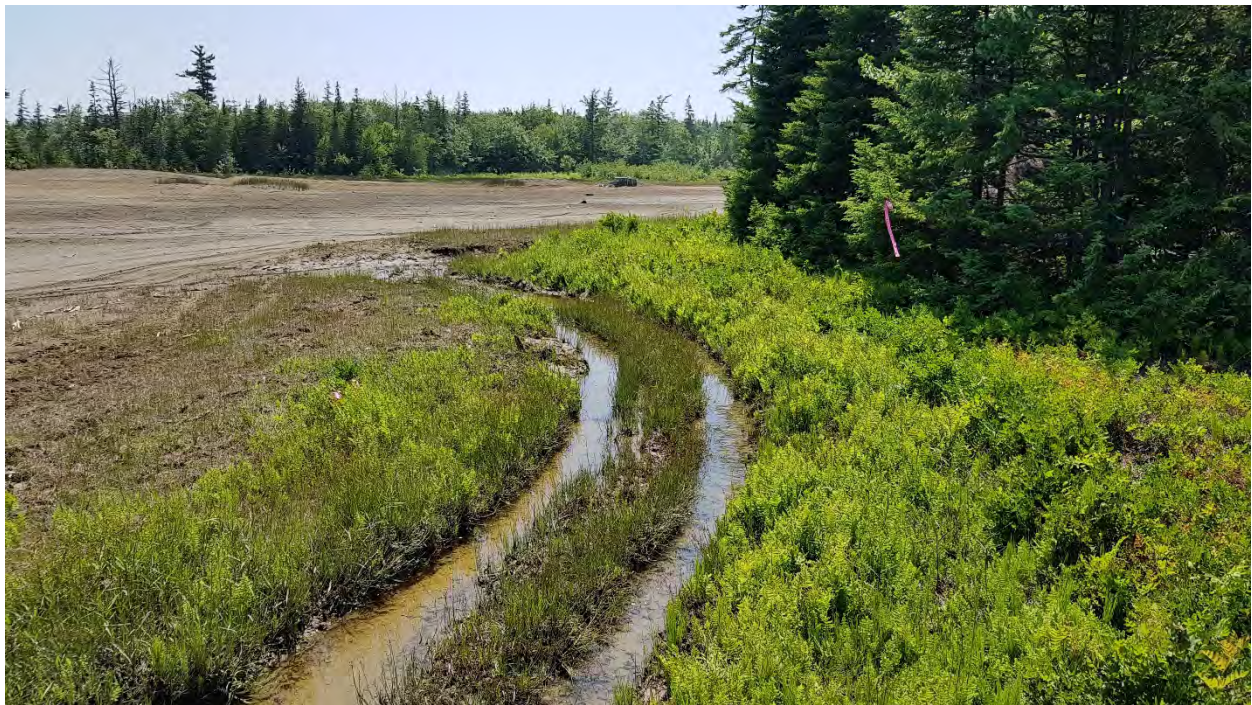
Photo 14. Area 1A (extremity) – Off-road vehicles have been driven in the drainage corridor of the wetland extremity, causing more rapid drainage to develop. Signs of seasonal severe erosion/sedimentation were observed along this path.

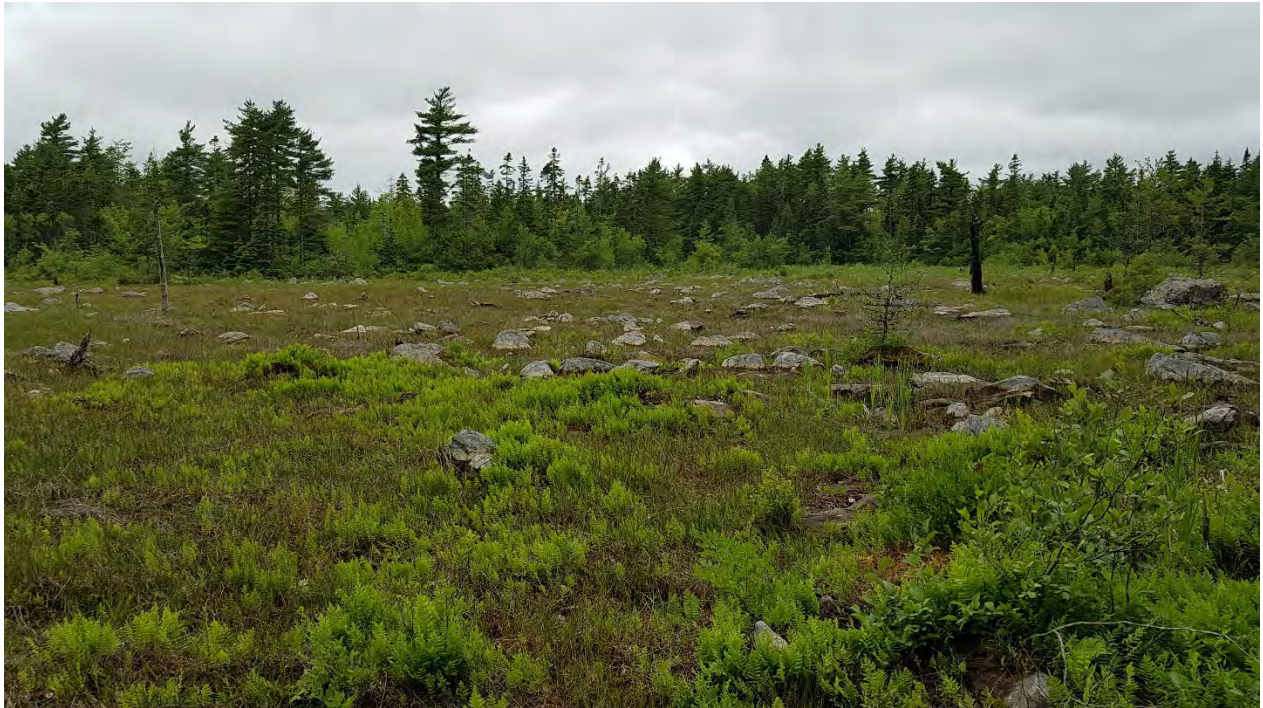
Photo 15. Area 1D – Looking west toward Area 1D. Coarse waste rock and fine tailings were observed in the wetland; however, the general vegetation community is very similar to both 1A and 1C.

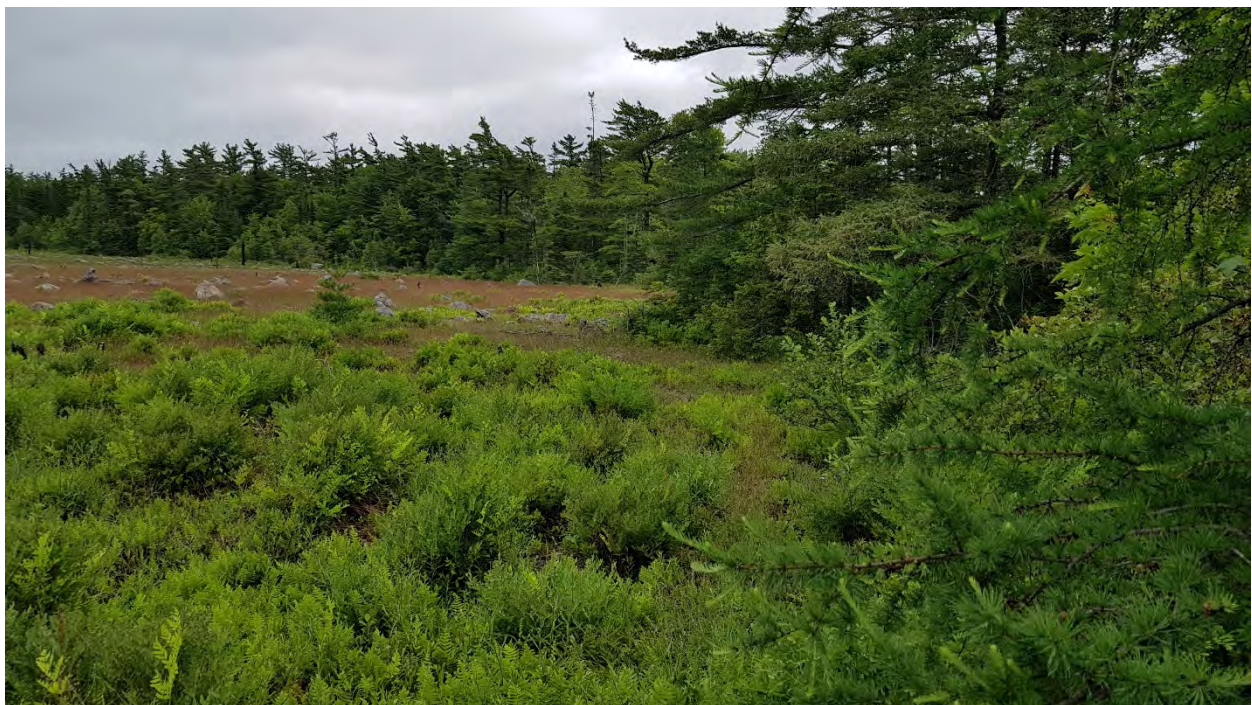
Photo 16. Area 1D – Looking north from the location above; wetland to the left and adjacent mixed forest to the right. The wetland boundary is fairly sharp at the toe of relatively steep slope.

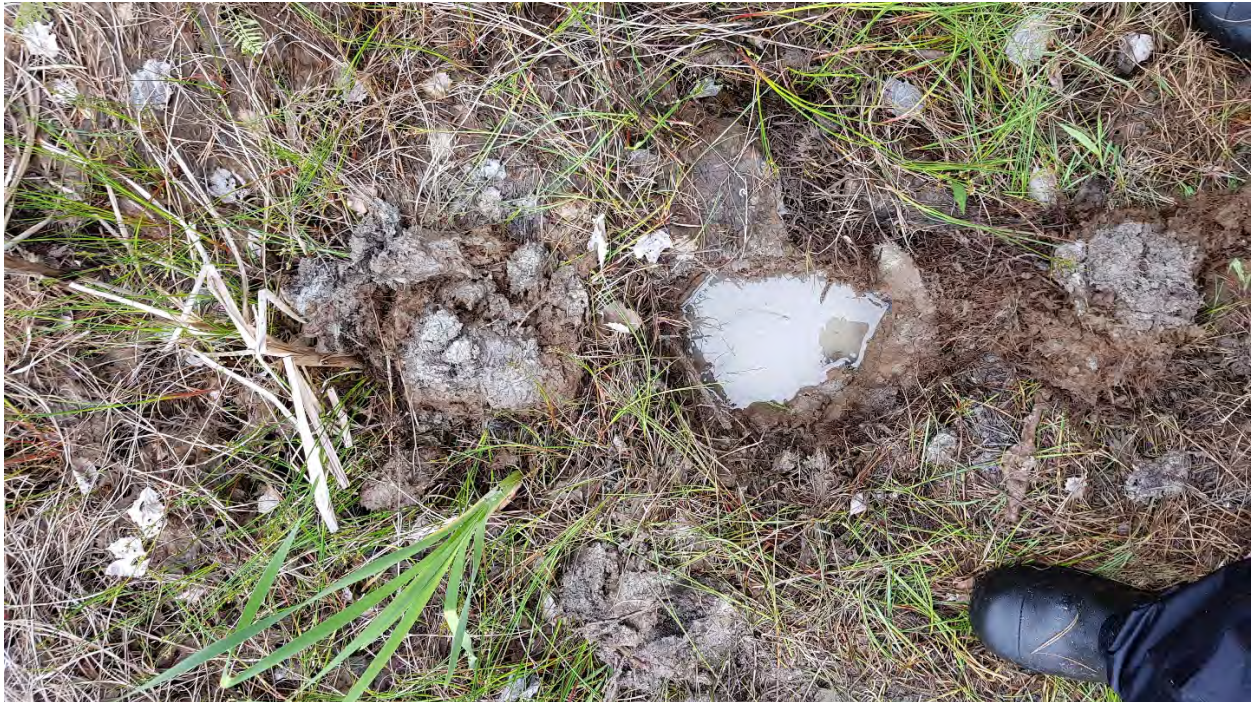
Photo 17. Area 1D – Wetland soil is fully saturated grey sand with variable thin organic layers at the surface.

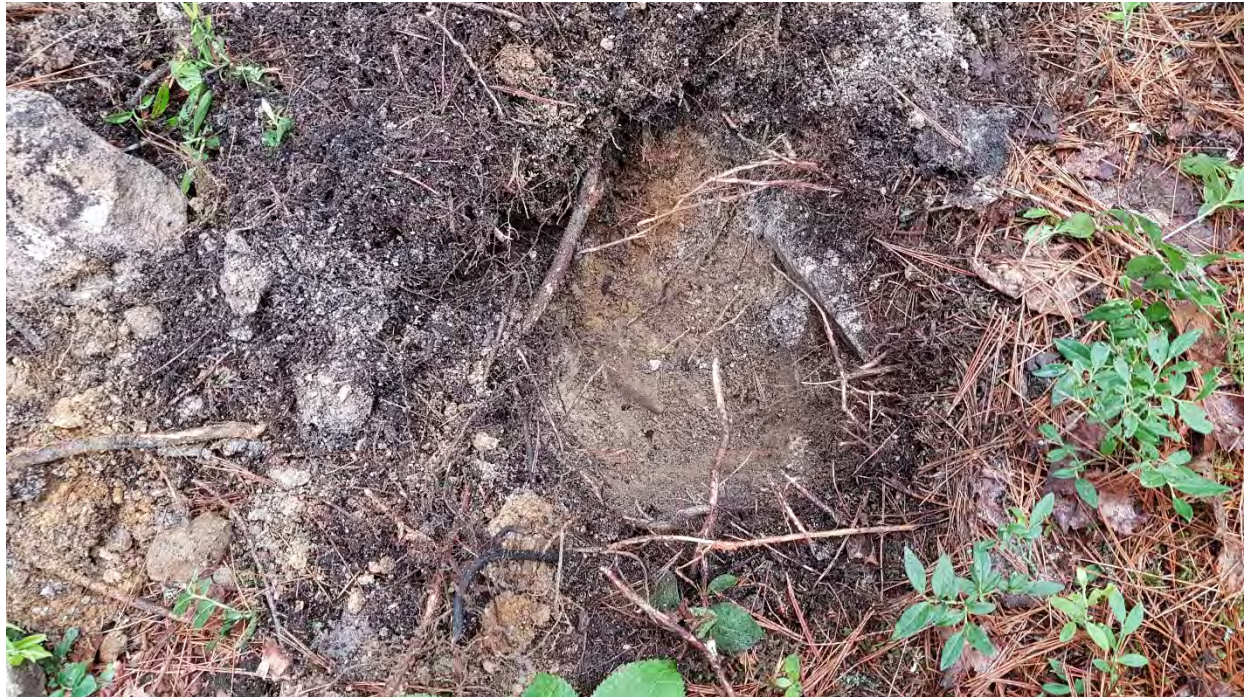
Photo 18. Area 1D – The adjacent upland soil is also grey sand at depth but with no saturation and signs of weak podzolic soil development. It is possible that the natural soil colour is grey; which adds some complexity to wetland delineation.

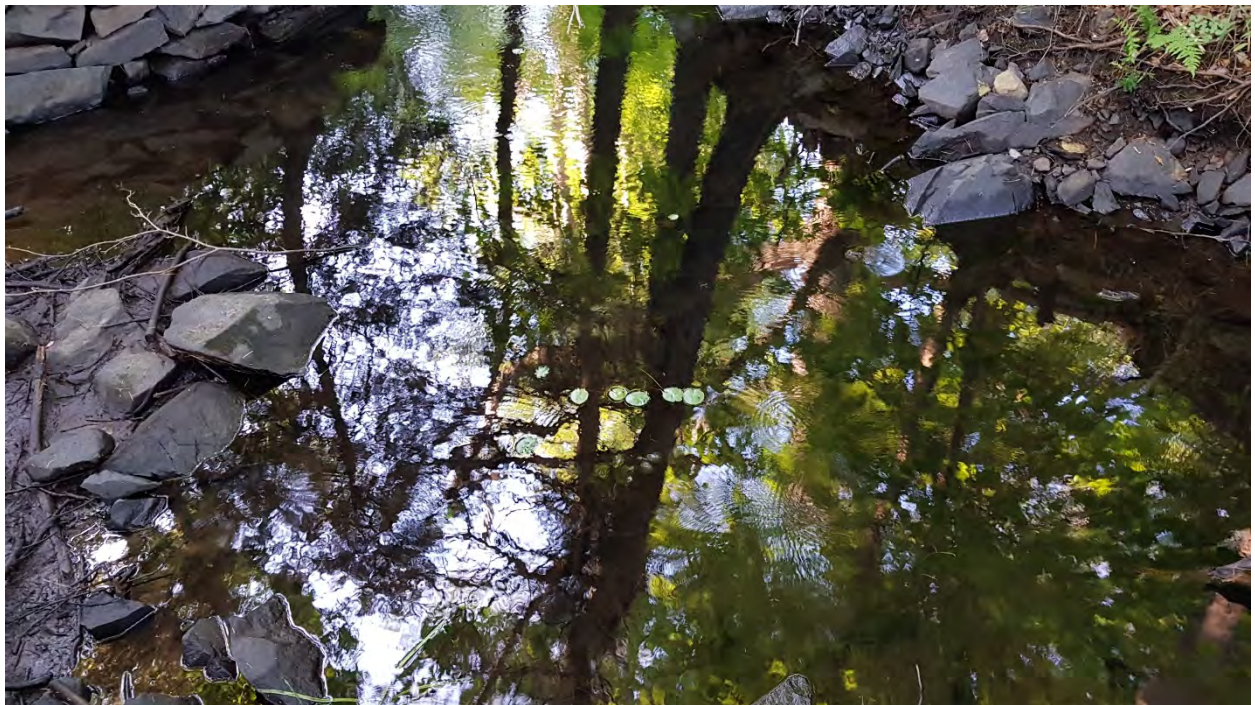
Photo 22. Area 1B – The water at the inlet was clear and supported aquatic vegetation. The degree of interruption to fish passage is unknown.

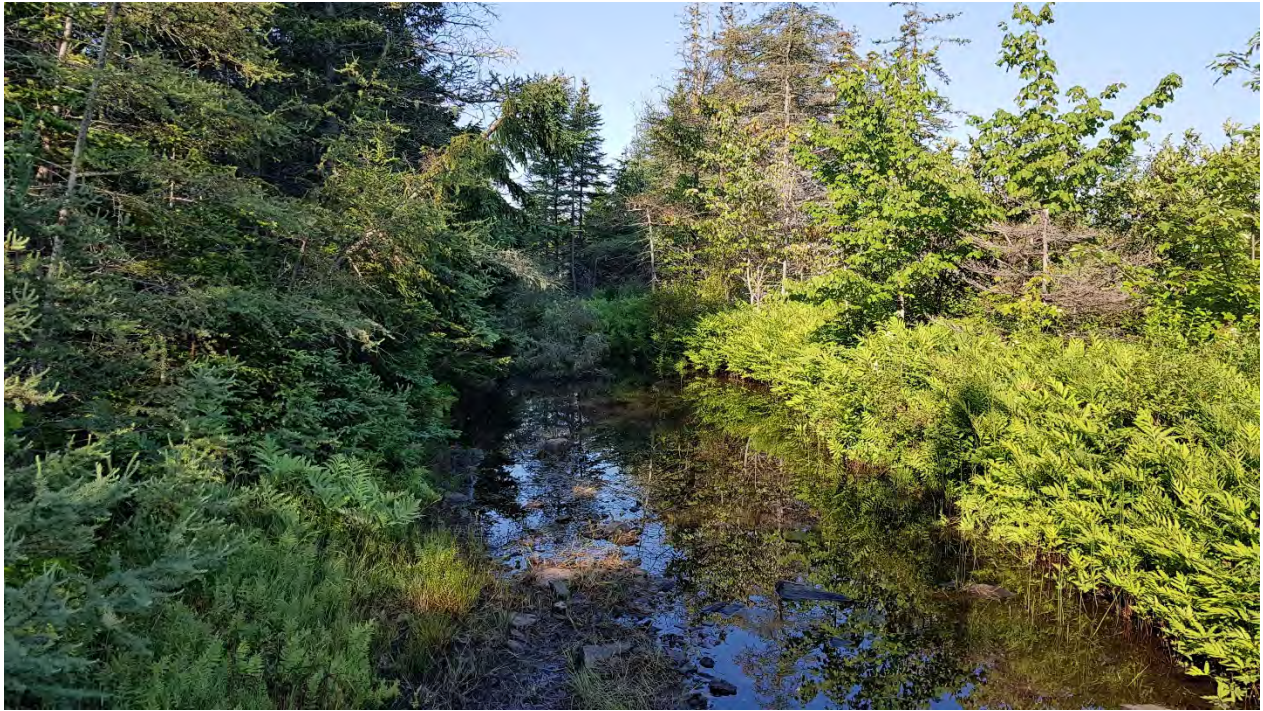
Photo 23. Area 1B – Looking south from the location above, along a constructed forest road. The road crosses through the edge of the wetland.

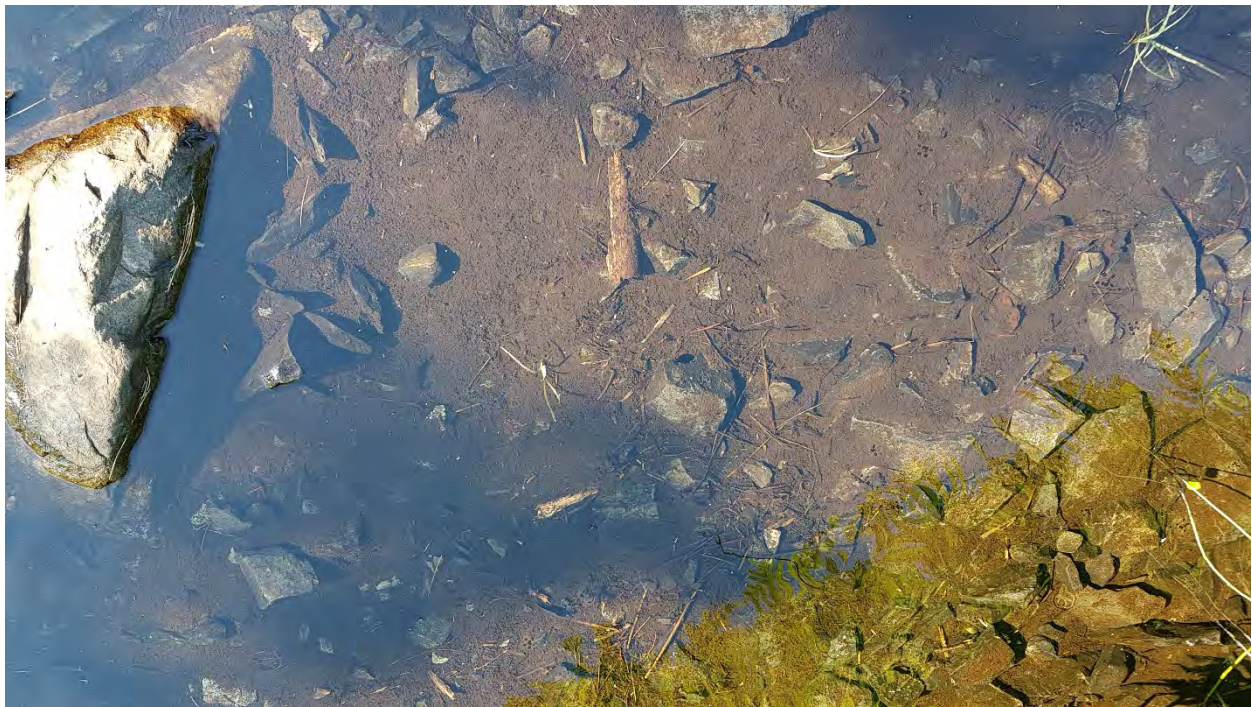
Photo 24. Area 1B – The above road width has been filled with coarse waste rock.

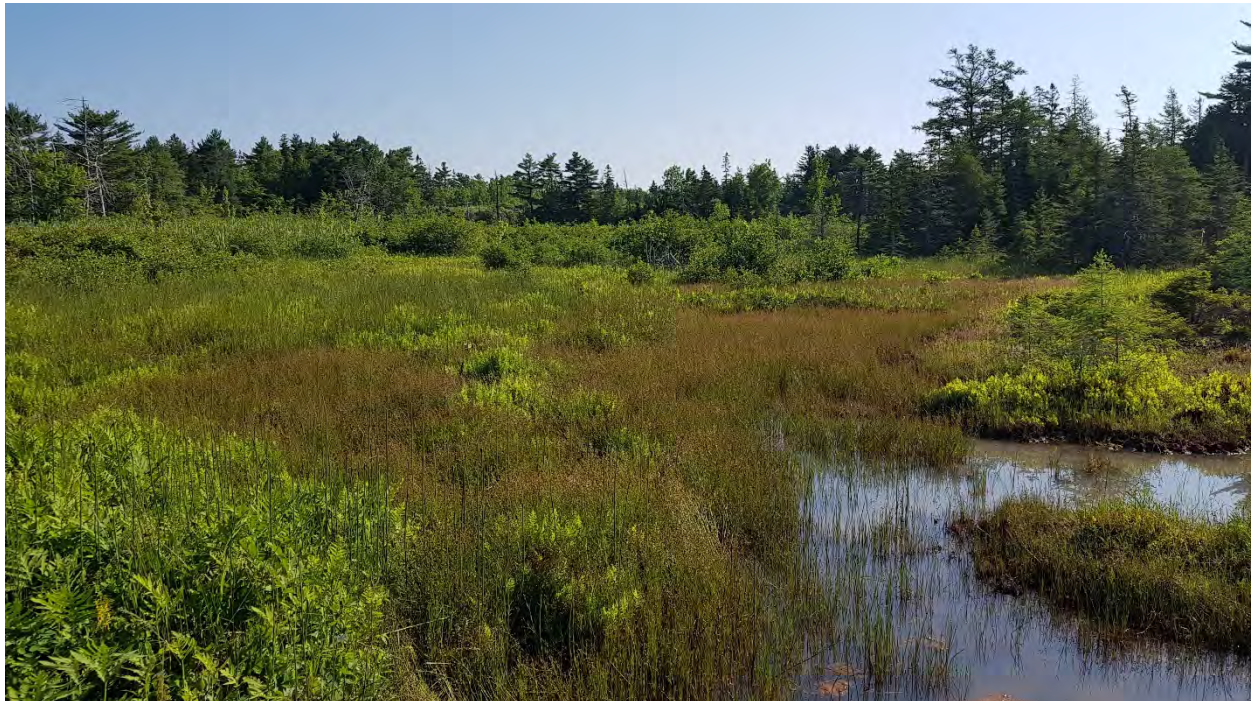
Photo 26. Area 1B – A portion of the wetland in Area 1B has been significantly disturbed by historic earthworks (right side of photo). This area has generally revegetated naturally and has developed open water habitat in the excavations.

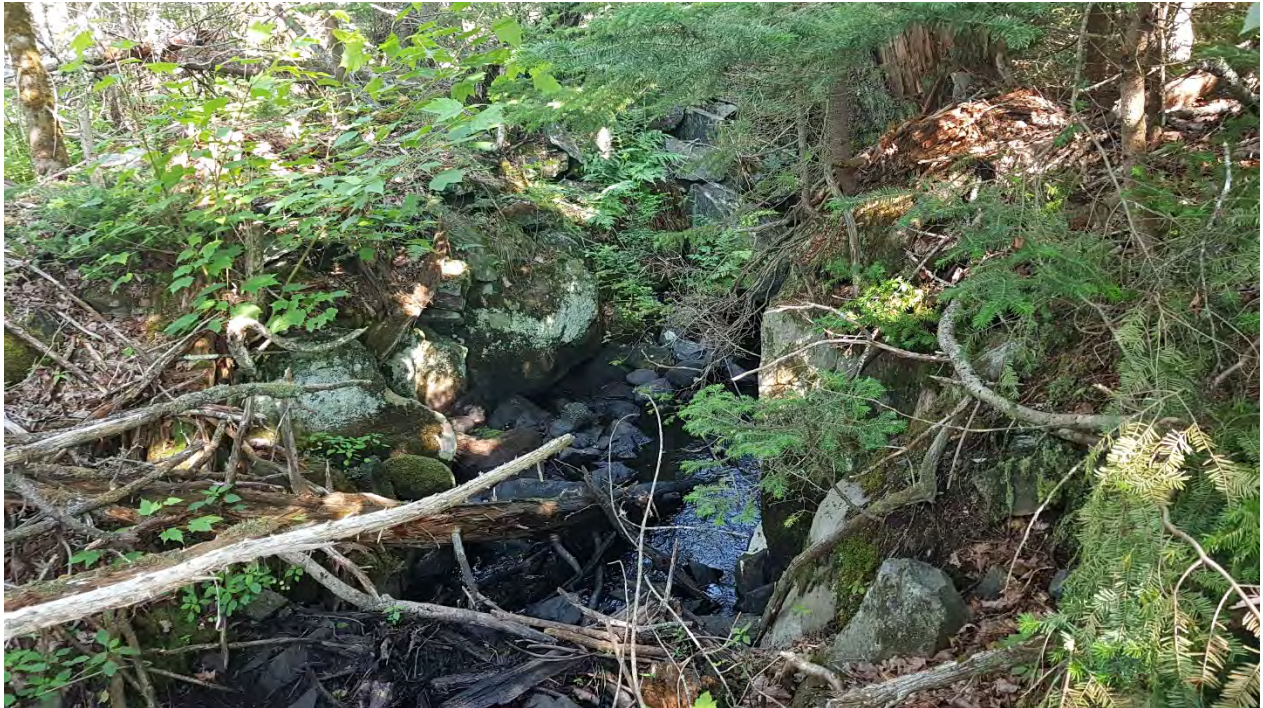
Photo 29. Area 1G – Looking west from Area 1G along a deep man-made trench that drains this part of the wetland. The trench connects directly to Mitchell Brook where it enters Area 1C from the forest edge.

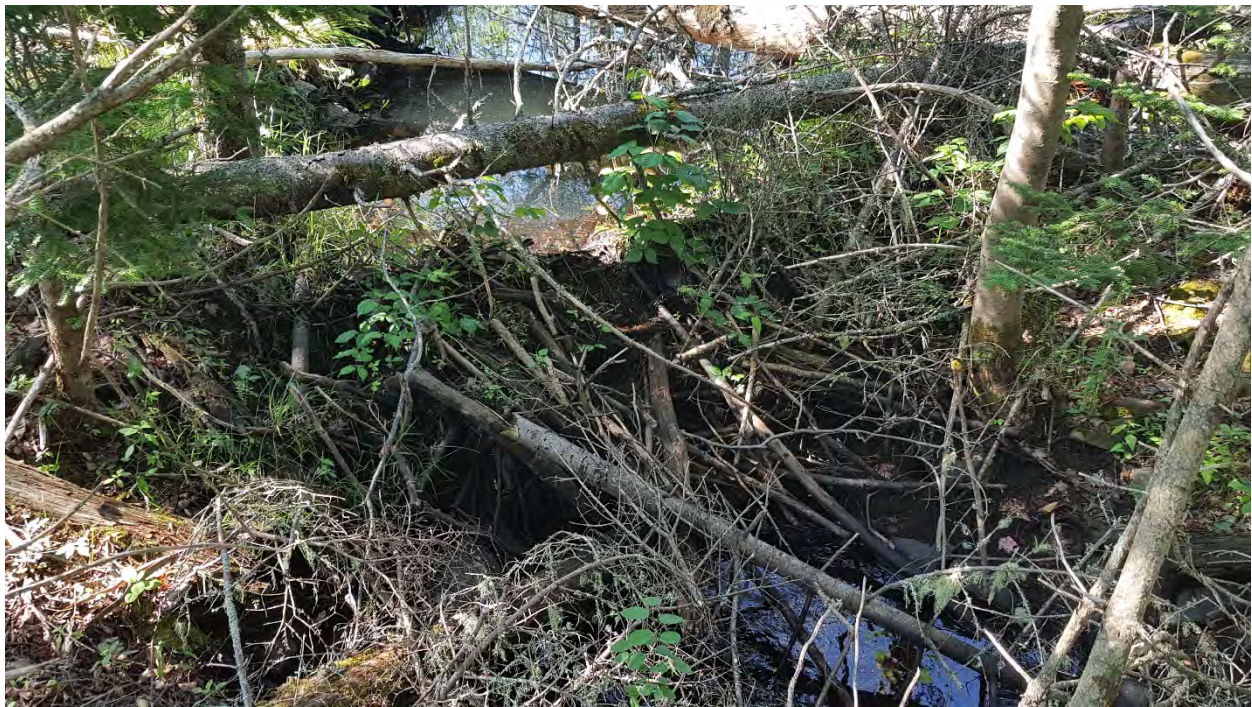
Photo 30. Area 1G – A small beaver dam currently blocks effective drainage in the trench but there is still a significant flow downstream.

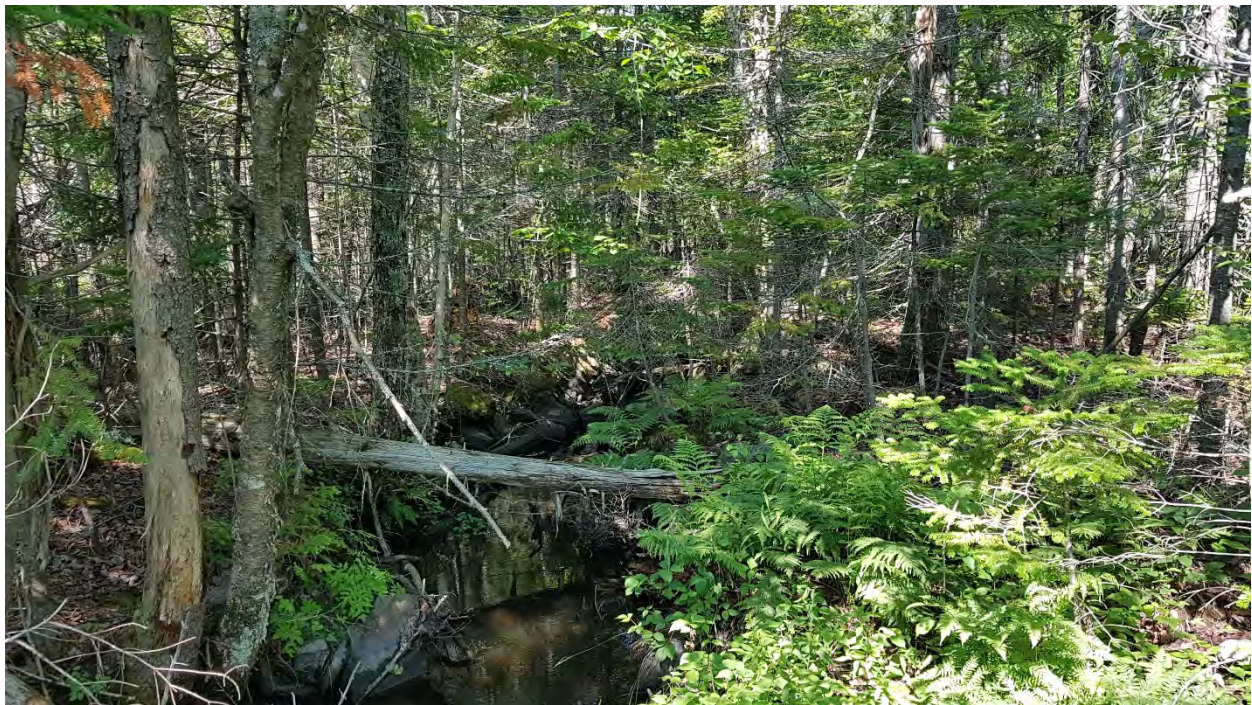
Photo 32. Area 1C – Looking east toward the confluence of Mitchell Brook with the man-made trench. The contributing flow from the trench is significant.
