**Wetland Assessment Report**  
**Montague Gold Mines, Nova Scotia**  
**Final Report**

Project #: TV183013

May 2021

**Intrinsik Corporation on Behalf of Nova Scotia Lands**

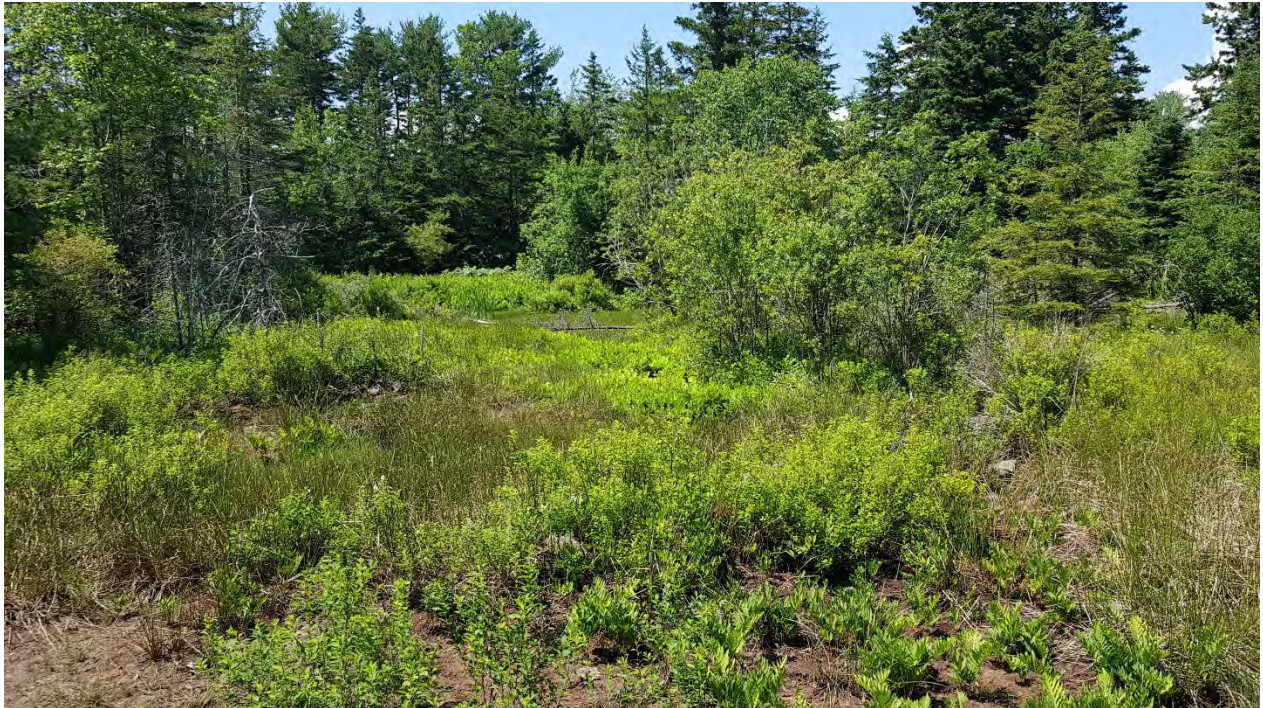
Photo 35. Tailings Area 1F – Looking west across Area 1F, which was considered too small to be a regulated wetland. The reason for its existence is the site access road (seen in the distant gap in trees, which has no culvert).

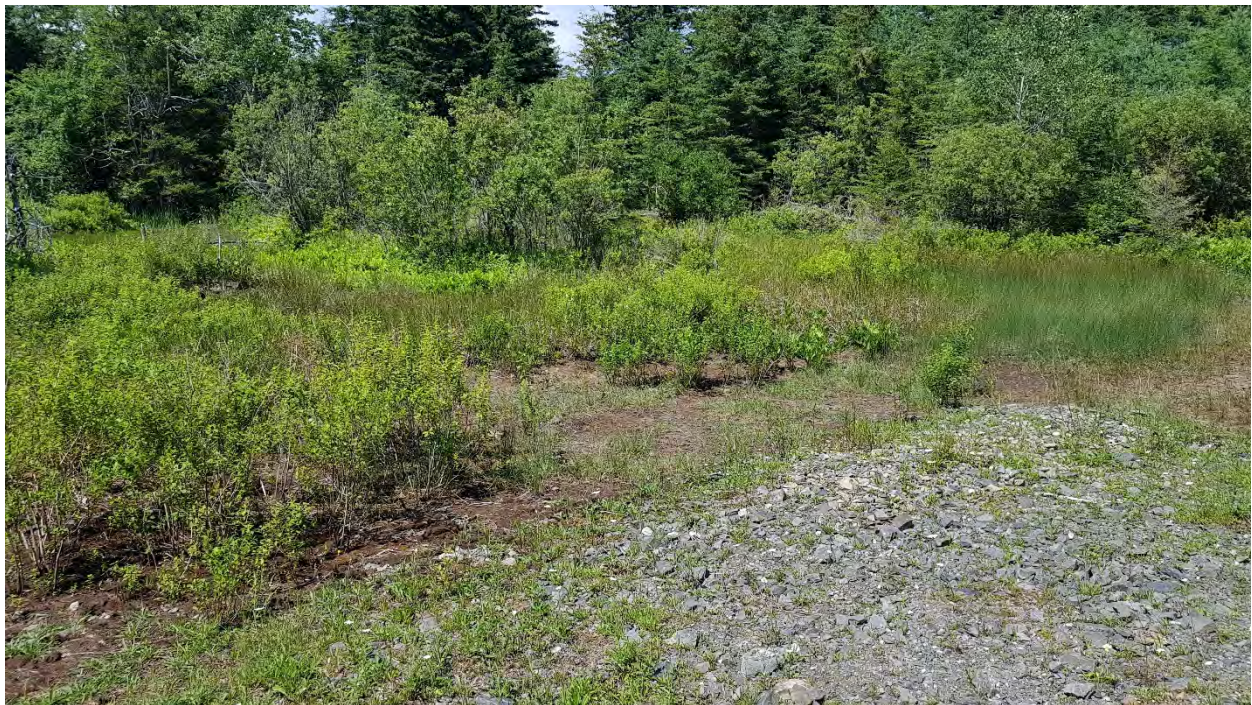
Photo 36. Tailings Area 1F – the majority of the ground in Area 1F is coarse waste rock and an old road (lower right) which leads to an abandoned mine shaft nearby.

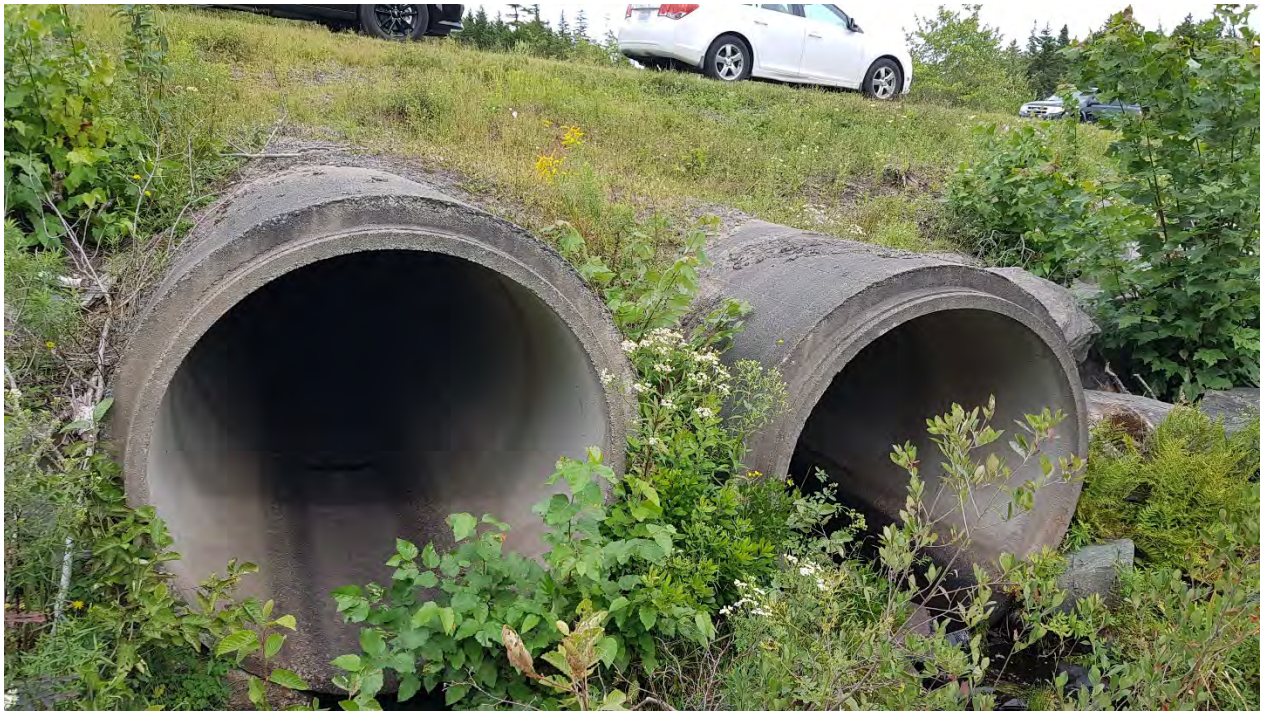
Photo 35. Mitchell Brook downgradient of Area 1E –Two large culverts (Culvert 2 in Figure 2) at Mitchell Brook where it crossed the highway.

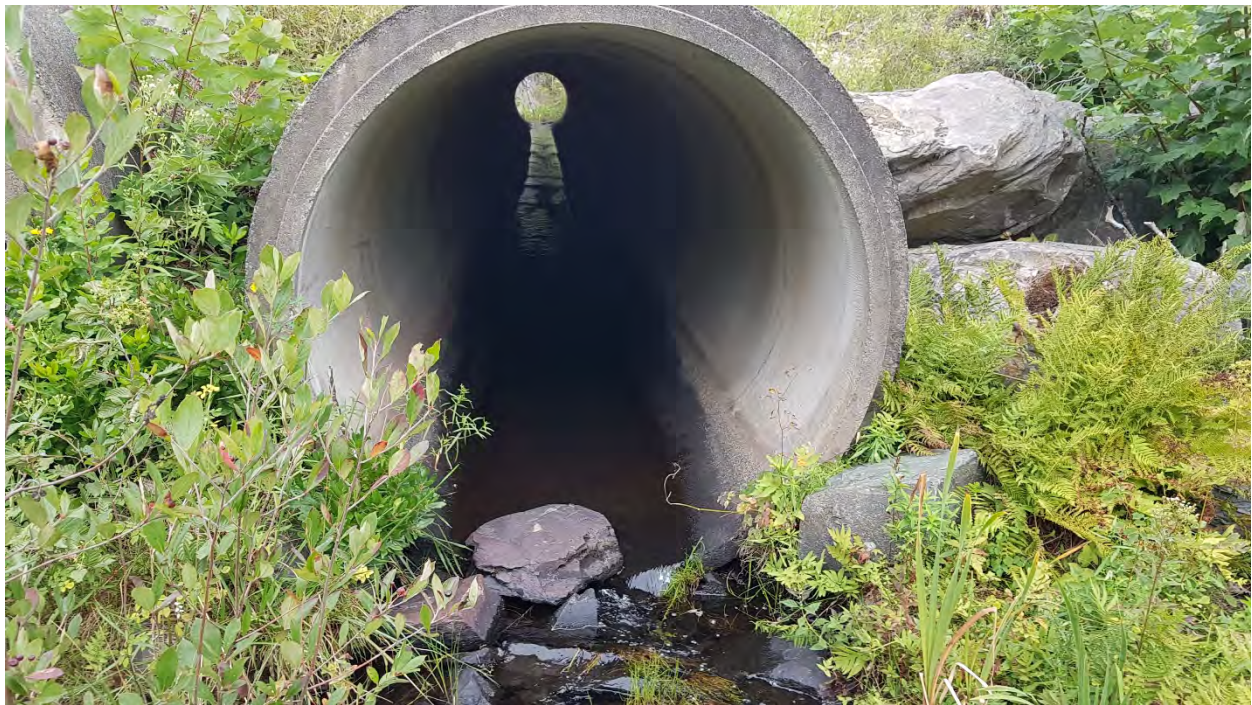
Photo 36. Mitchell Brook downgradient of Area 1E – Water stains indicate significant high seasonal flows.

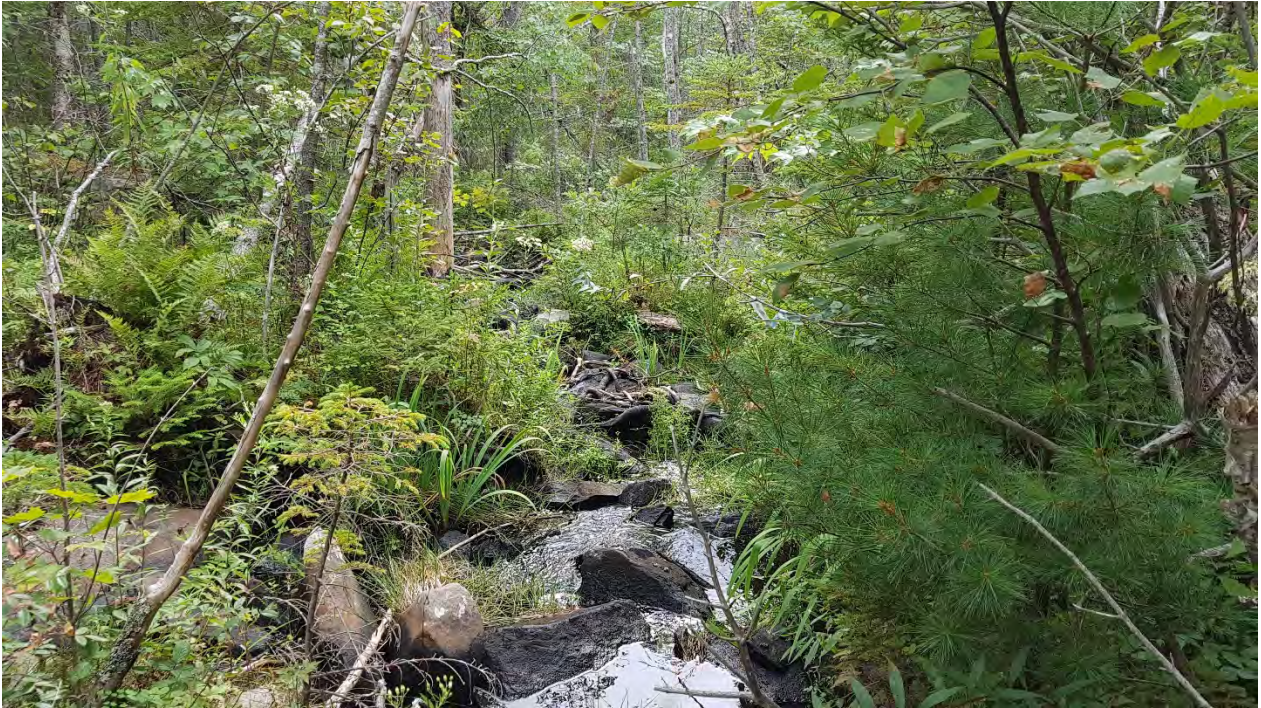
Photo 35. Mitchell Brook downgradient of Area 1E – Looking downstream from Culvert 2; the gradient is very steep and fast flowing.

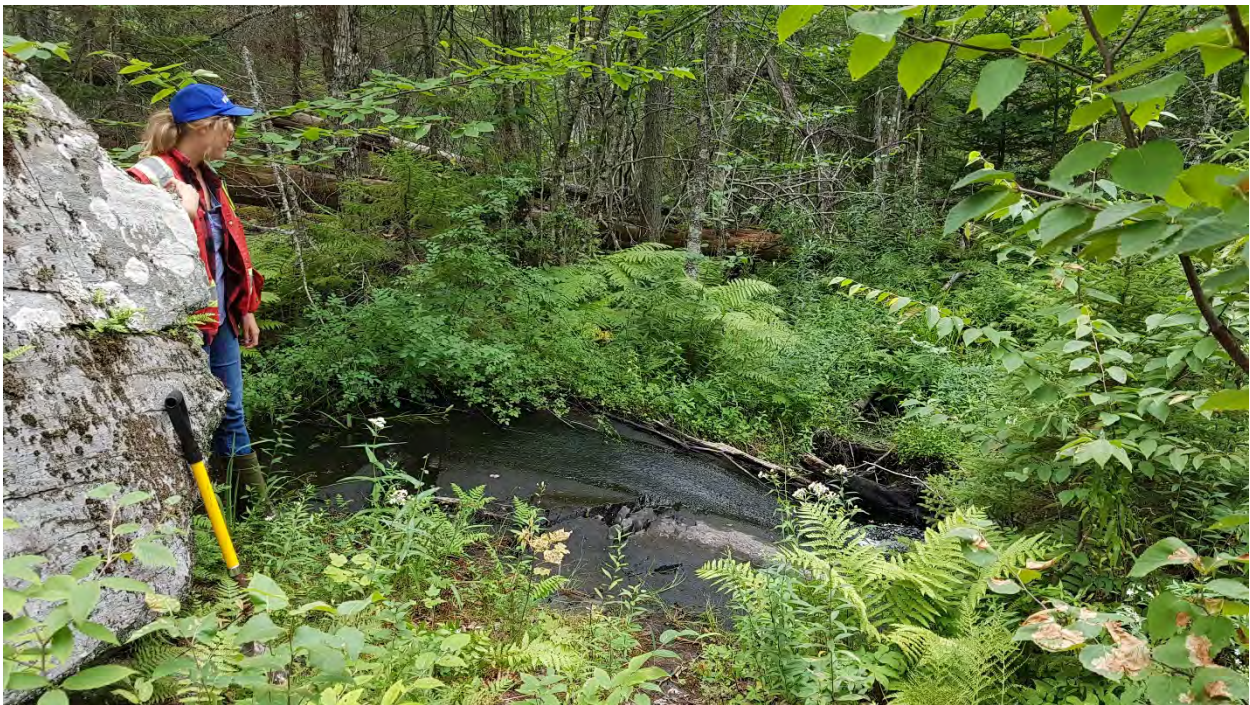
Photo 36. Mitchell Brook downgradient of Area 1E – At one point, the water flows in a thin sheet over a bedrock chute.

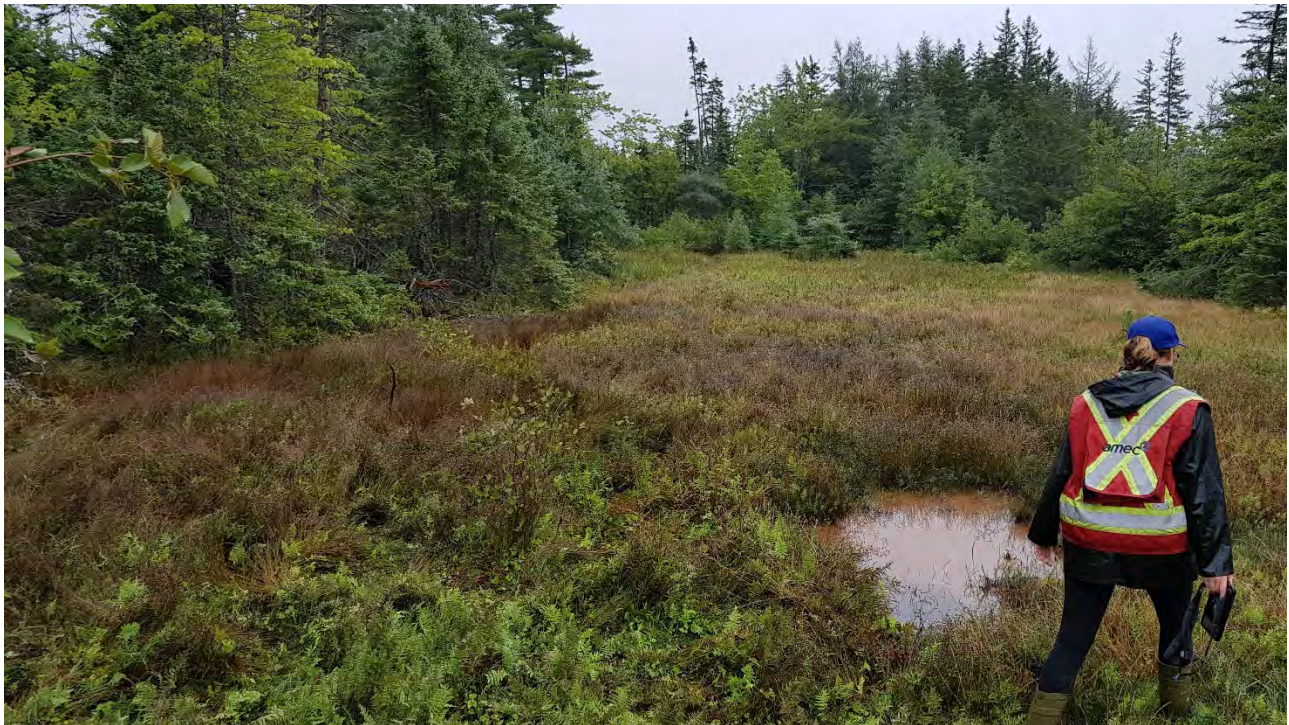
Photo 2. Area 3A – Looking south from the location above toward tailings impacted wetland. There is coarse and fine tailings around the eastern edge of the wetland and several fenced in abandoned mine works.

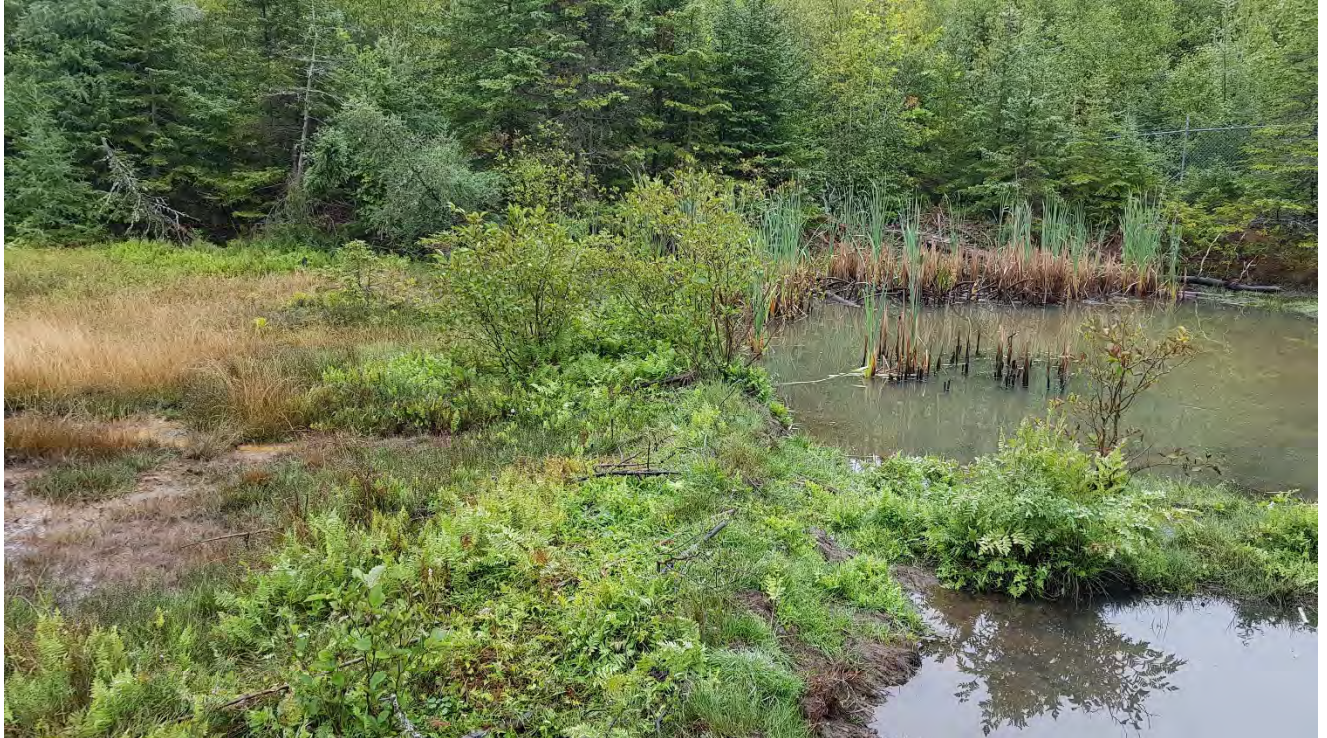
Photo 3. Area 3A – Looking east along the beaver dam. Water in the pond and drainage from it was visibly dirty, following significant rain the previous night.

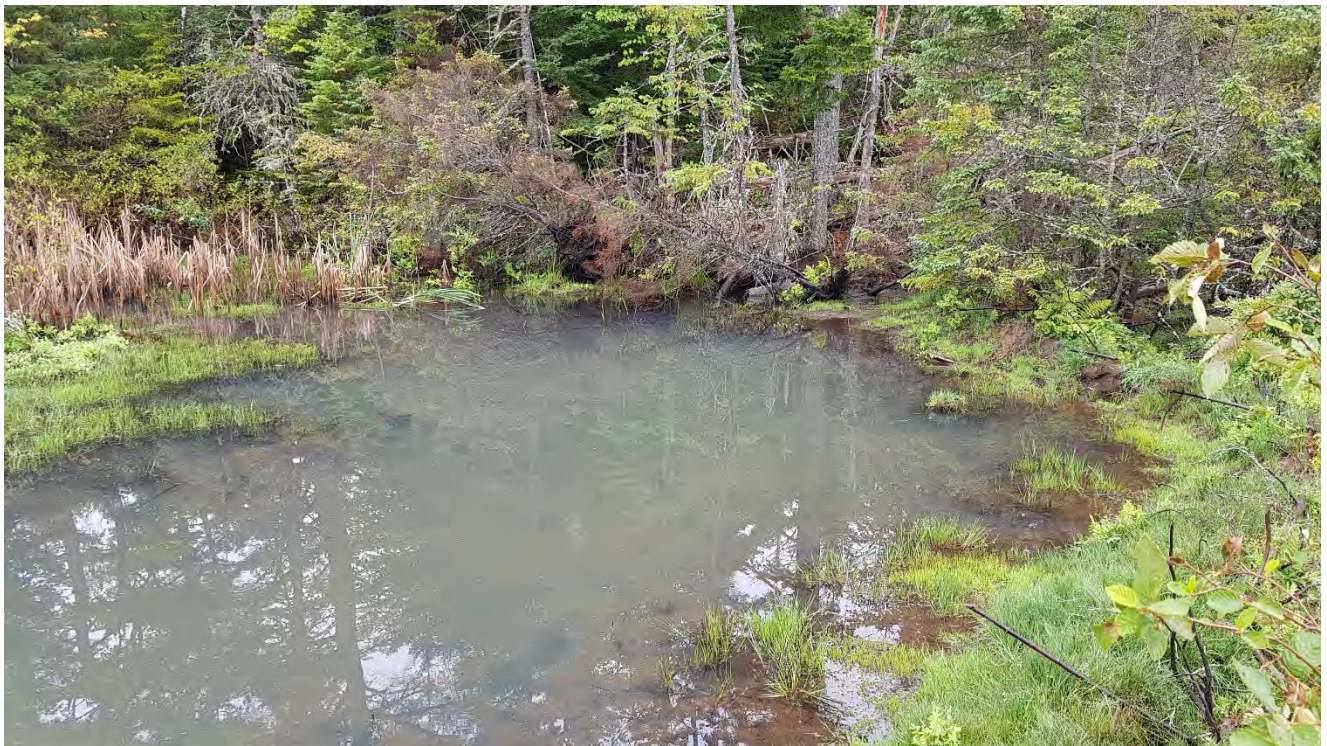
Photo 4. Area 3A – Looking west from the location above. The western shore is a very steep slope.

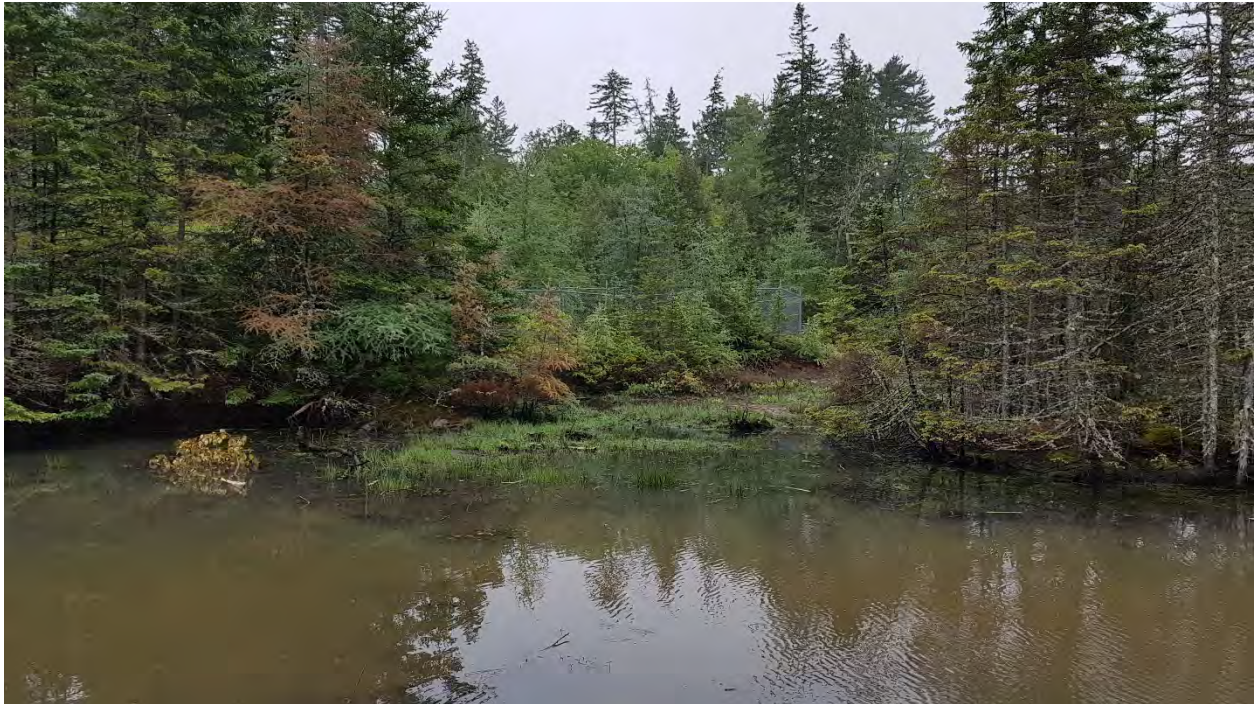
Photo 5. Area 3A – Fenced in mine works are visible at centre and historic mining earth disturbance remains partially bare.

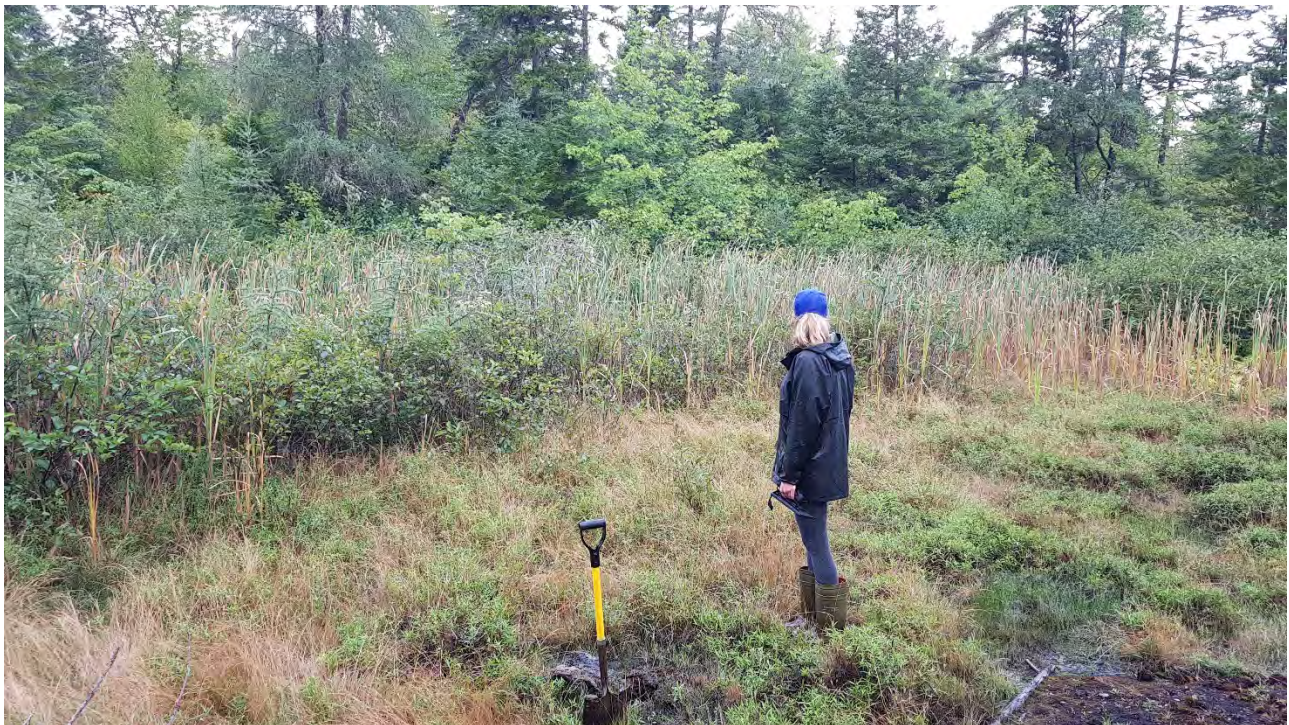
Photo 2. Area 3B – An area of historic fill (presumably mine tailings) was observed on the east edge where low growing vegetation persists.

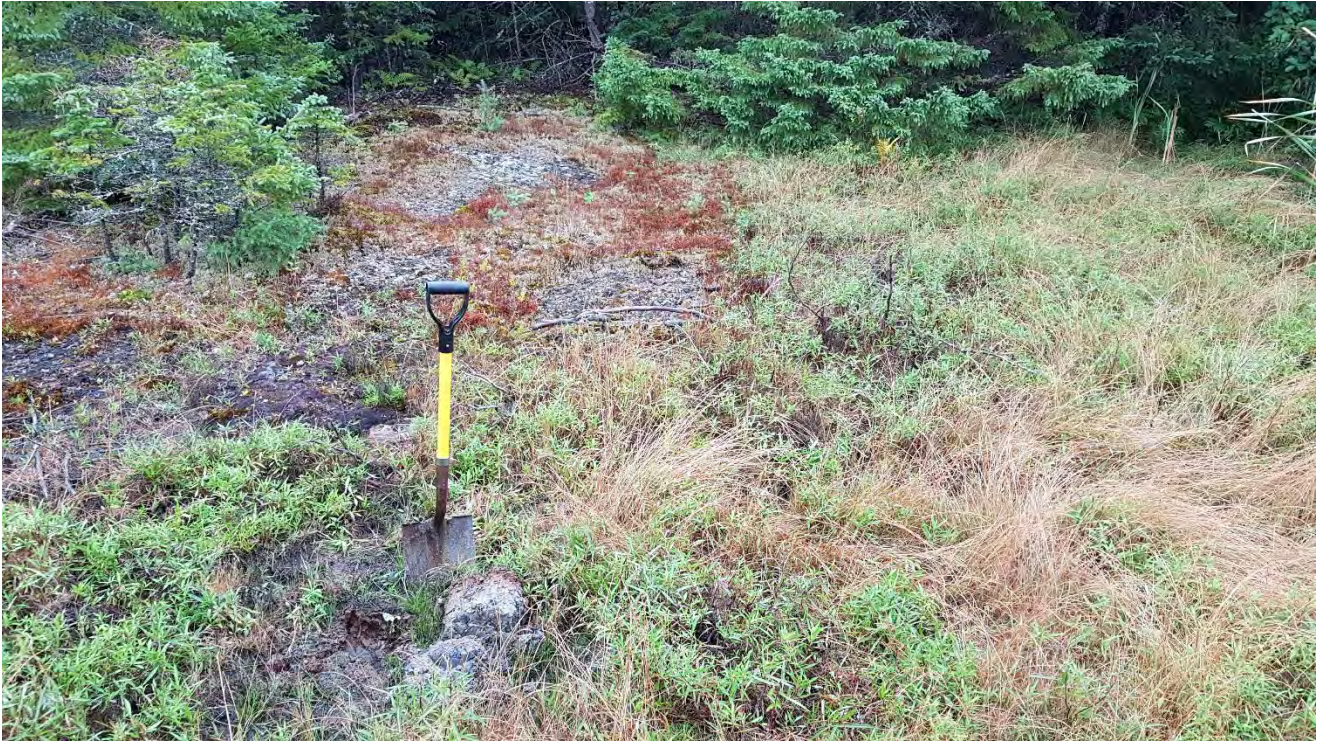
Photo 3. Area 3B – Adjacent to the wetland (left side), the fill (gravel and fines) is almost unvegetated in places, having only lichen and moss cover.

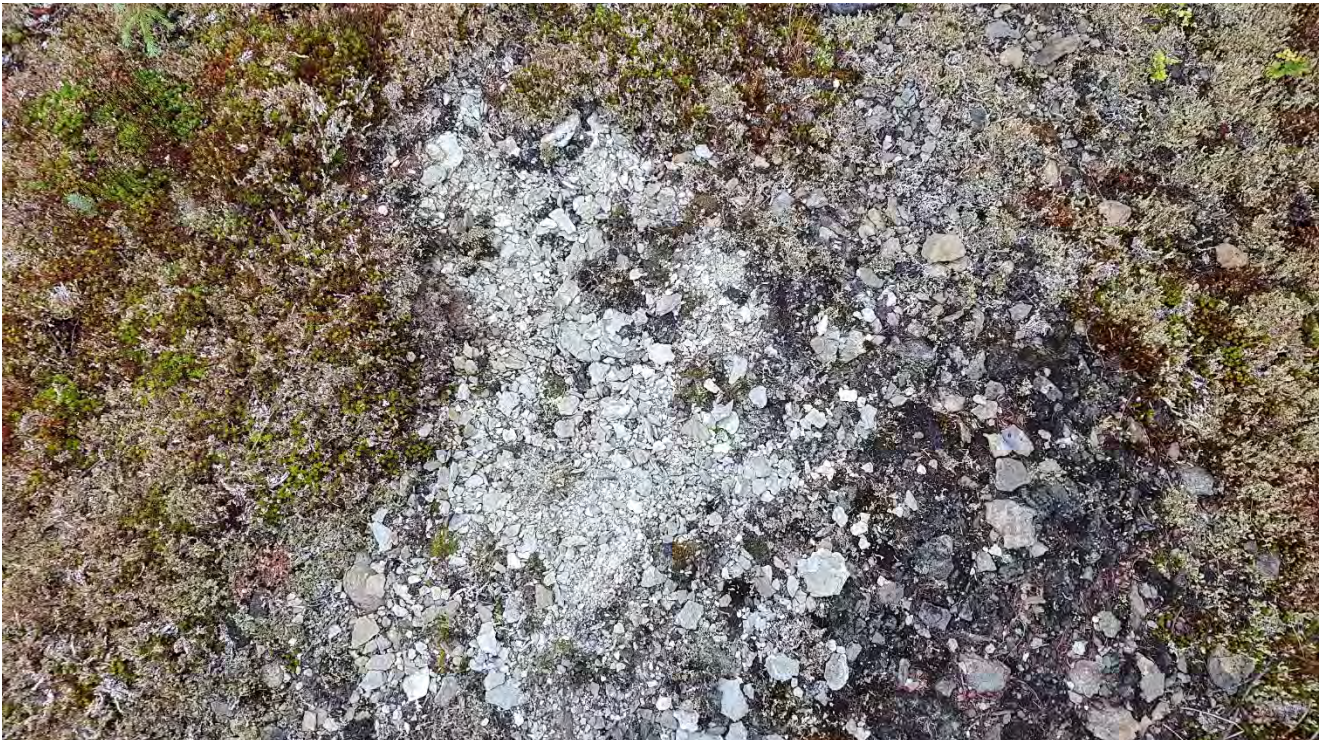
Photo 4. Area 3B – Unvegetated fill deposit adjacent to wetland.

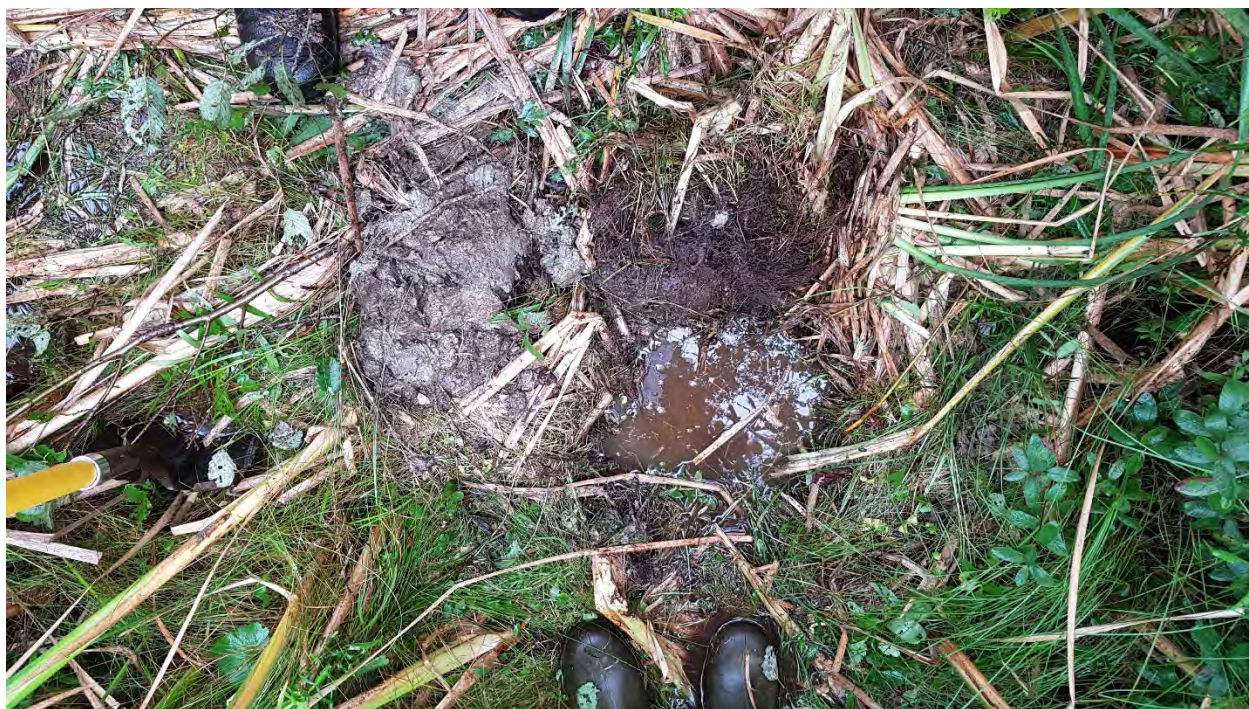
Photo 6. Area 3B – The wetland soil is fully saturated grey coarse sand with relatively low organic content.

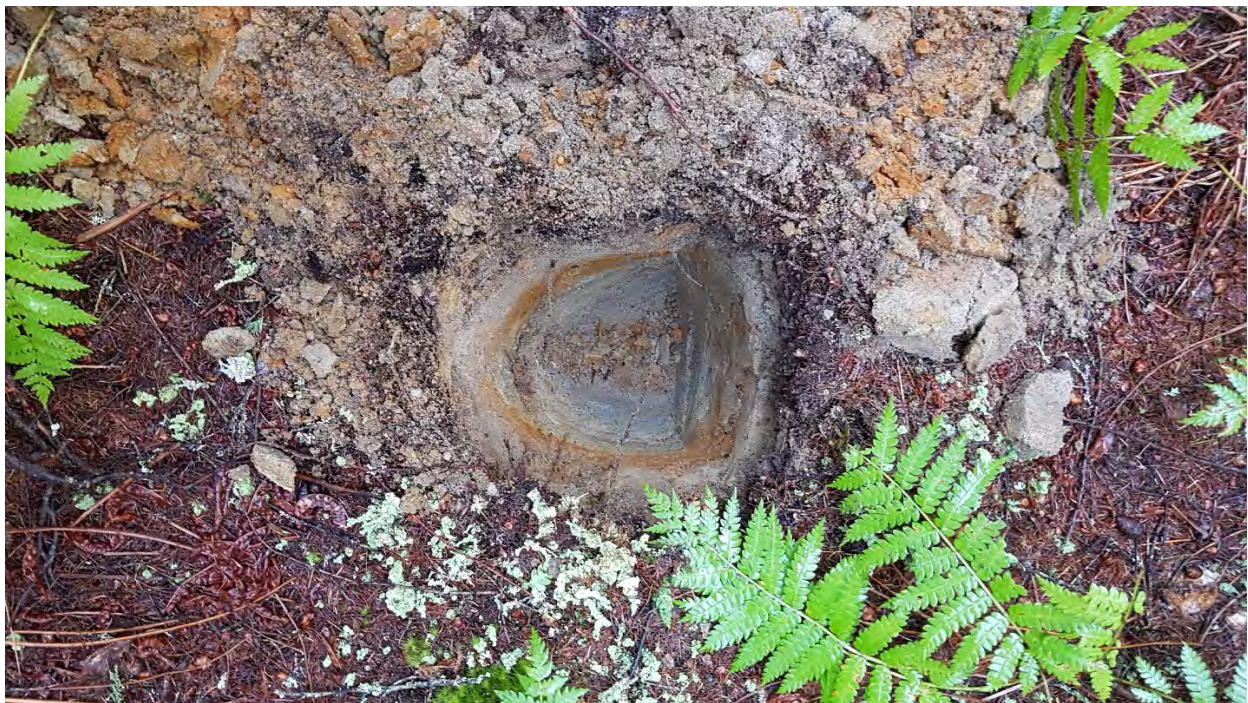
Photo 8. Area 3B – The upland soil is also grey coarse sand, showing signs of leaching and iron accumulation in the upper part.

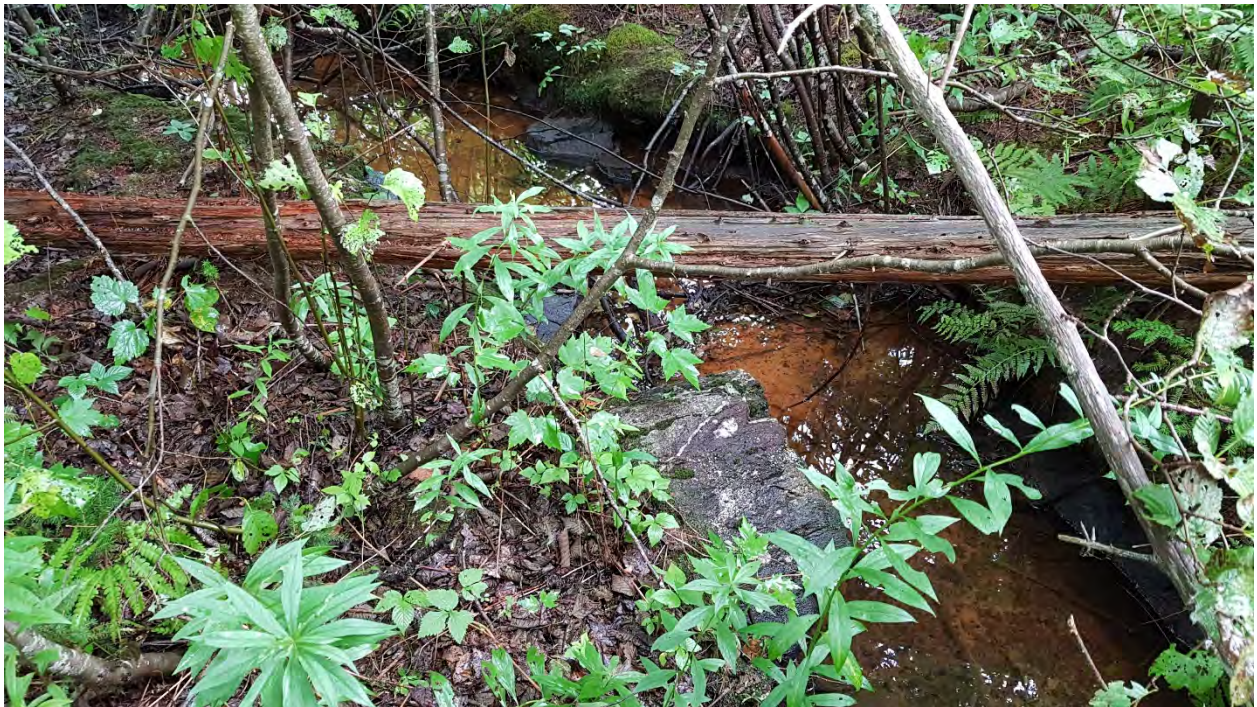
Photo 9. Area 3B – A small stream flows out of Area 3B, showing signs of seasonal high flow volumes. This watercourse flows intermittently into the beaver pond at the south end of Area 3C.

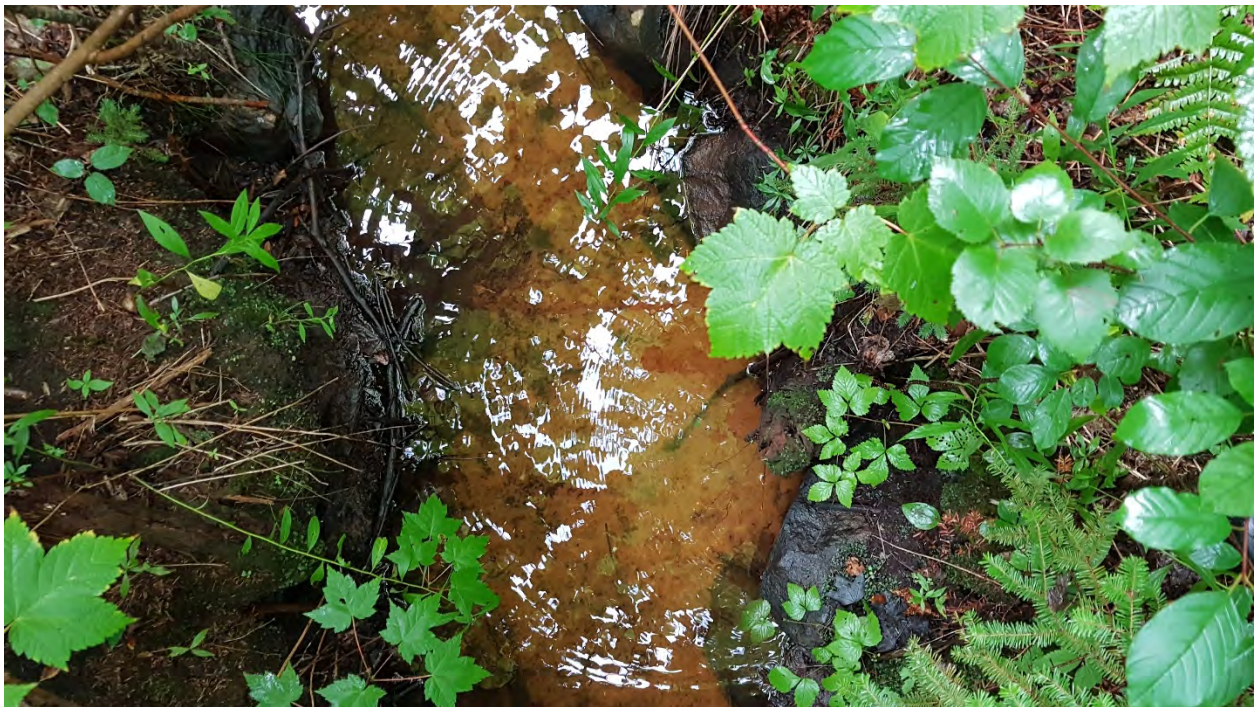
Photo 10. Area 3B – The bed is filed with sand over coarse rock fragments.

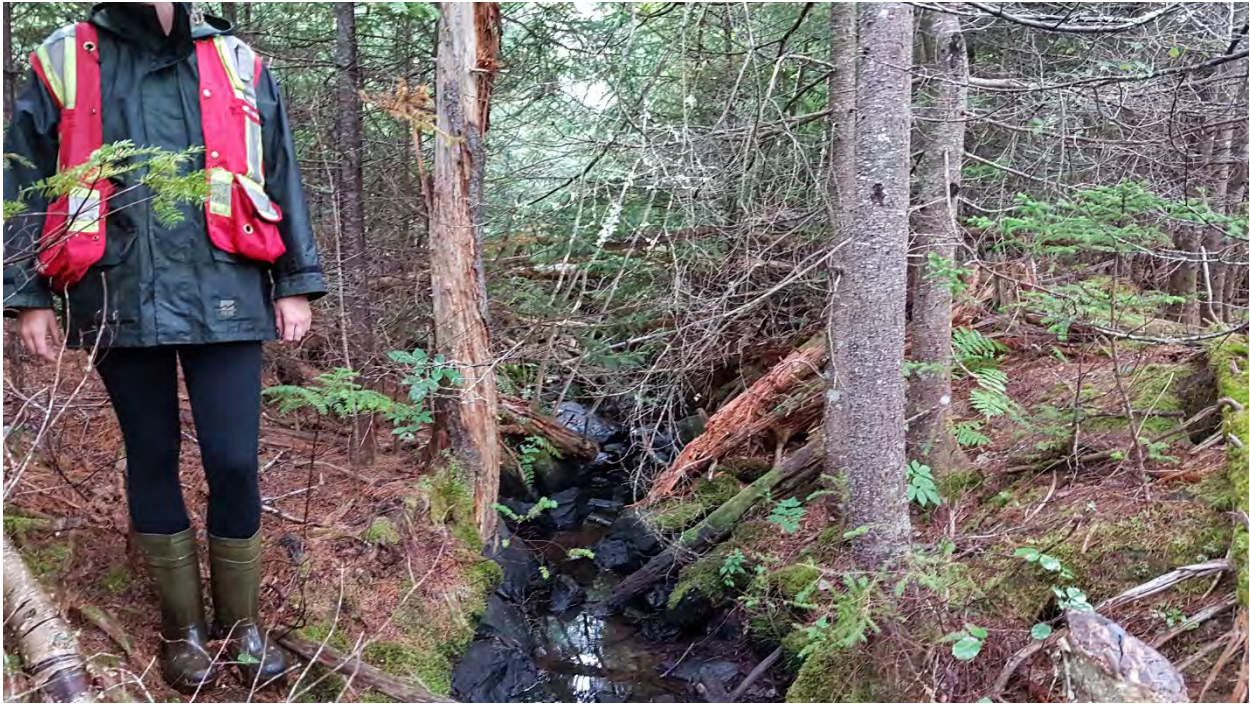
Photo 1. Area 3C – A man-made trench drains Area 3A.

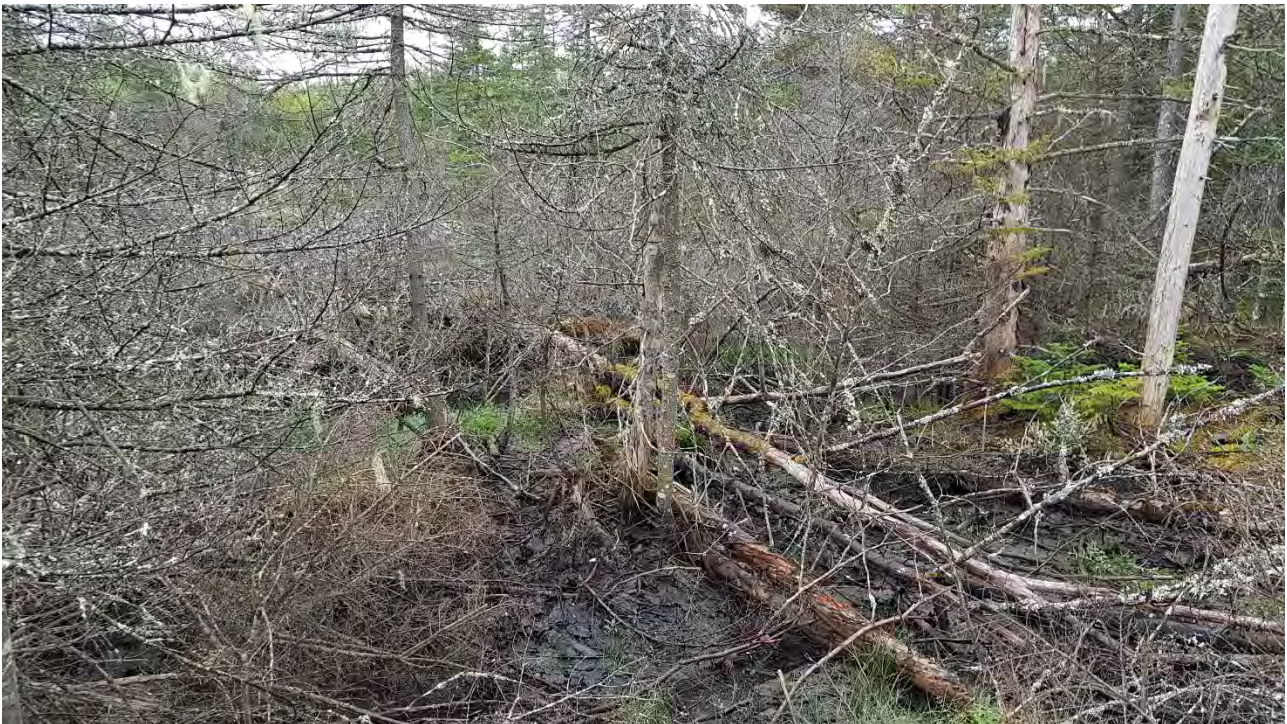
Photo 2. Area 3C – The trench empties into the southwest corner of Area 3C in the edge of a beaver impoundment. At the time of the survey, the water level was very low, possibly indicating the dam was not being maintained.

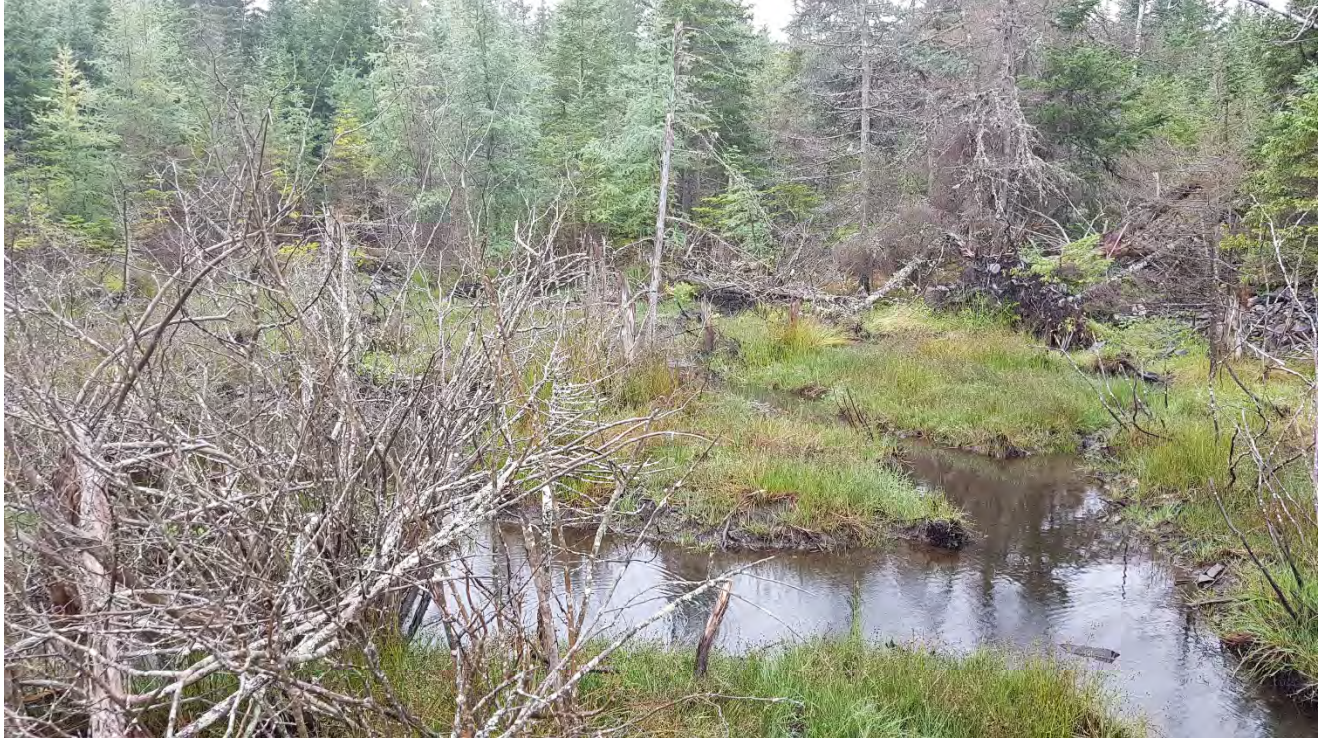
Photo 3. Area 3C – Looking south in the main beaver pond, toward the direction that receives drainage from Area 3B. There are signs of severe seasonal erosion.

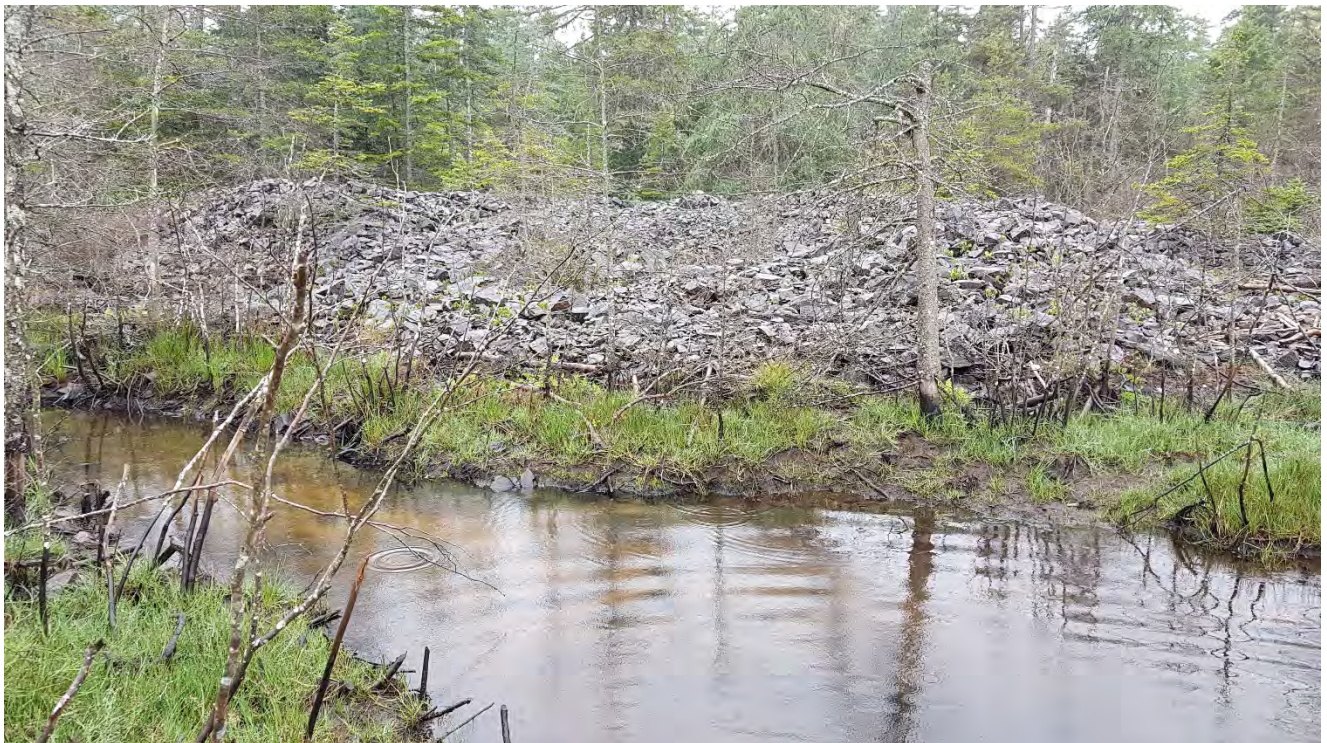
Photo 4. Area 3C – The beaver pond is located in an area of significant historic mine tailings deposits.

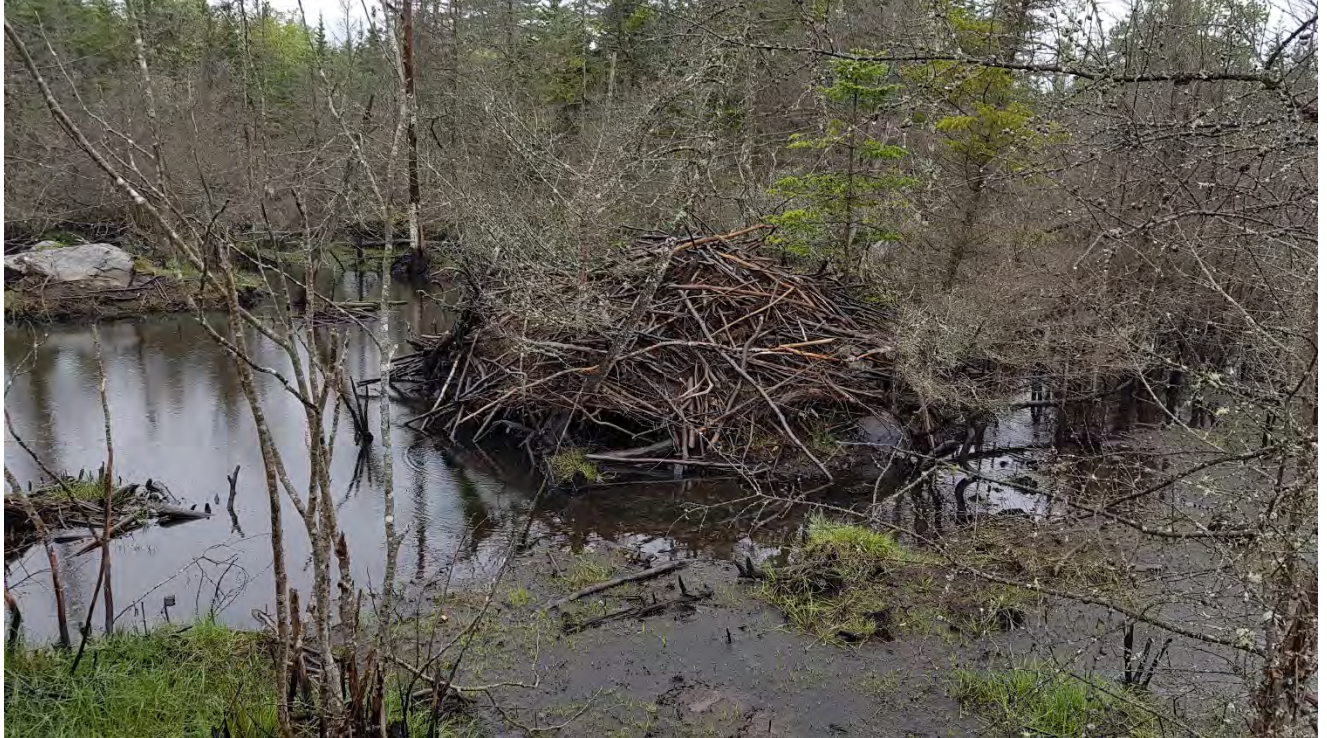
Photo 5. Area 3C – A beaver lodge is present, although normally it would be surrounded by water.

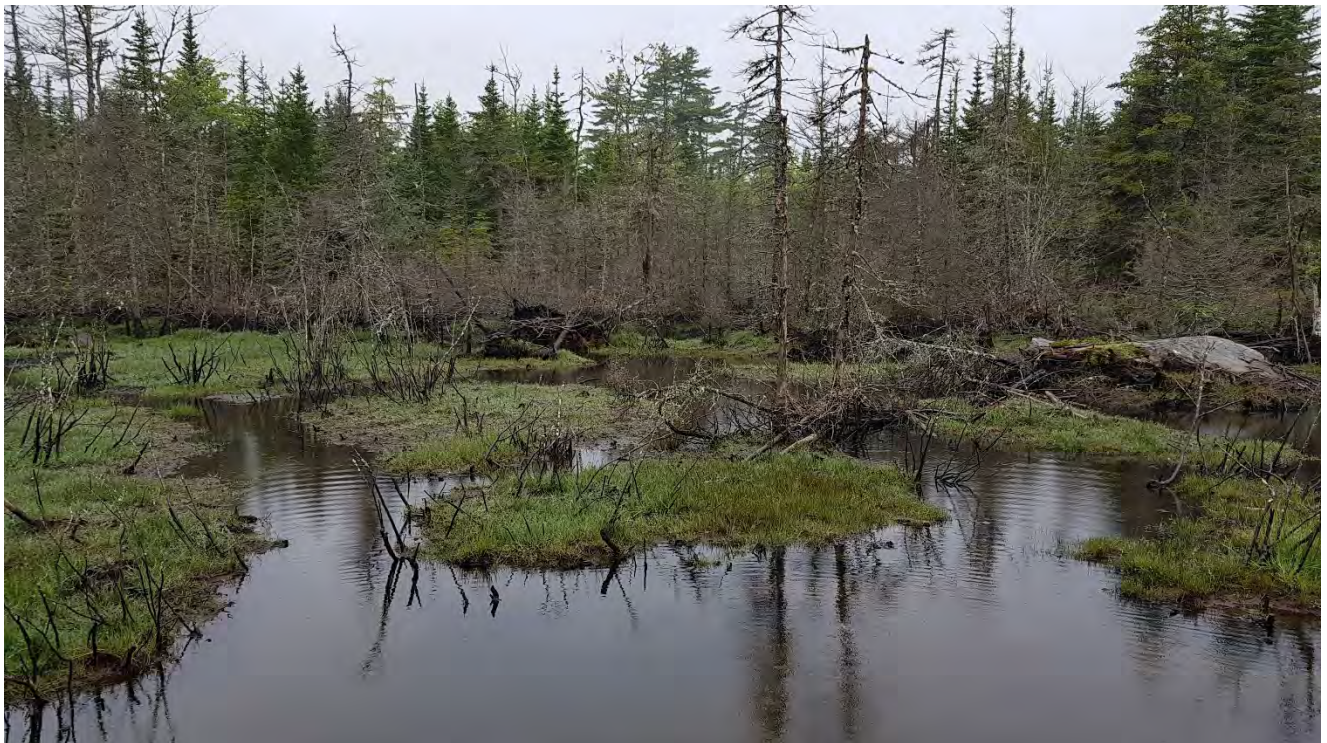
Photo 6. Area 3C – Currently there is a large, vegetated area in the drained beaver pond with a network of shallow water channels.

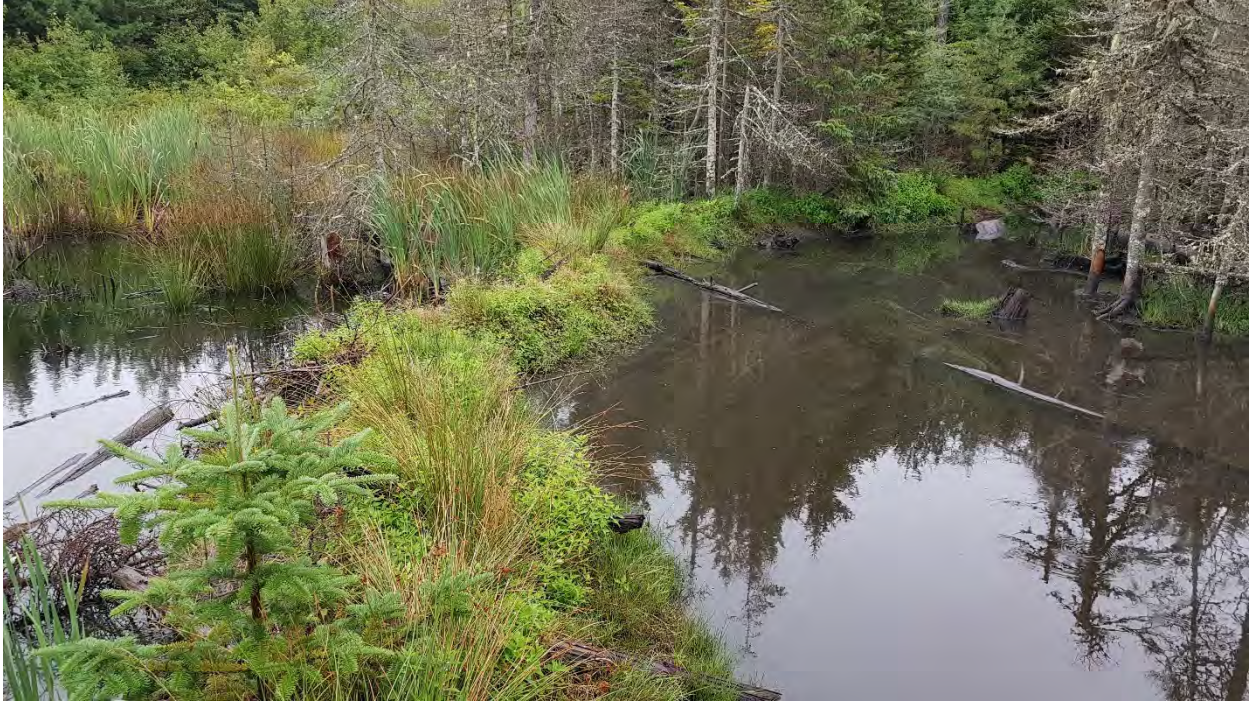
Photo 7. Area 3C – There is a better maintained beaver dam further downstream at the powerline corridor.
