**Wetland Assessment Report**  
**Montague Gold Mines, Nova Scotia**  
**Final Report**

Project #: TV183013

May 2021

**Intrinsik Corporation on Behalf of Nova Scotia Lands**

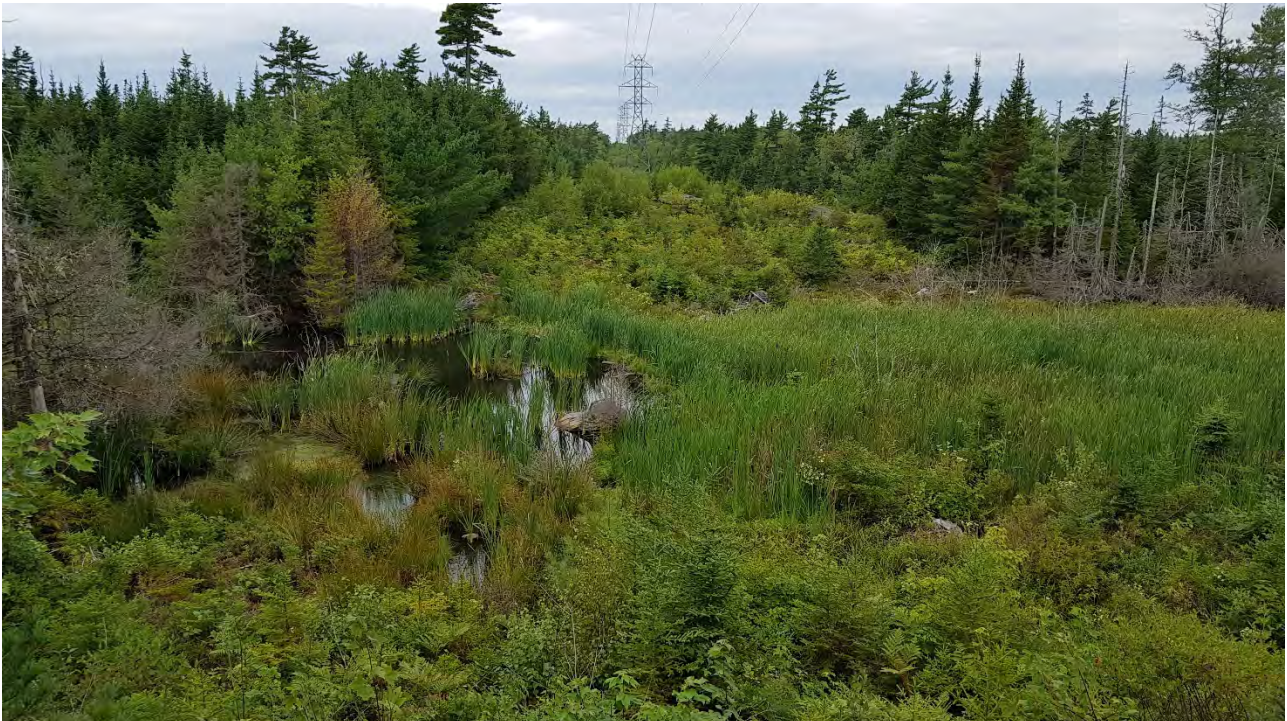
Photo 8. Area 3C – Looking west at the powerline, across the main drainage channel in Area 3C (flows from left to right). The wetlands in Area 3 are “topographically constrained”, having relatively steep sided ridges along the edges.

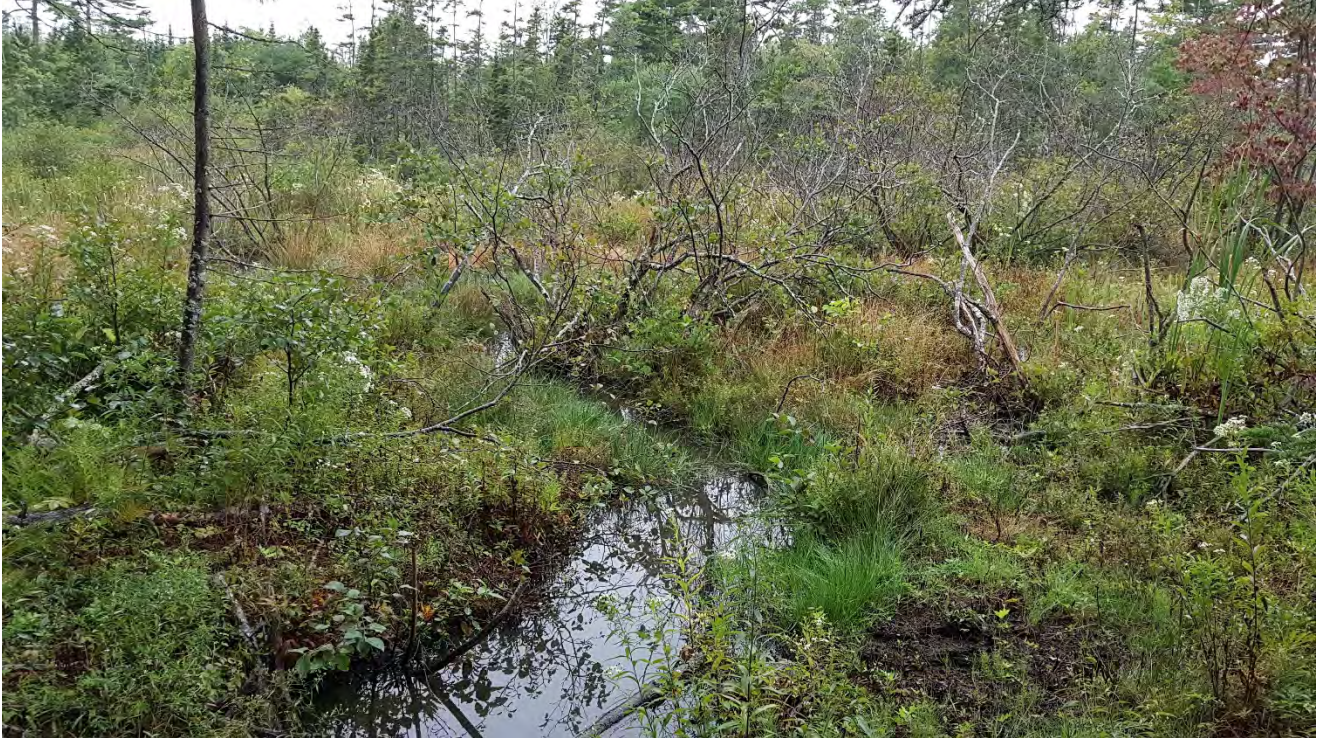
Photo 9. Area 3C – Looking northeast in an extremity of Area 3C where a smaller tributary joins it north of the powerline.

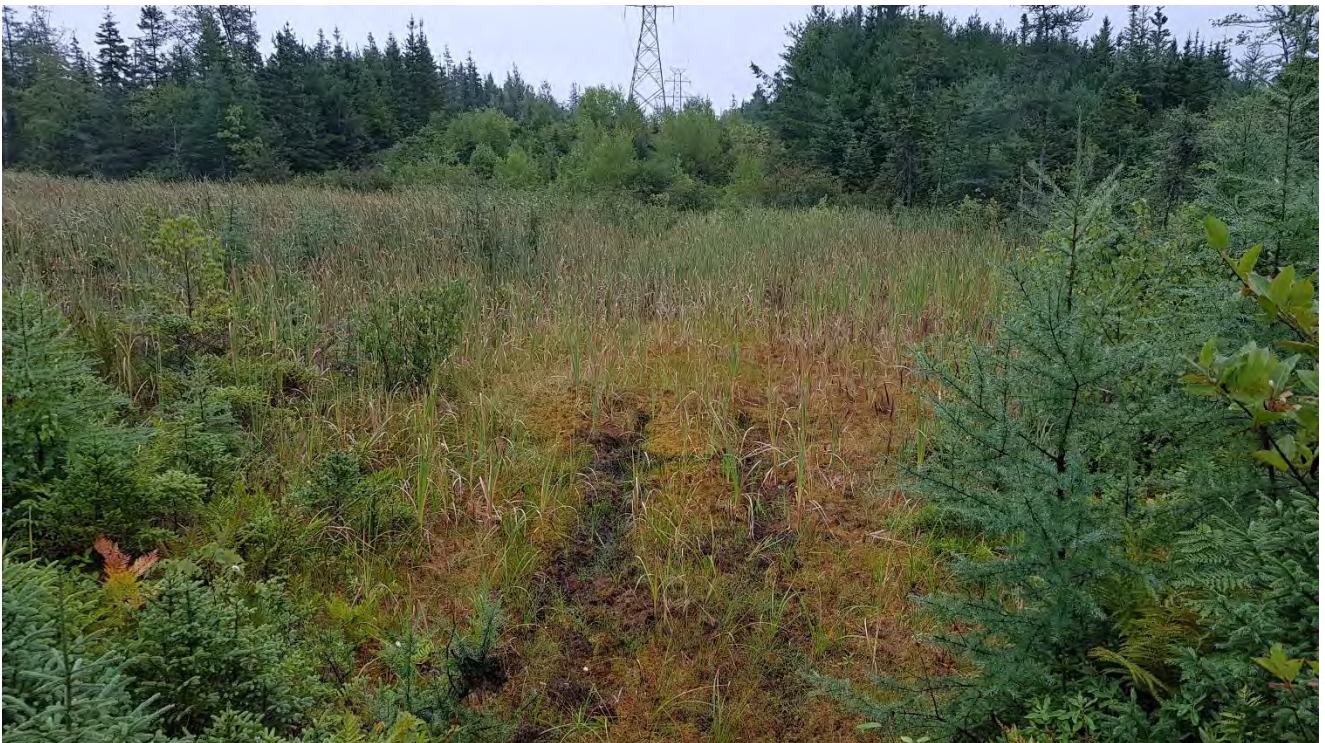
Photo 10. Area 3C – Looking east along the powerline in the southwest "lobe" of Area 3C. There was no indication this part of the wetland has been impacted by historic mining activity.

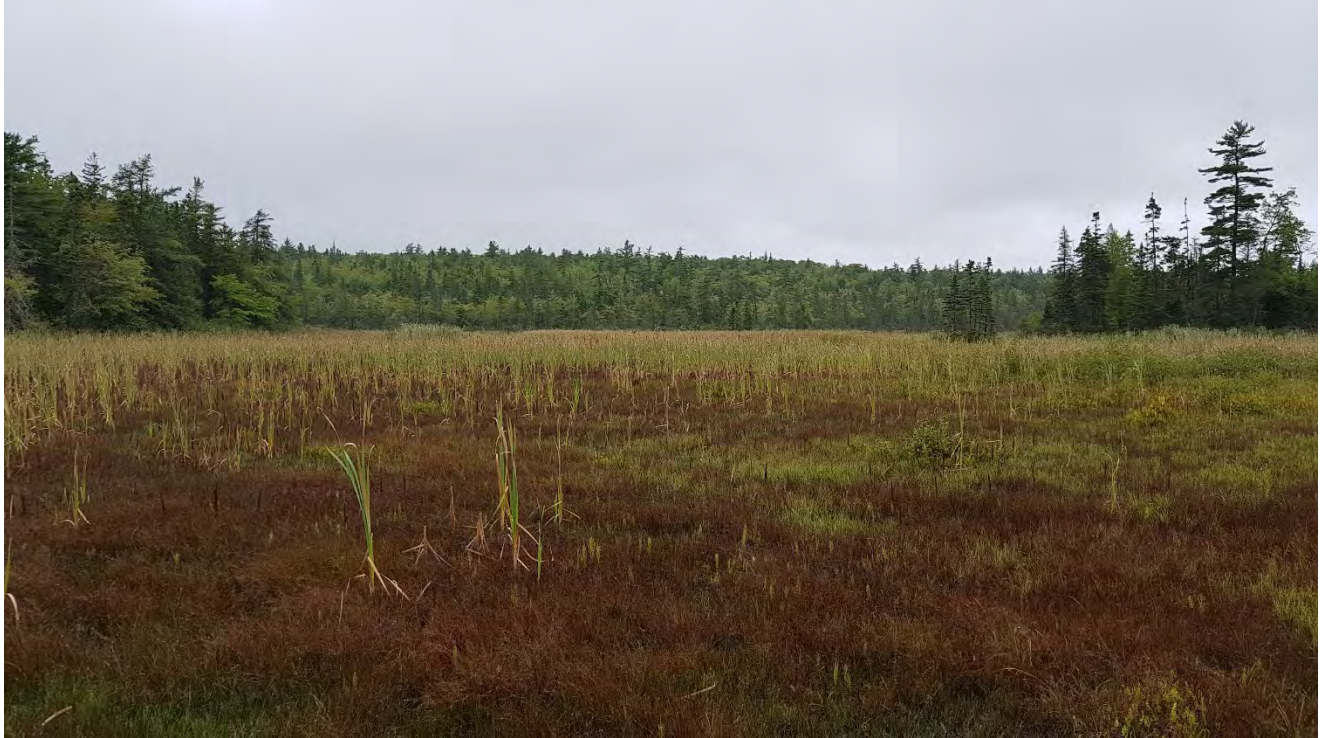
Photo 11. Area 3C – Looking northeast in the large flat meadow of Area 3C. The vegetation is somewhat similar to other tailings impacted areas. There is no channel in this meadow and the water flow must be mainly sheet flow.

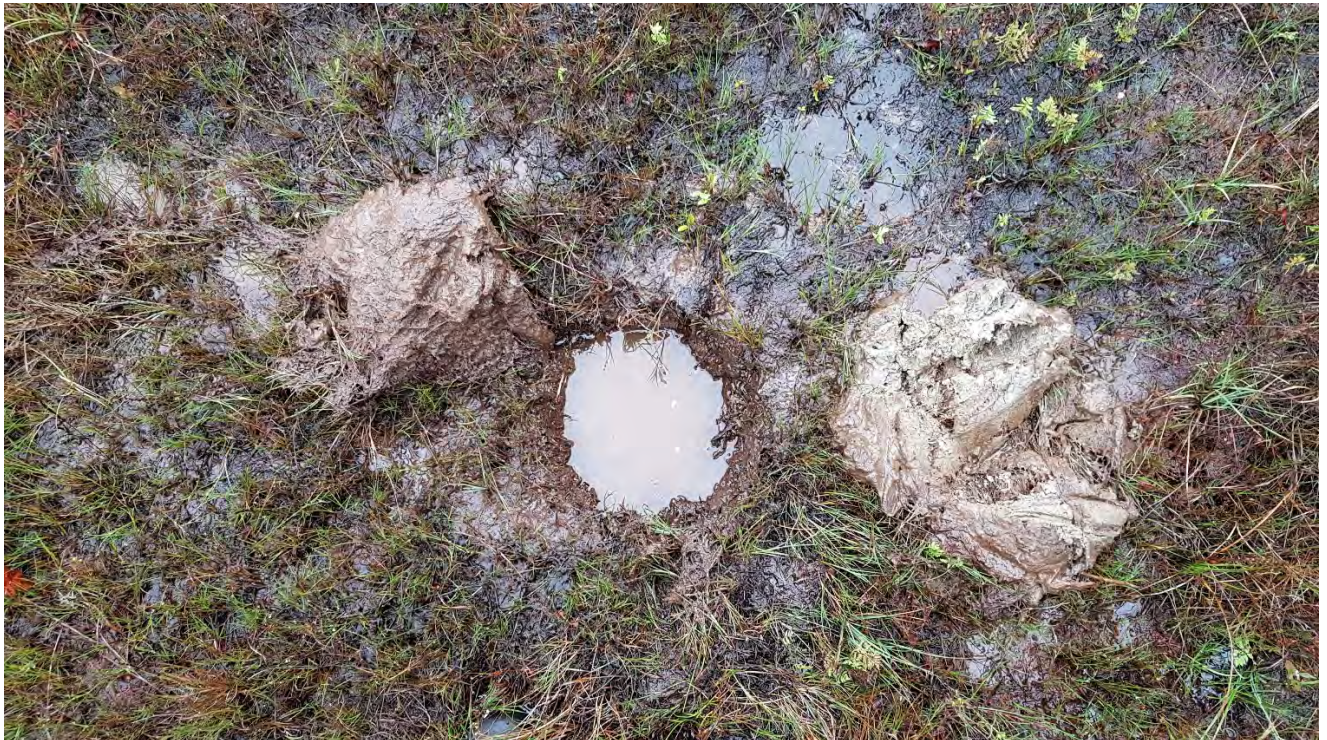
Photo 12. Area 3C – The wetland soil is grey coarse sand, identical to other tailings impacted sites. The sand substrate is dense and firm to walk on.

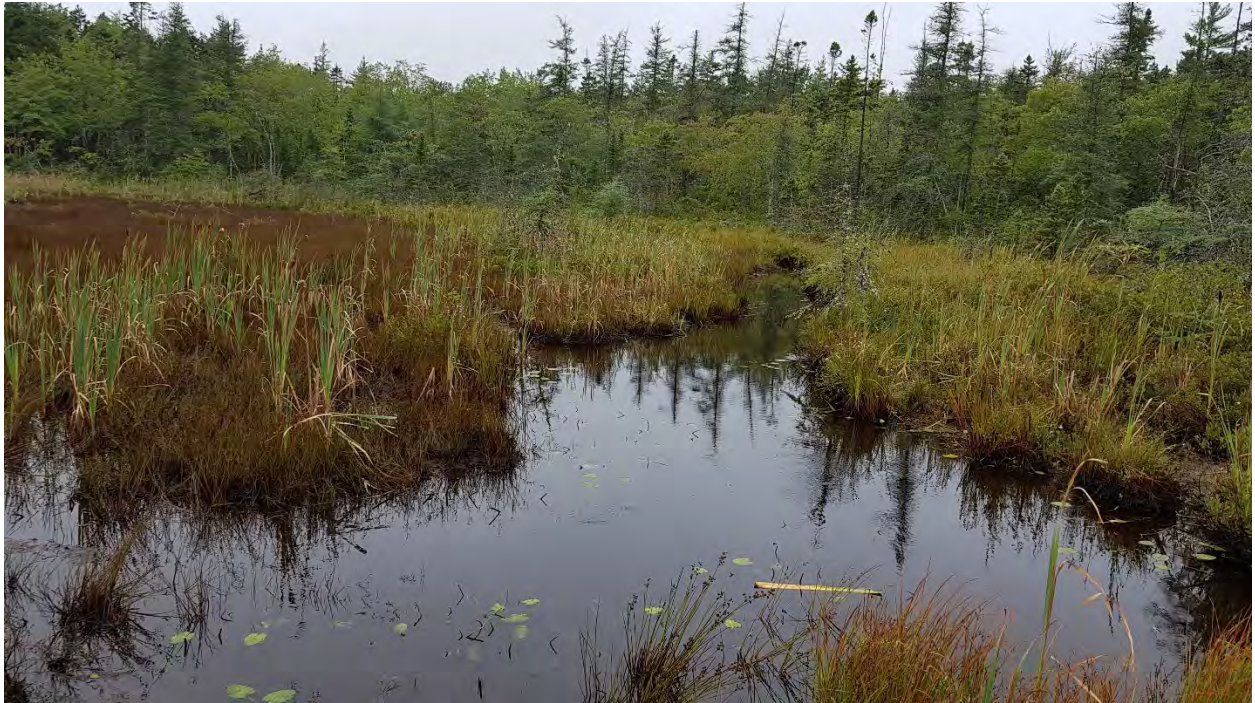
Photo 13. Area 3C – Looking west, where a major tributary enters the wetland. The more impacted wetland area is visible at left. It appears the wetland areas north of the watercourse (right side) are less heavily impacted.

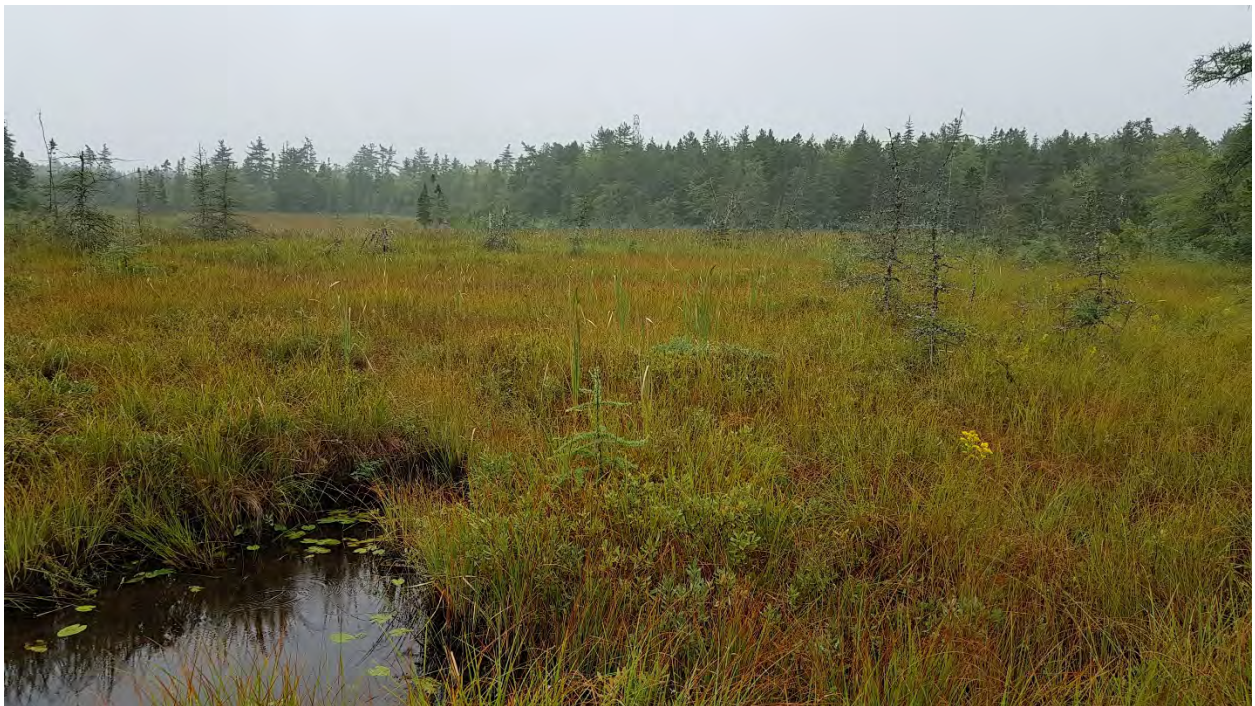
Photo 14. Area 3C – Looking southwest across the main meadow toward the location in Photo 11, above. More natural wetland vegetation and landforms begin to develop as indicated by increased microtopography, higher organic content in soils, and higher species diversity.

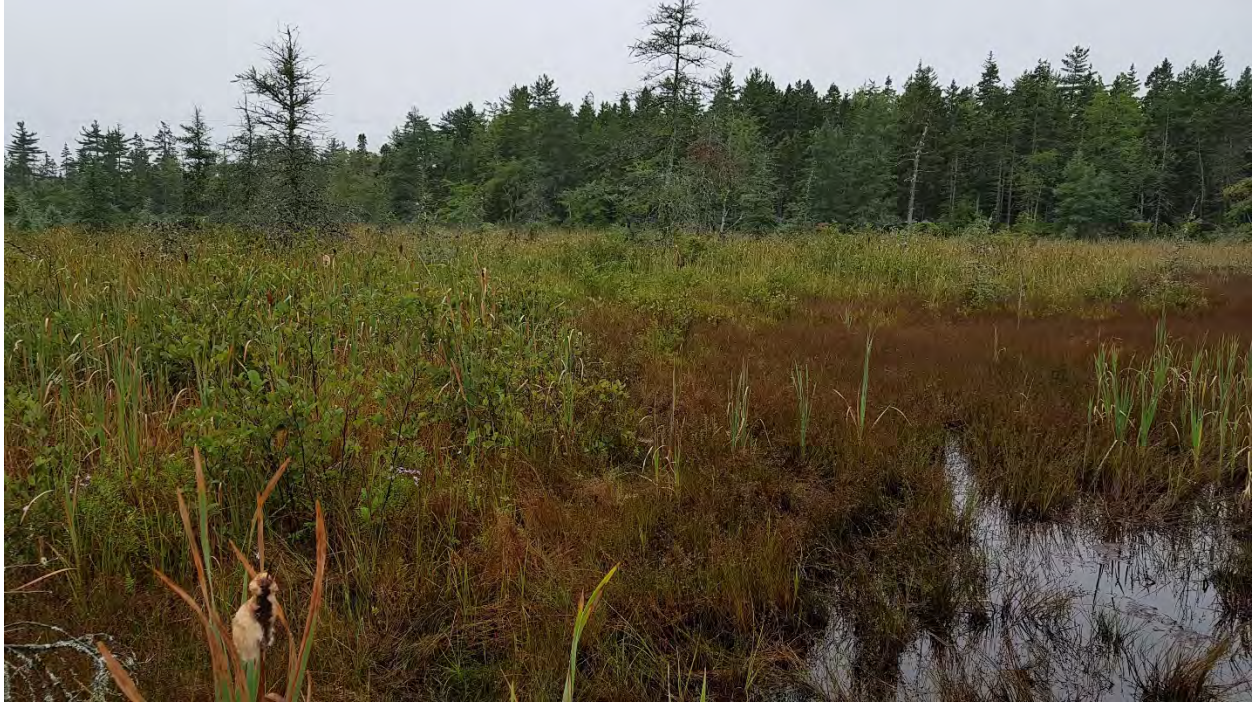
Photo 15. Area 3C – Looking southeast, across the wetland where impacted areas (at right) appear to transition into natural conditions (at left).

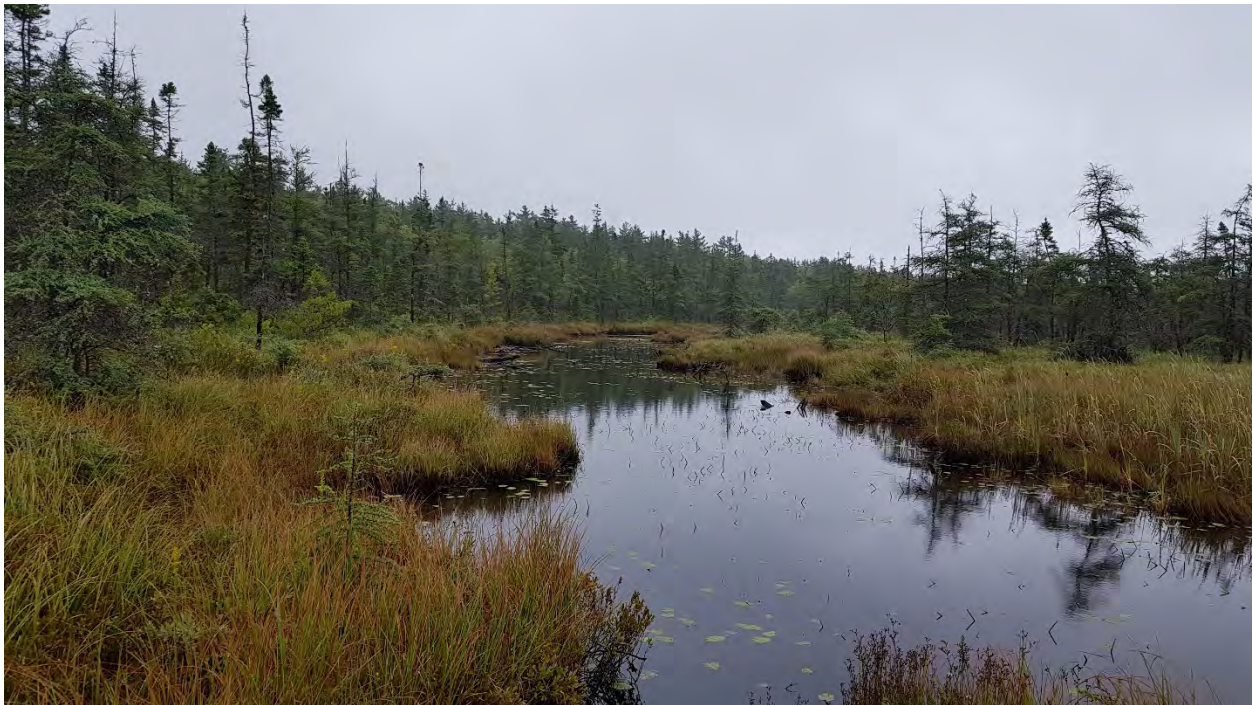
Photo 16. Area 3C – Looking northeast, downstream from the location above. From this point on, the condition of the wetland appeared relatively natural.

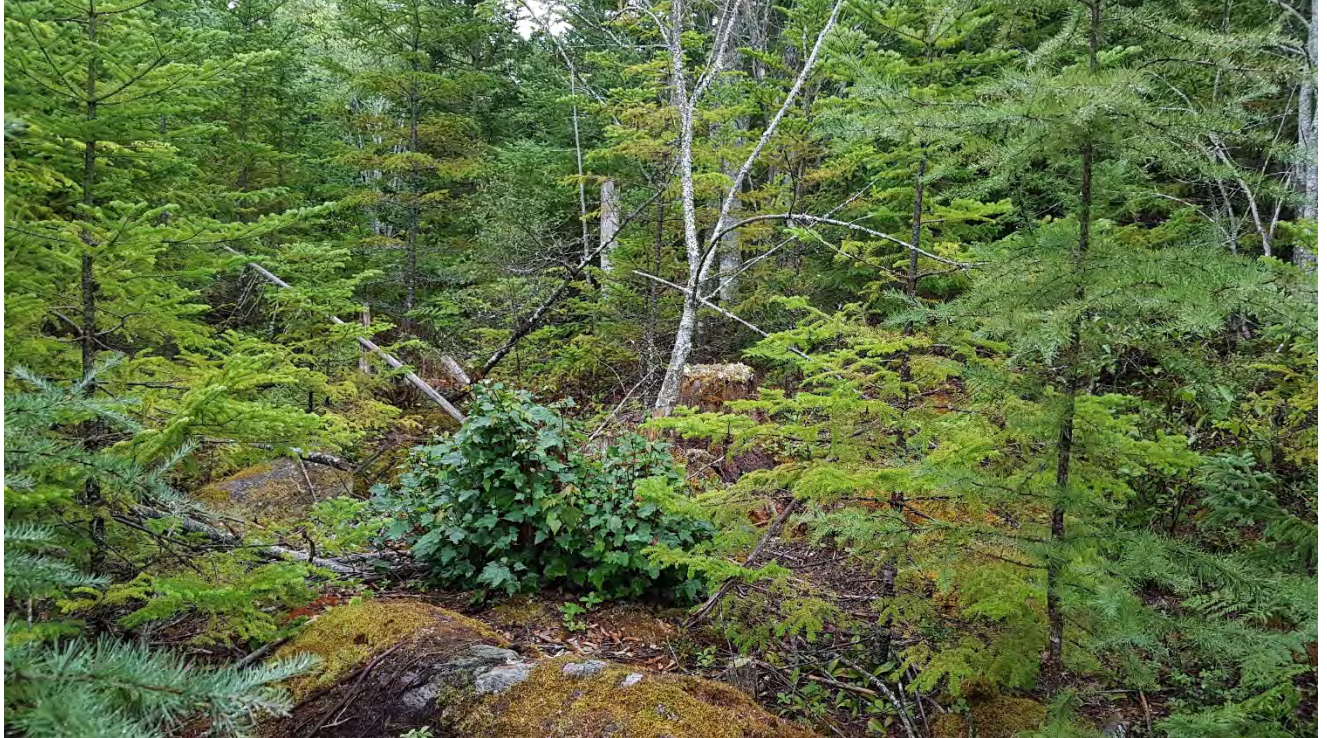
Photo 17. Area 3C – Some uplands in Area 3C show signs of past timber harvesting with relatively young regen and open structure.

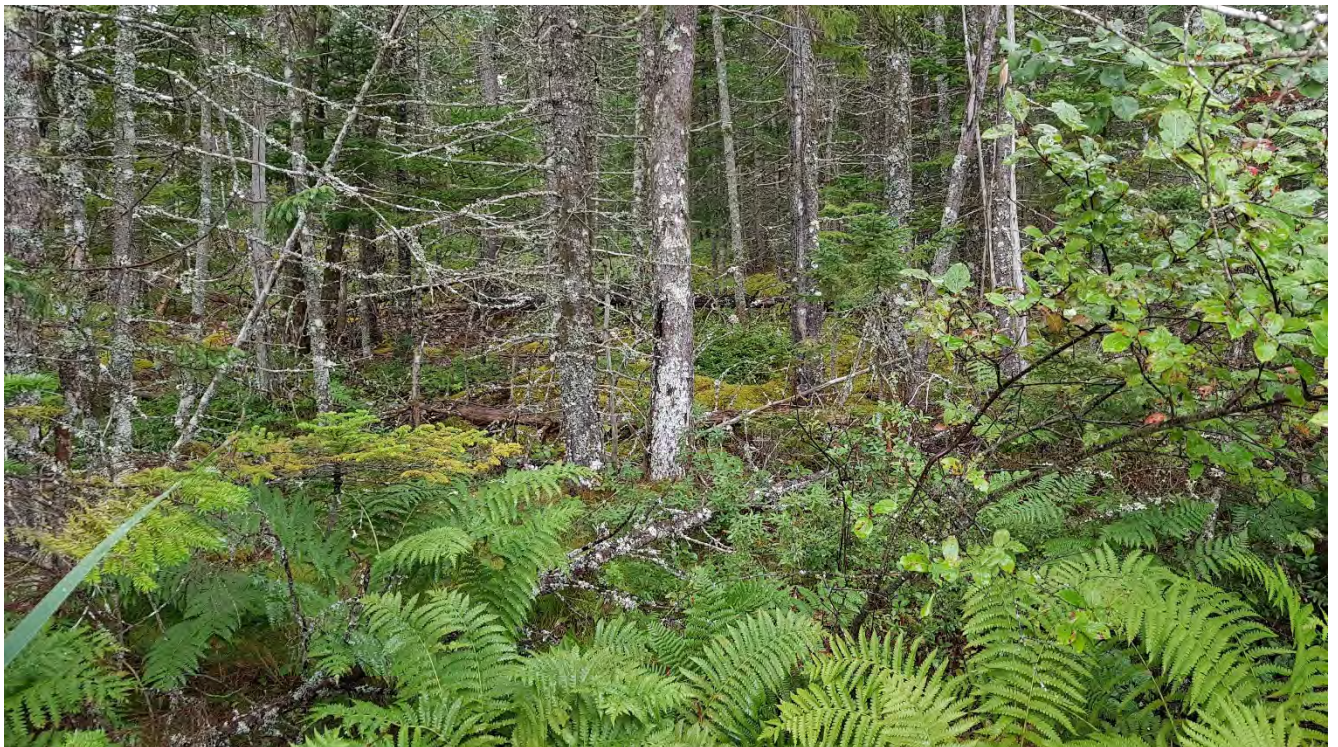
Photo 18. Area 3C – Mature forest is dominated by softwoods and there is a high percentage of blow-downs, perhaps indicative of coastal hurricane influence.

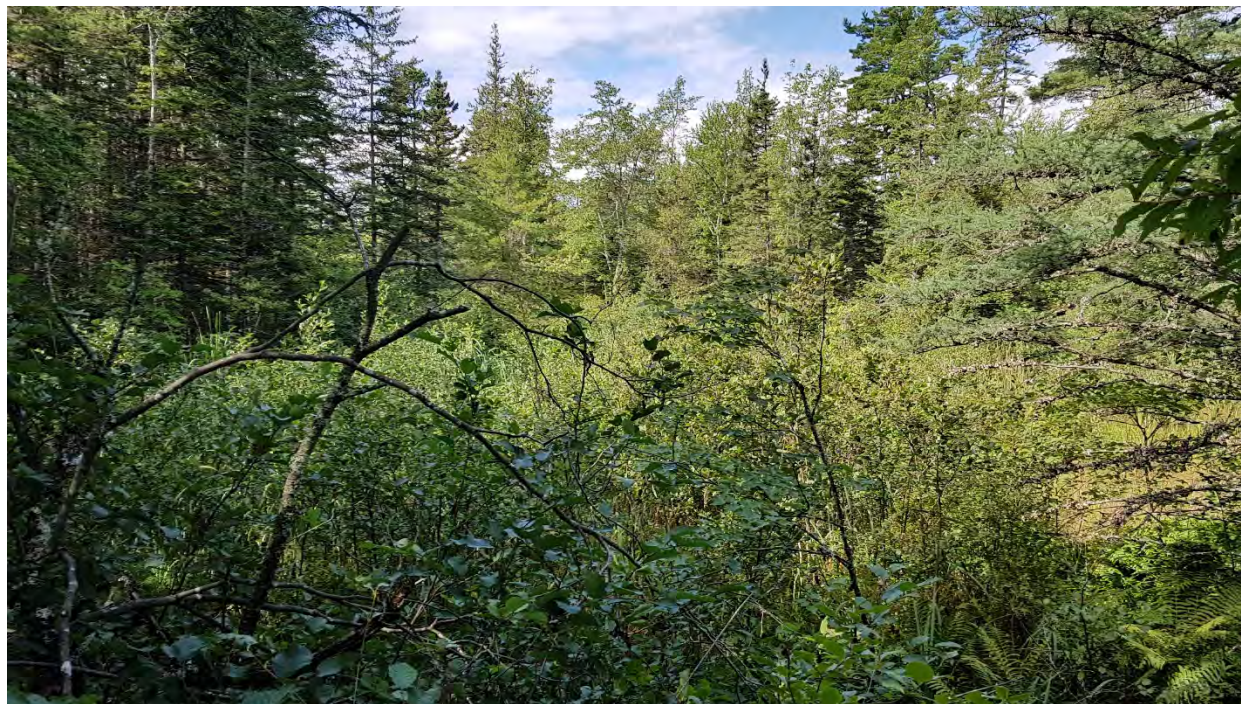
Photo 1. Area 3D – The south end of Area 3D is predominantly shrub swamp.

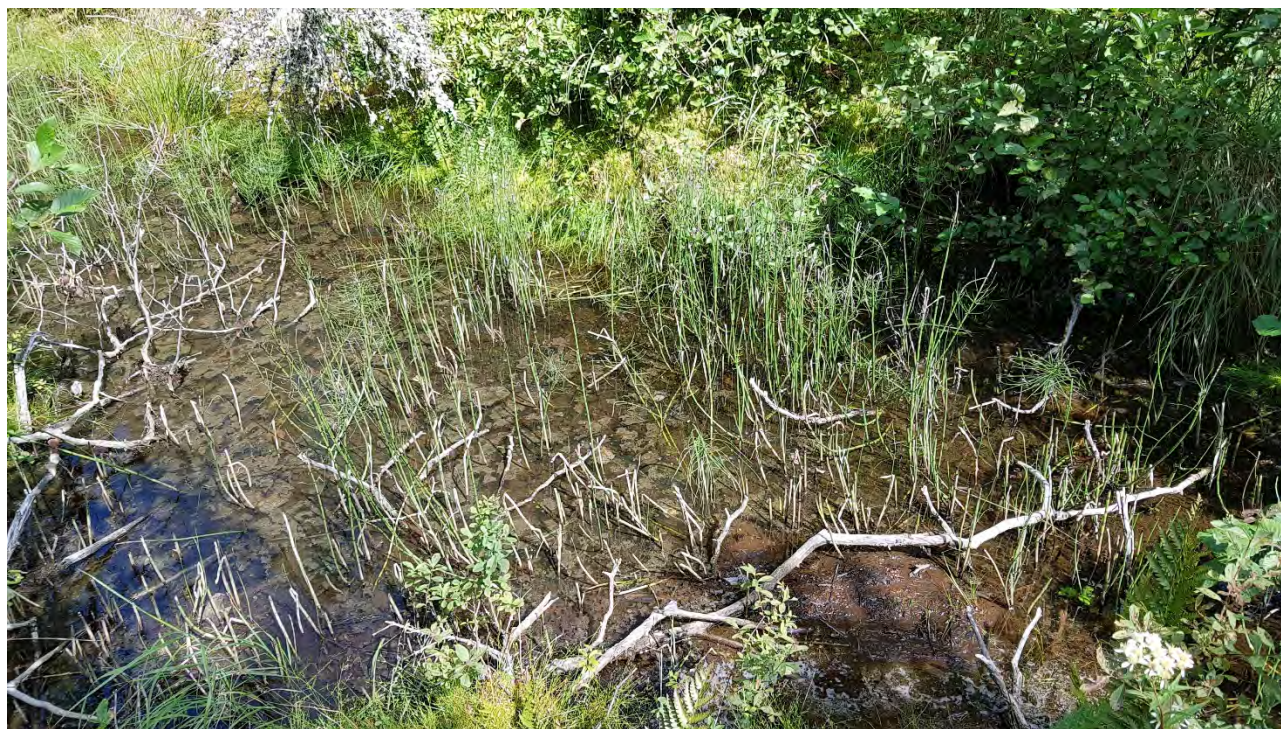
Photo 2. Area 3D – There is standing water and deep muck in the south part.

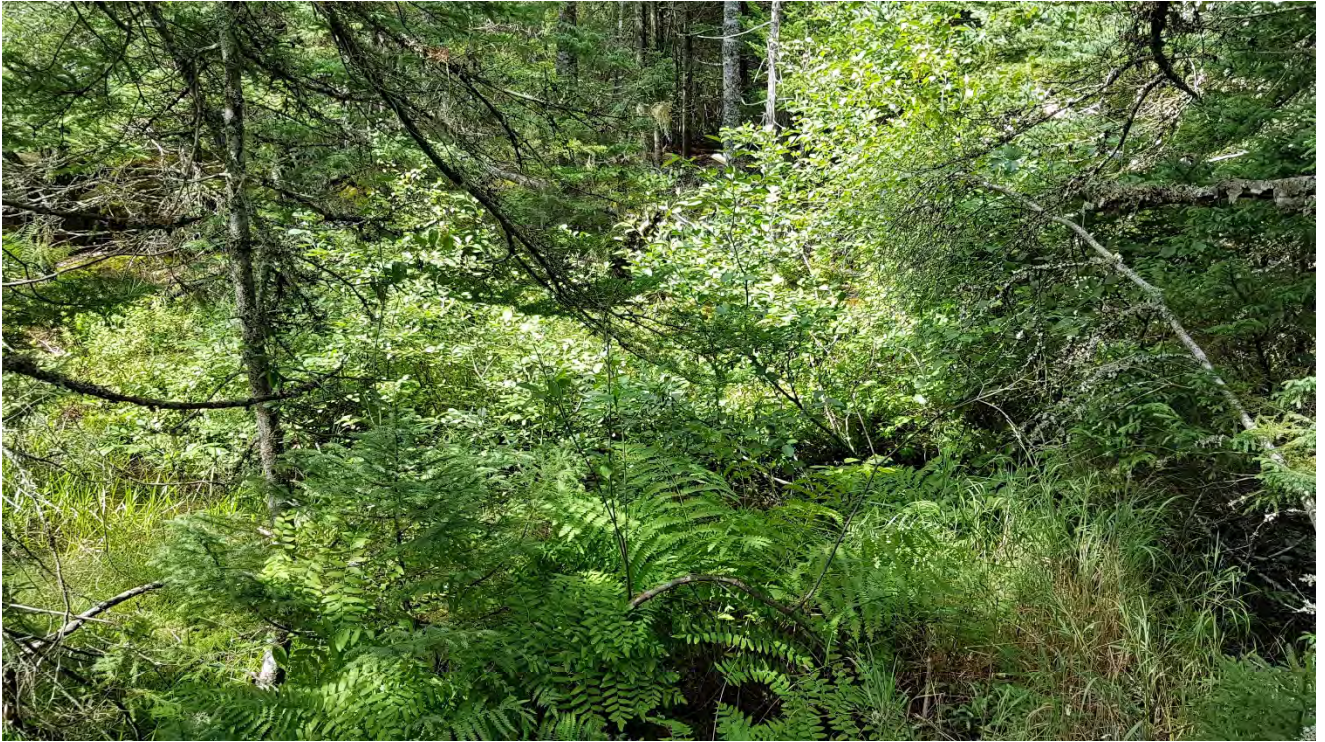
Photo 3. Area 3D – The south part and the north part are connected by a narrow drainage path.

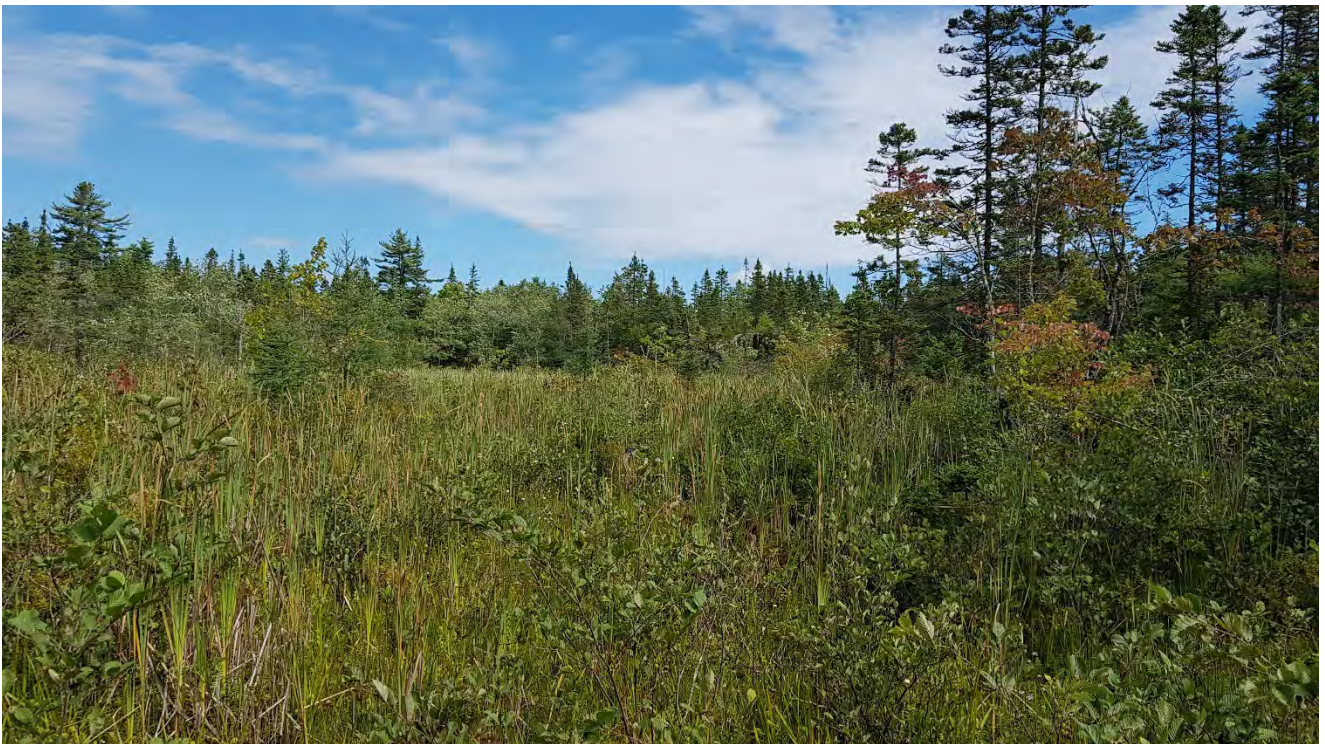
Photo 4. Area 3D – The north part of the wetland is more open, consisting of peatland (poor fen) with a shrub swamp margin.

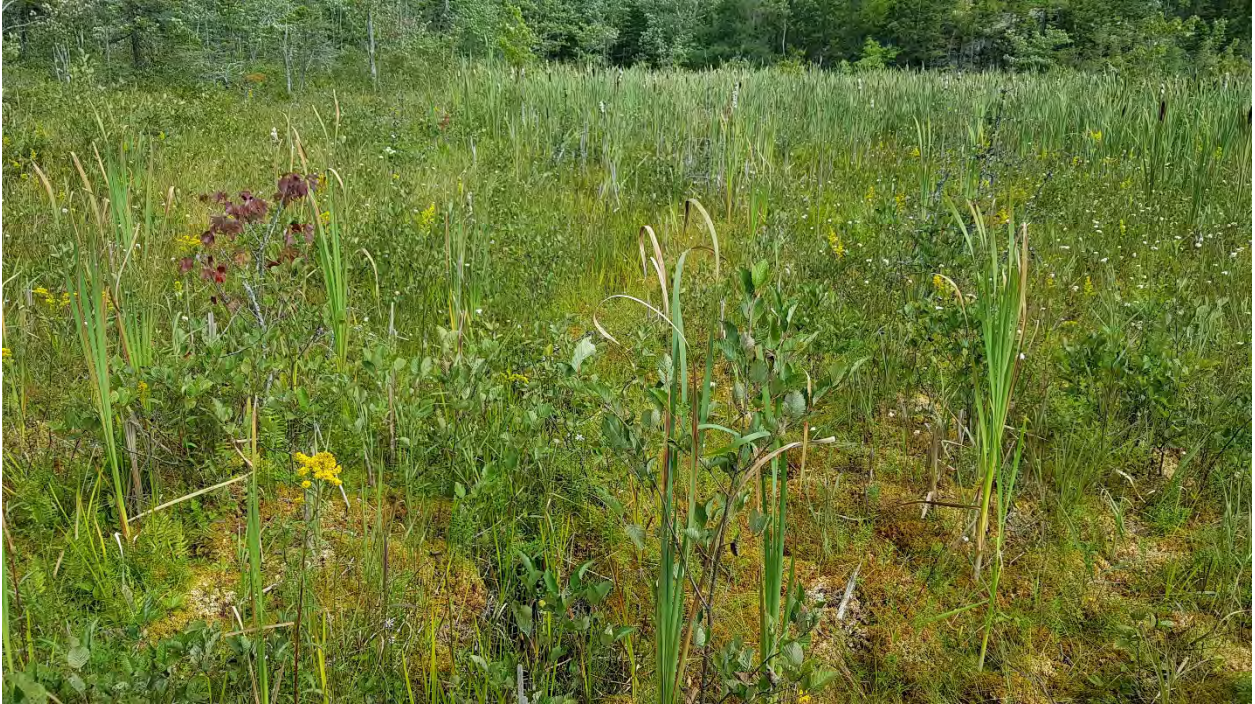
Photo 5. Area 3D – Thick sphagnum moss covers most of the ground and there is little standing water. There is no obvious indication of historic mining impacts in this wetland, although abandoned mine works are directly adjacent.

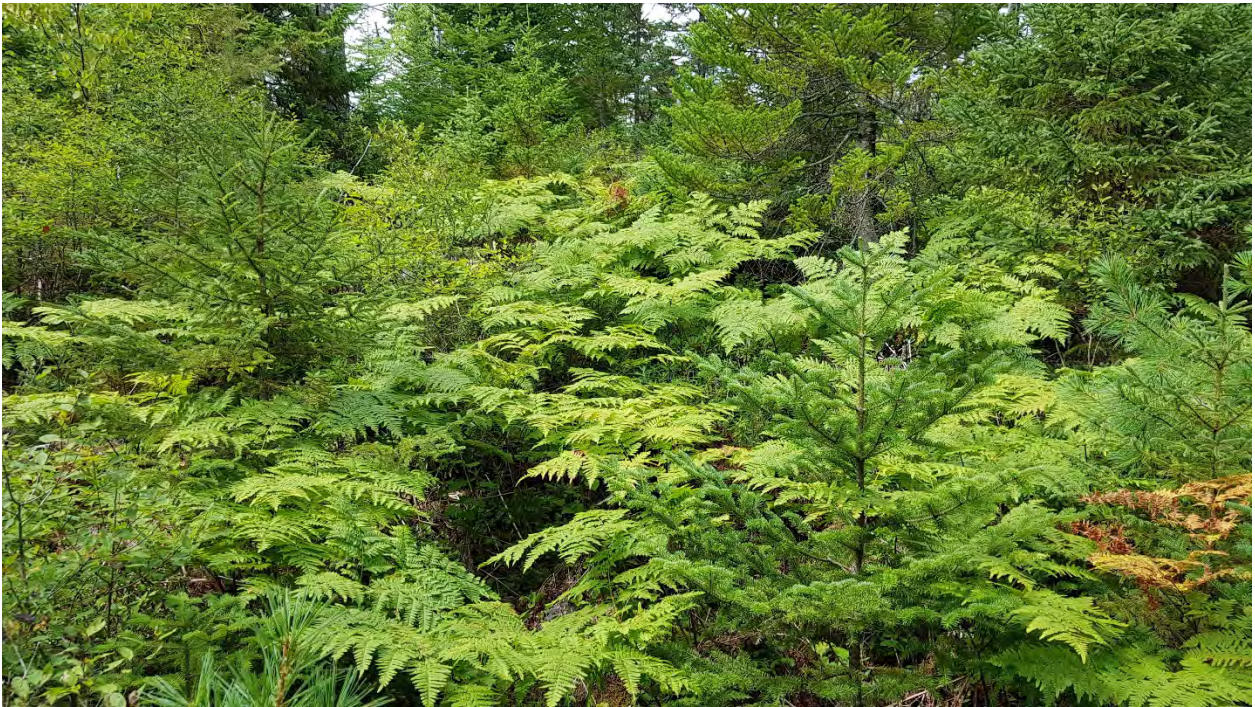
Photo 6. Area 3D – The surrounding upland is mature mixed forest with an open canopy. The terrain is rippled with bedrock ridges.

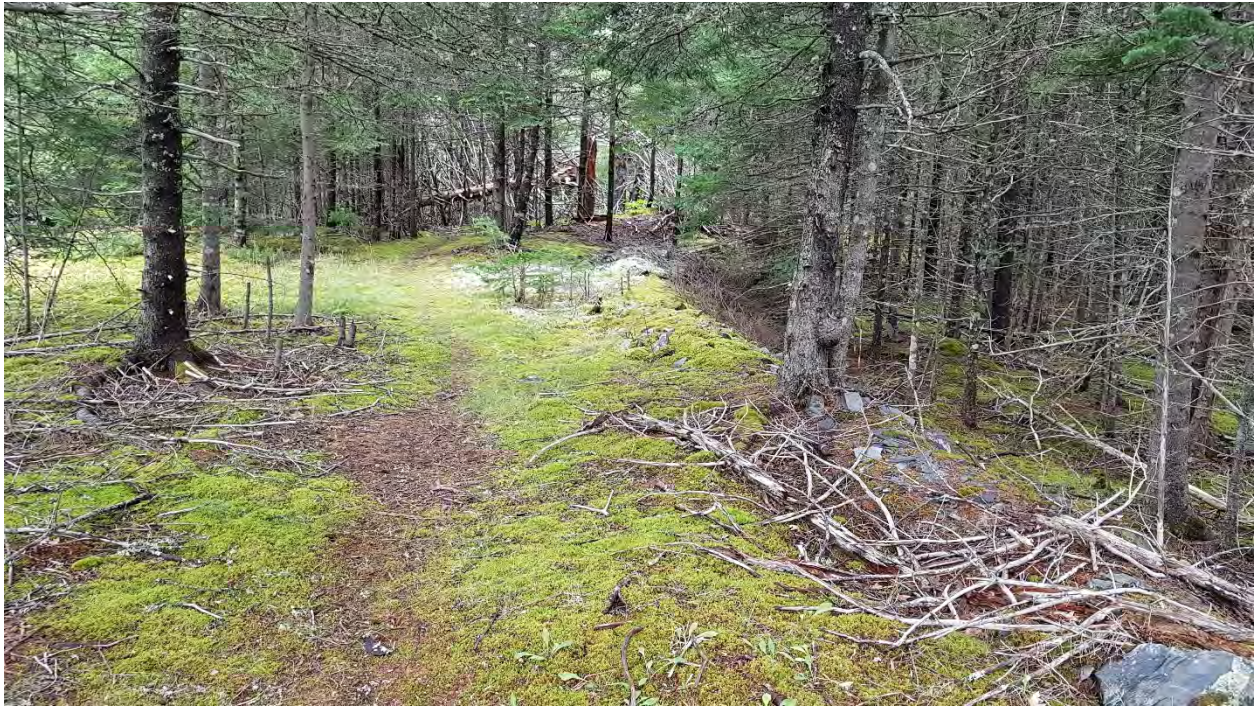
Photo 7. Area 3D – Old mine road adjacent to wetland in Area 3D.

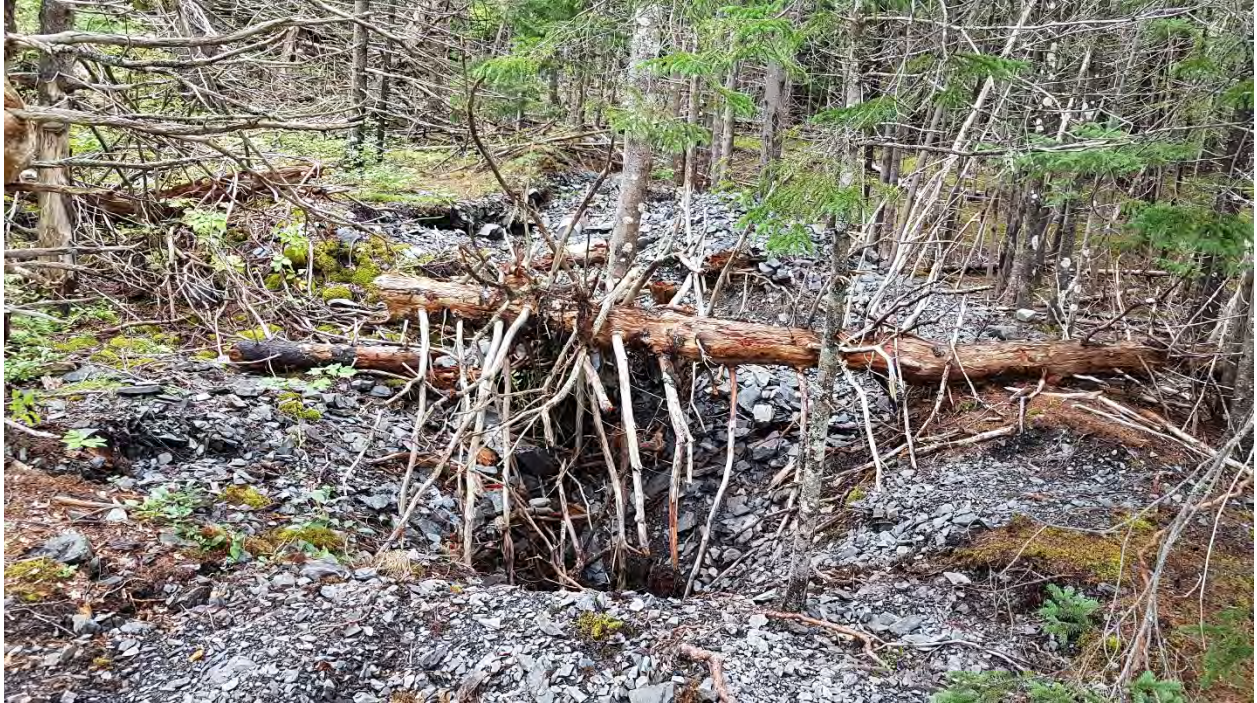
Photo 8. Area 3D – Abandoned mine work adjacent to wetland in Area 3D.

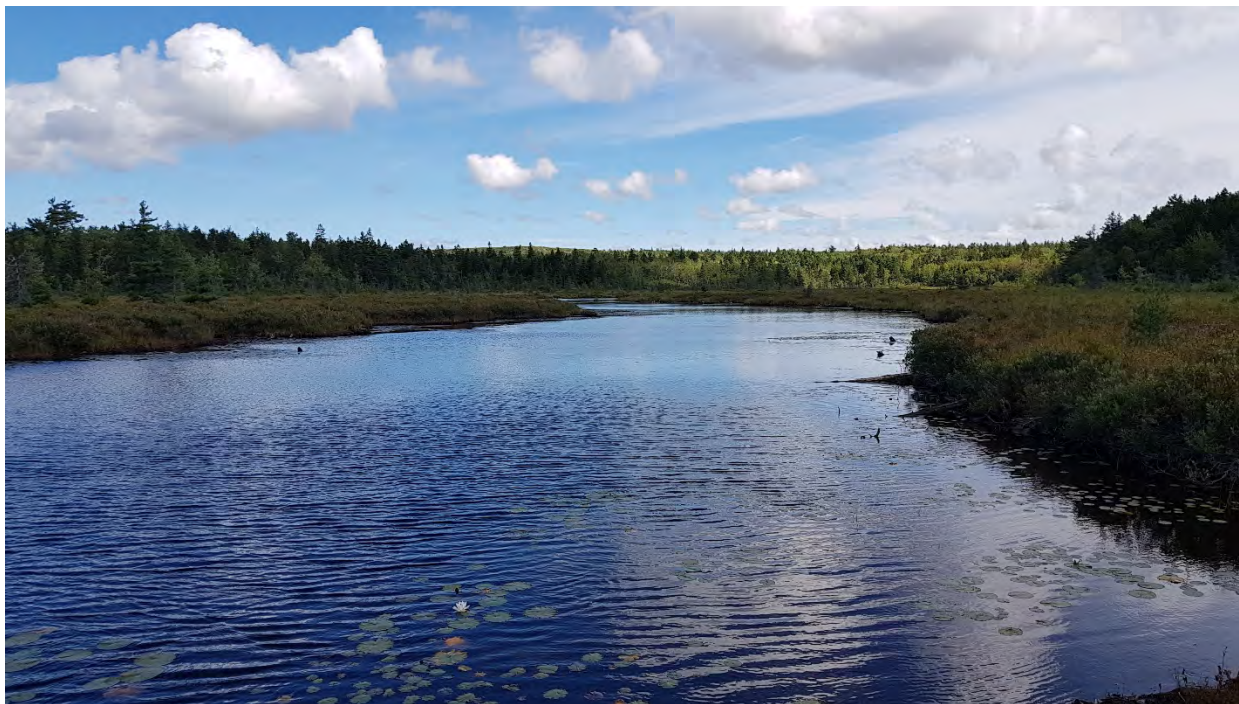
Photo 1. Area 4A – Looking east along Barry's Run.

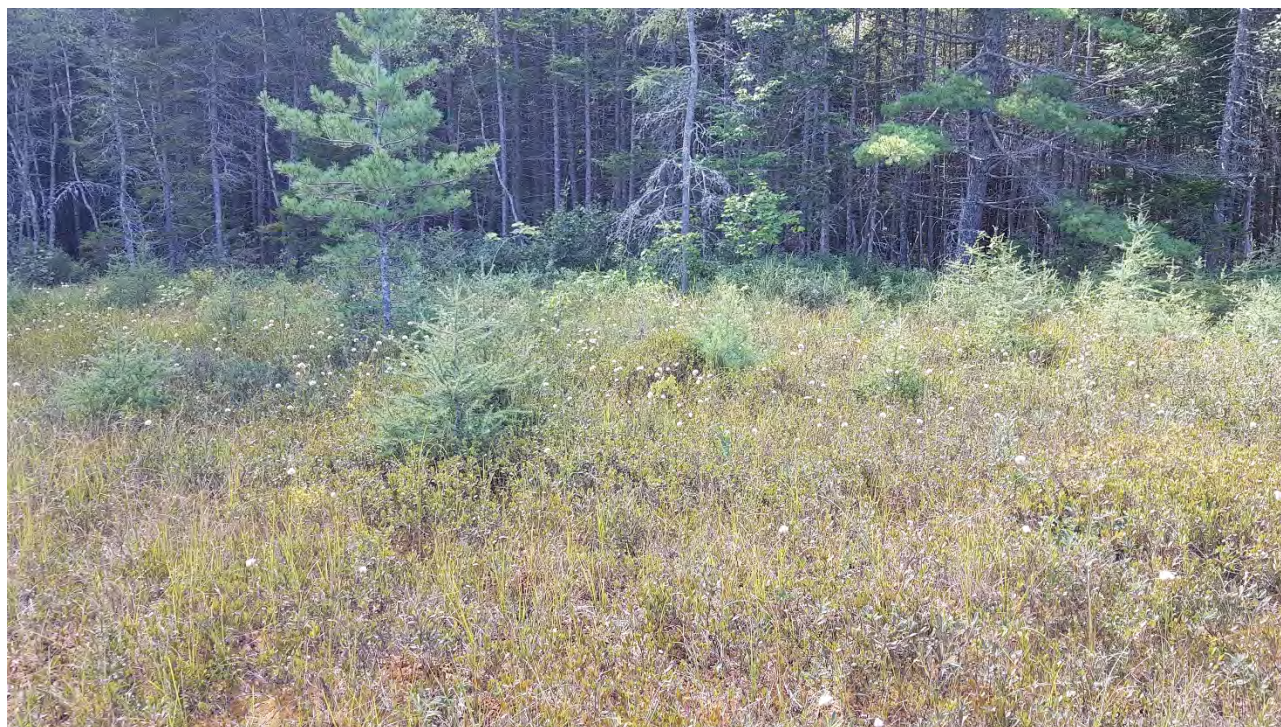
Photo 2. Area 4A – The majority of the wetland is shrubby fen peatland.

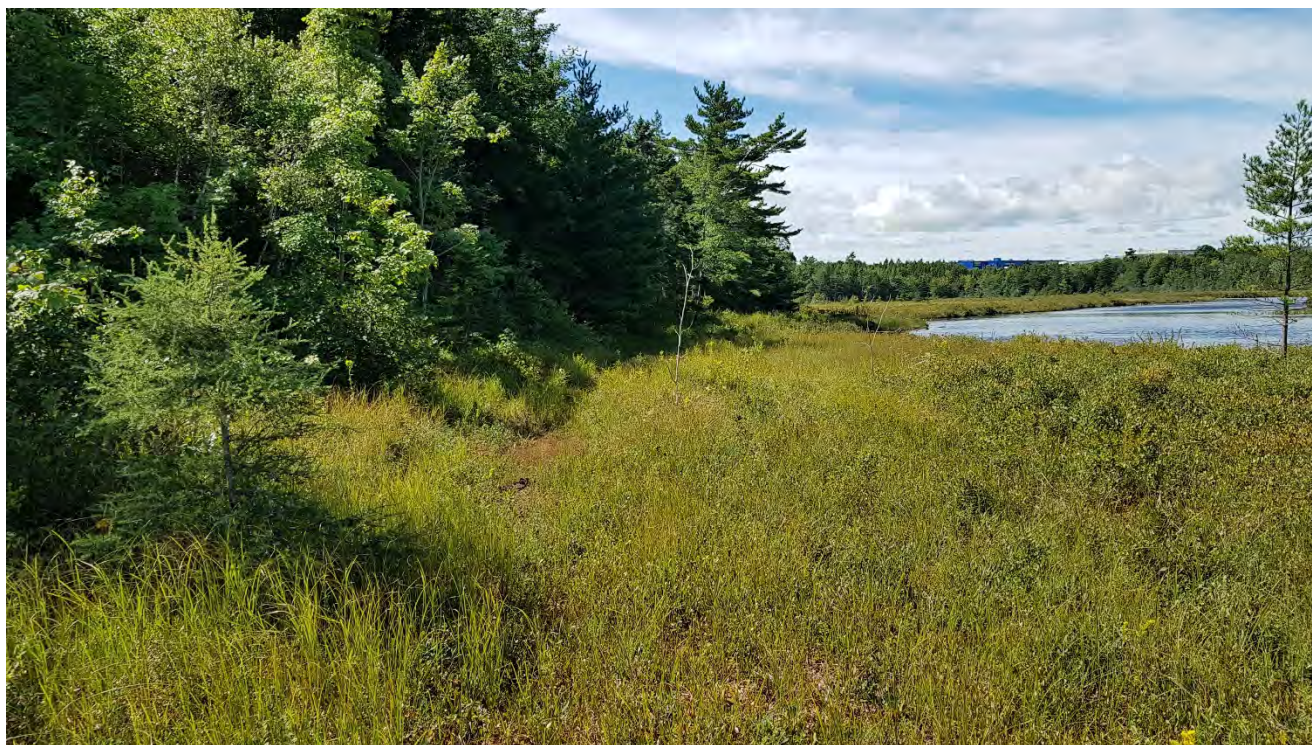
Photo 3. Area 4A – There are smaller areas dominated by sedges.

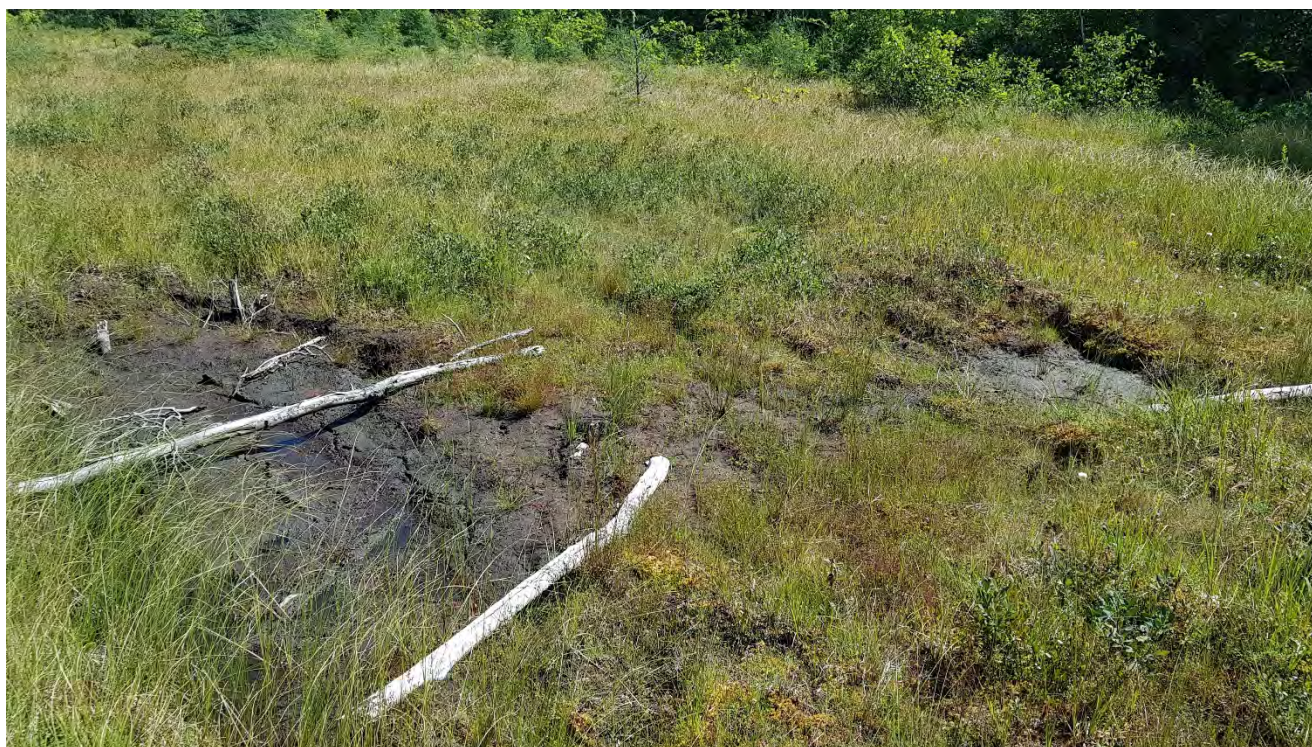
Photo 4. Area 4A – There are signs of infrequent off-road vehicle impacts (semi-annual).

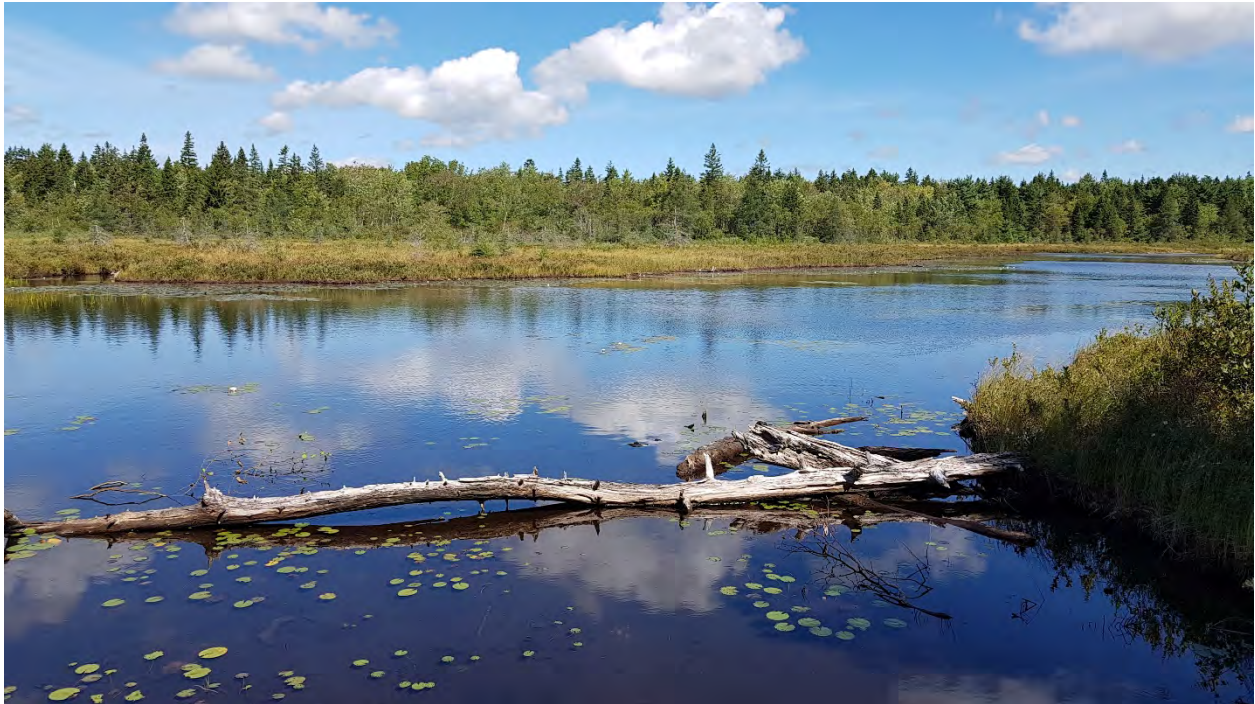
Photo 5. Area 4A – The aquatic habitat appears highly productive with much floating leaved vegetation. Woody debris like this fallen tree provide ideal basking platforms for turtles and shelter for fish.
