**Wetland Assessment Report**  
**Montague Gold Mines, Nova Scotia**  
**Final Report**

Project #: TV183013

May 2021

**Intrinsik Corporation on Behalf of Nova Scotia Lands**

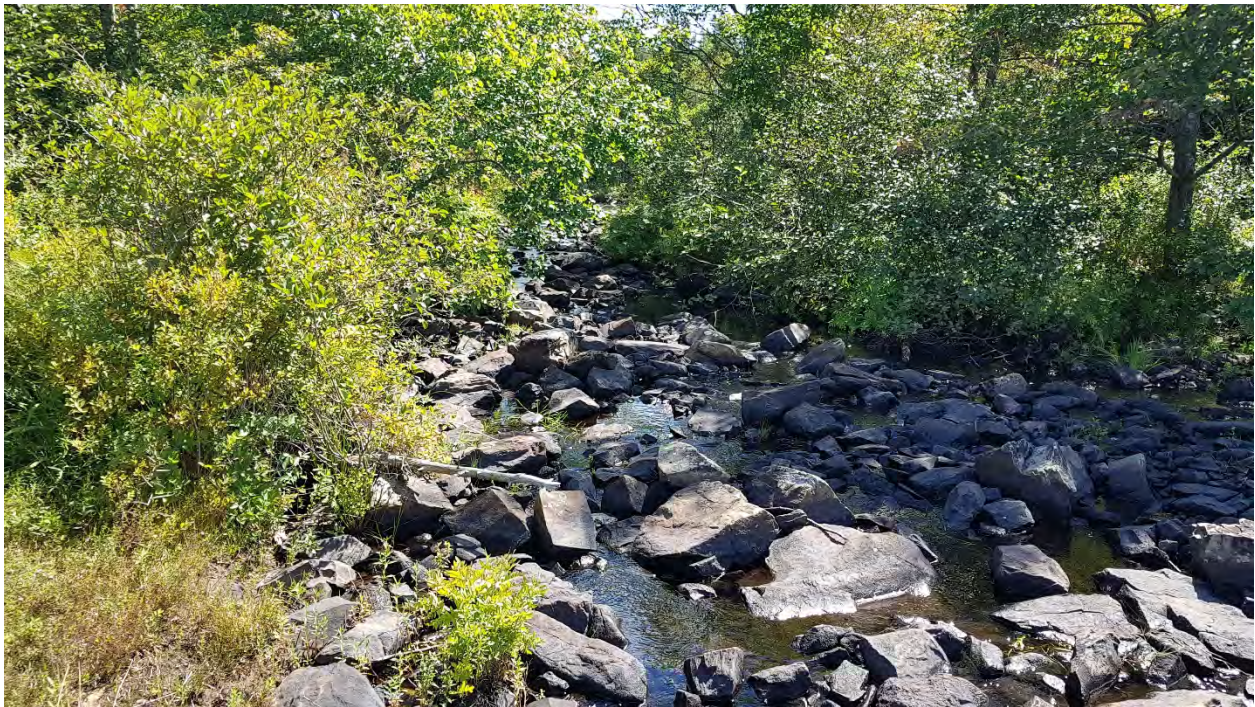
Photo 6. Area 4A – The inlet to the main Barry's Run meadow is a broad rocky riffle.

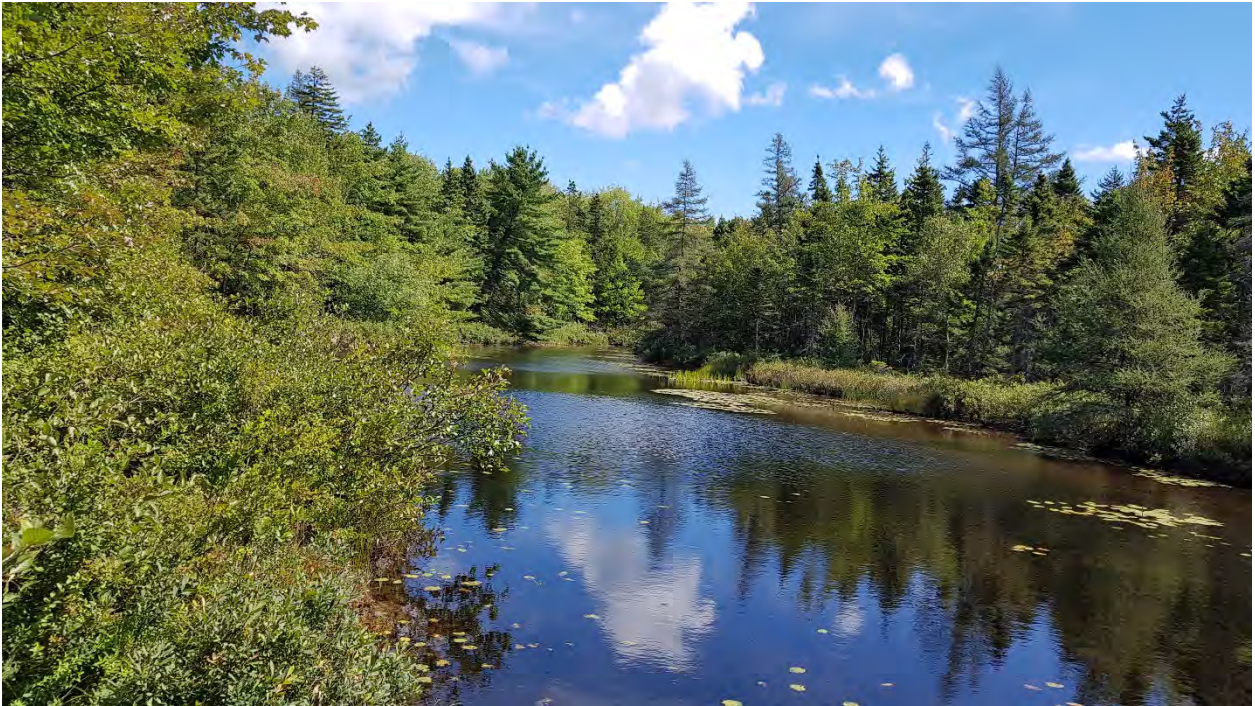
Photo 7. Area 4A – Shortly upstream of the meadow, at a slightly higher elevation, is a long wide slow-moving section of stream.

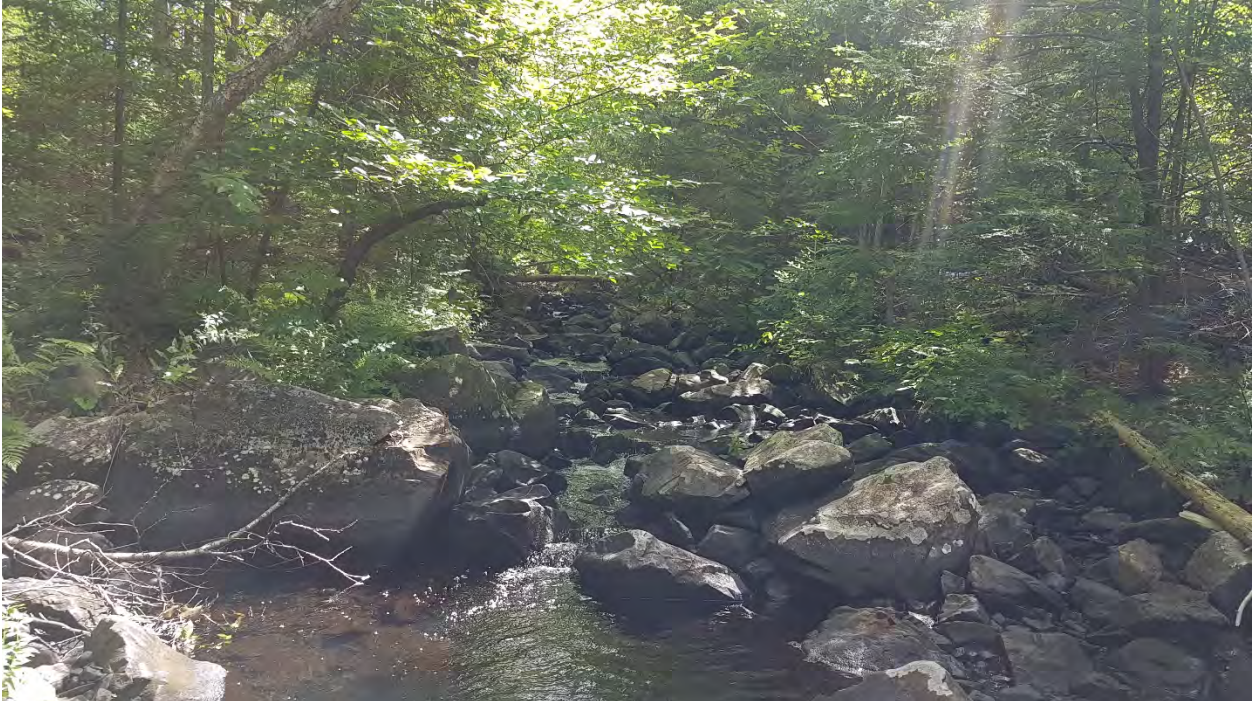
Photo 8. Area 4A – The watercourse flowing down from Area 4B is a steep rocky riffle with turbulent pools.

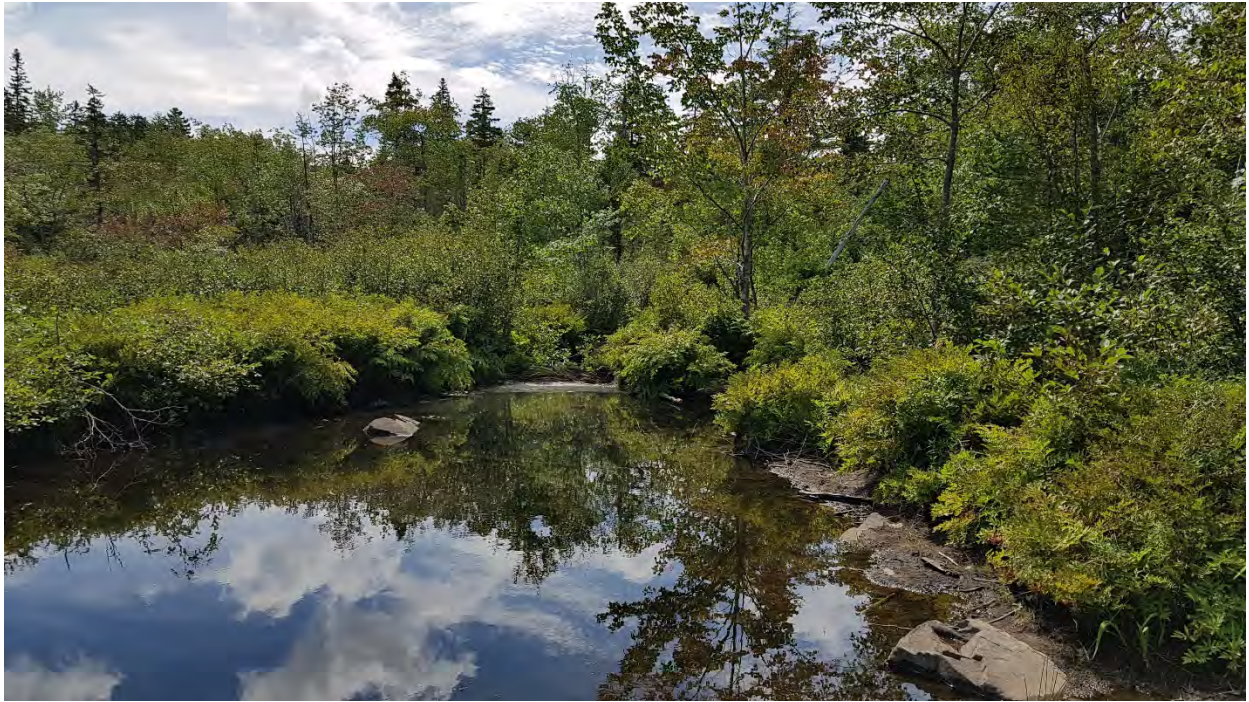
Photo 1. Area 4B – A beaver dam controls flow at the outlet.

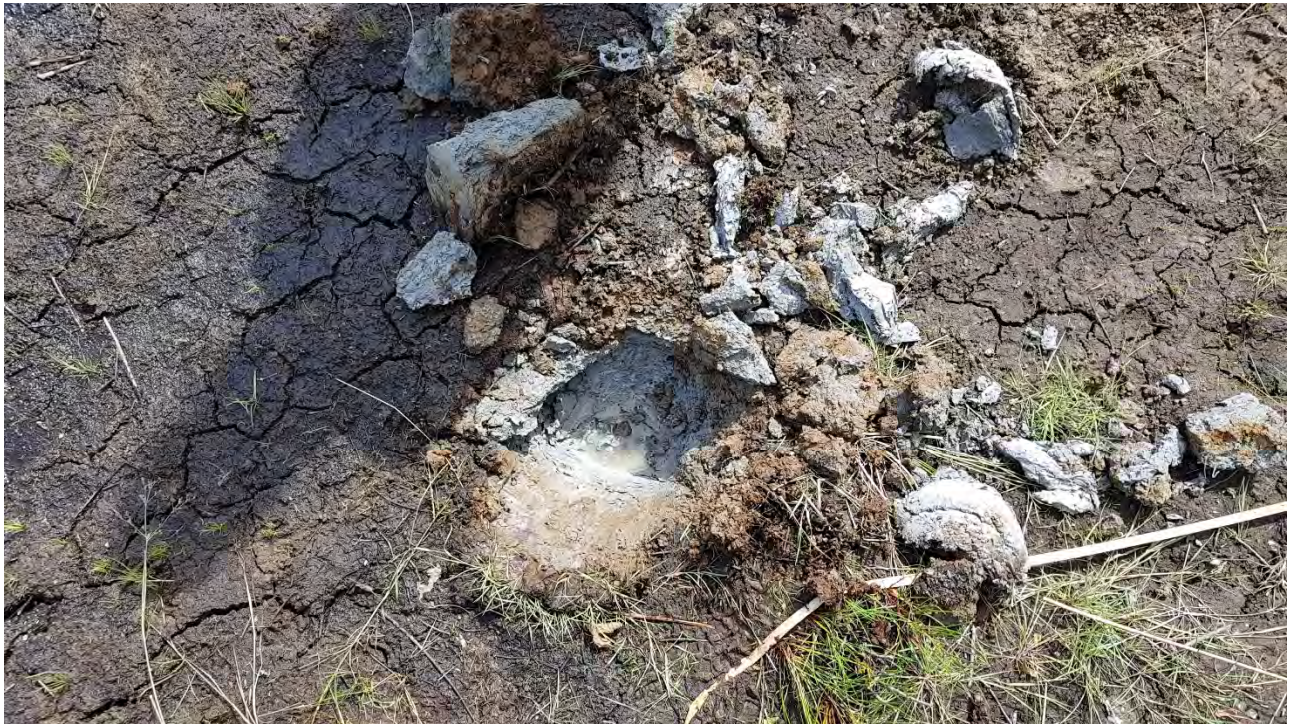
Photo 2. Area 4B – The beaver pond appears to contain deep deposits of dense grey sand which may be historic mine tailings.

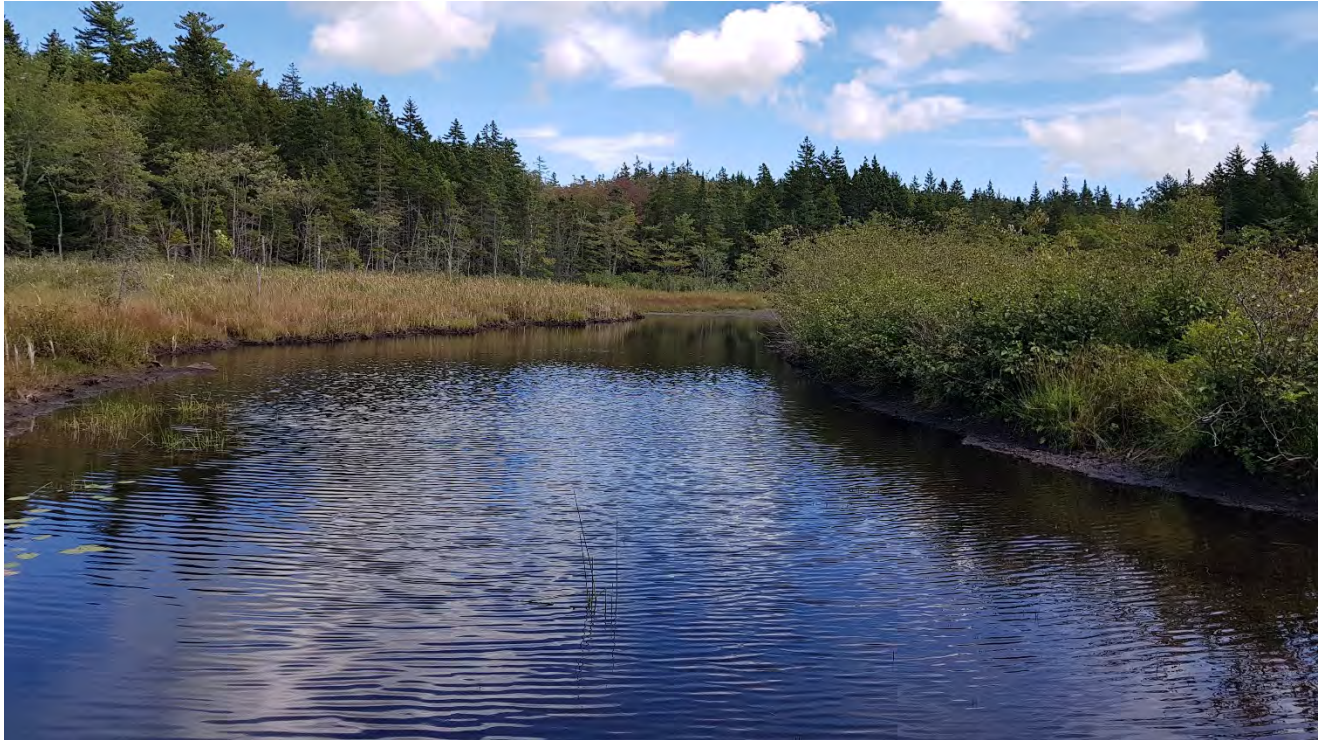
Photo 3. Area 4B – Looking upstream from the beaver dam. The wetland is mostly emergent vegetation north of the stream (at left) and alder shrub swamp on the south (at right).

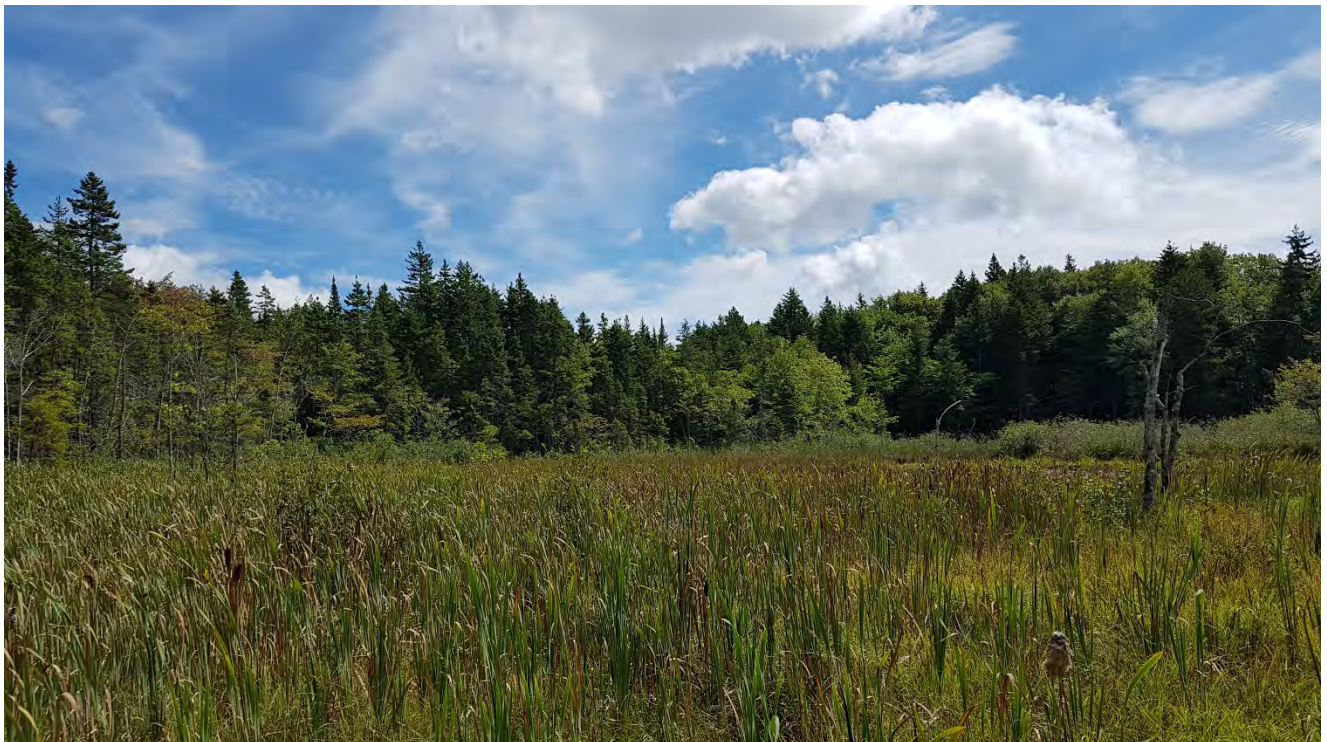
Photo 4. Area 4B – The emergent vegetation community is predominantly cattails and rushes.

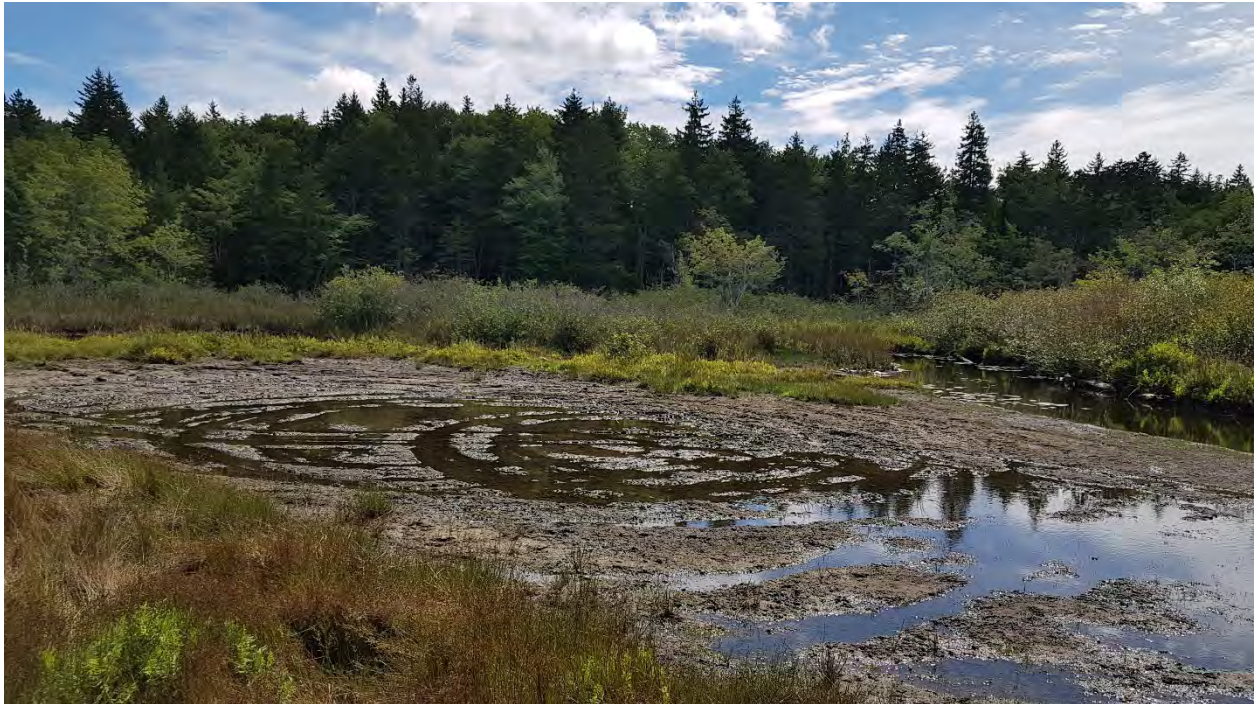
Photo 5. Area 4B – There is a large disturbance caused by off-road vehicle's which remains unvegetated. The soil is grey sand and may be historic mine tailings.

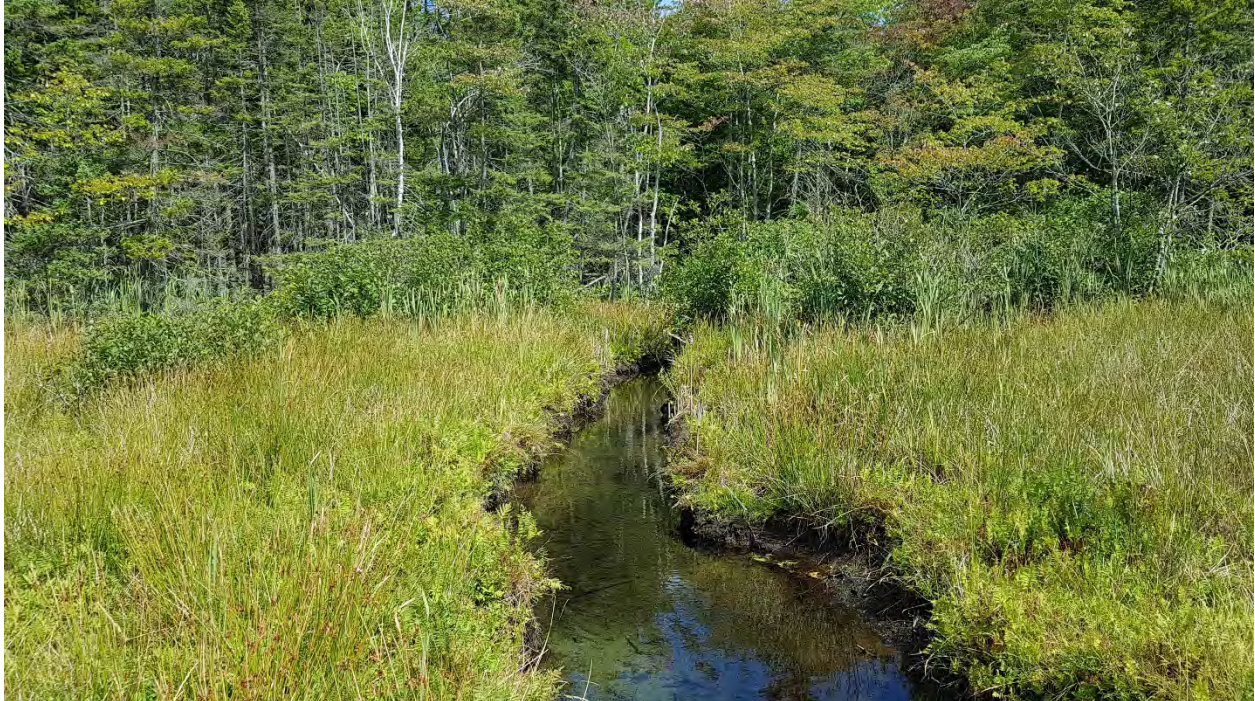
Photo 6. Area 4B – A smaller channel enters from the northeast that receives drainage from Area 1D via Culvert 3.

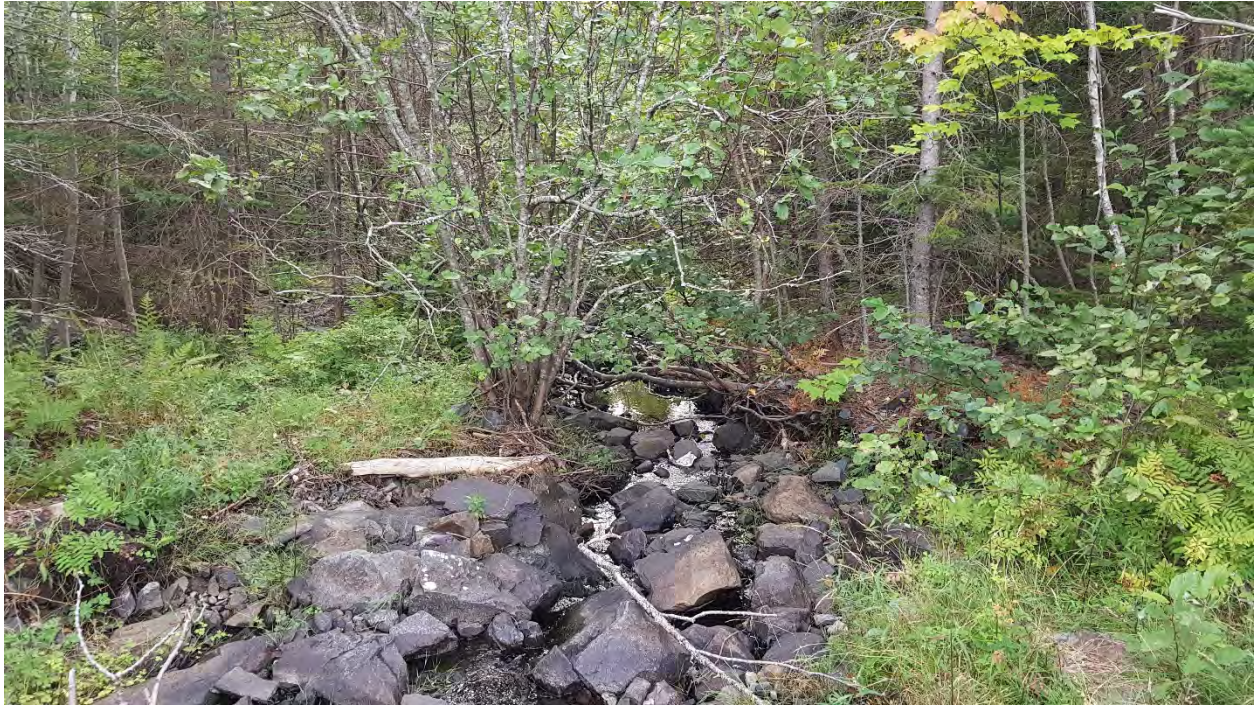
Photo 7. Area 4B – Looking downstream from Culvert 3, the drainage to Area 4B is intermittent in summer, frequently disappearing below ground but flowing permanently in sections.

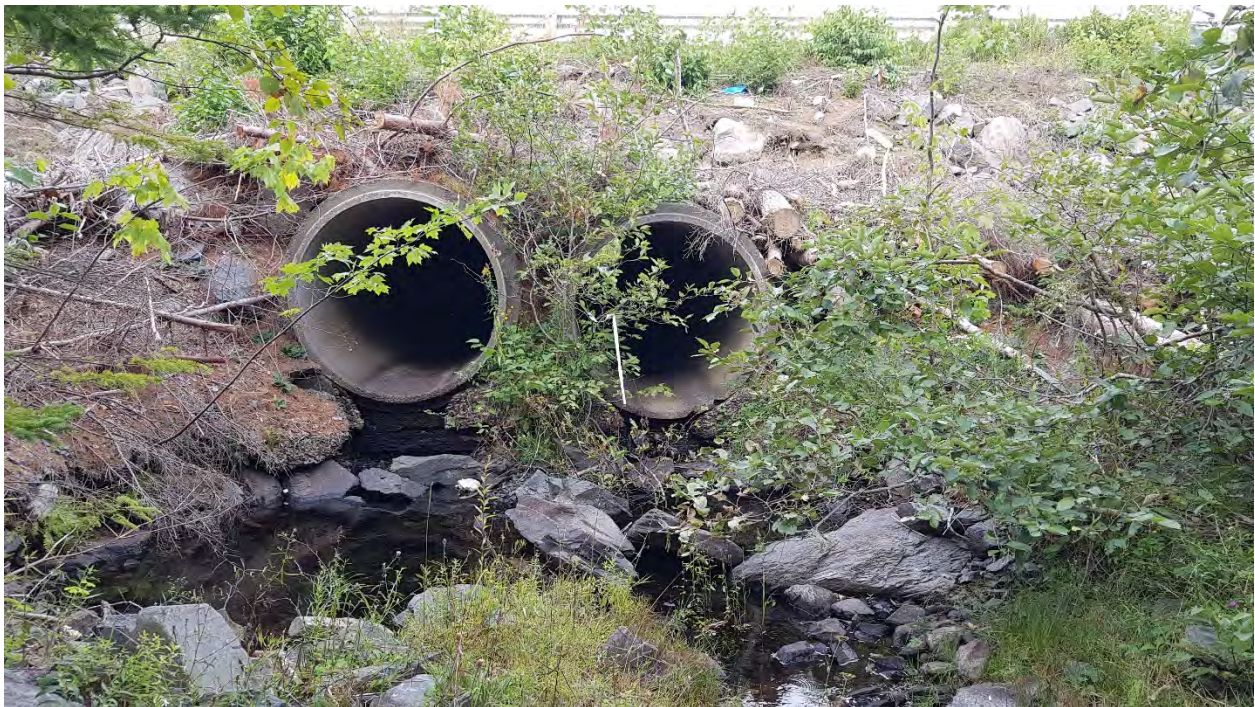
Photo 8. Area 4B – Culvert 3 has signs of seasonal high-volume flows but in July there was no flow in the culverts, although a strong current emanated from the base of the embankment.

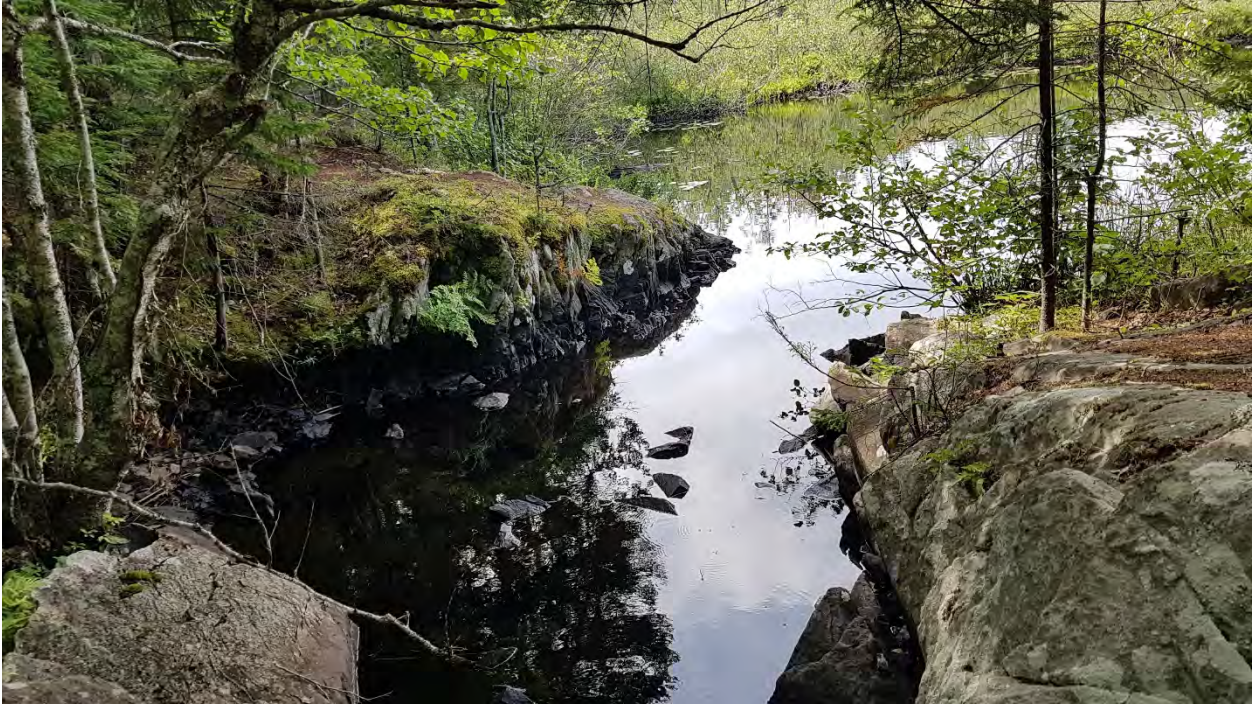
Photo 9. Area 4B – The main inlet to the wetland is a broad rocky channel that receives combined flow from Mitchell Brook (Culvert 2) and Areas 4C & 4D to the southeast.

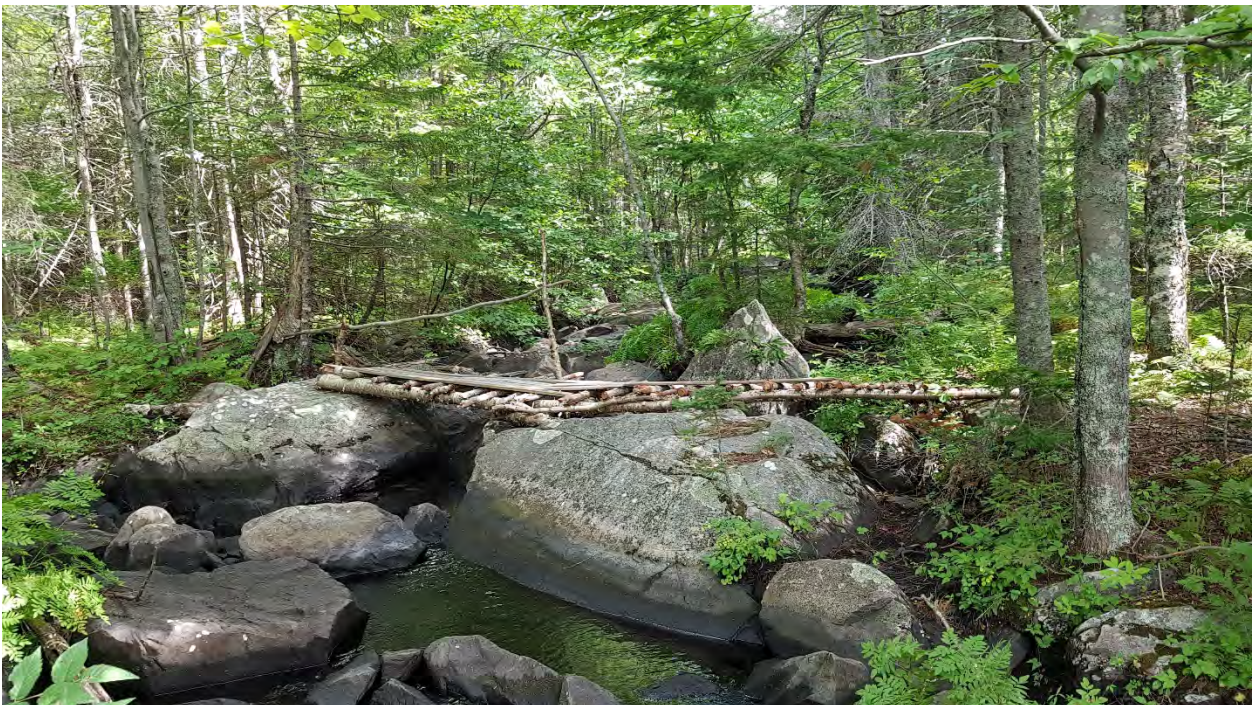
Photo 10. Area 4B – Looking upstream from the location above. This wetland seems to have attracted interest from recreational users, having a primitive footbridge and well used trails around it.

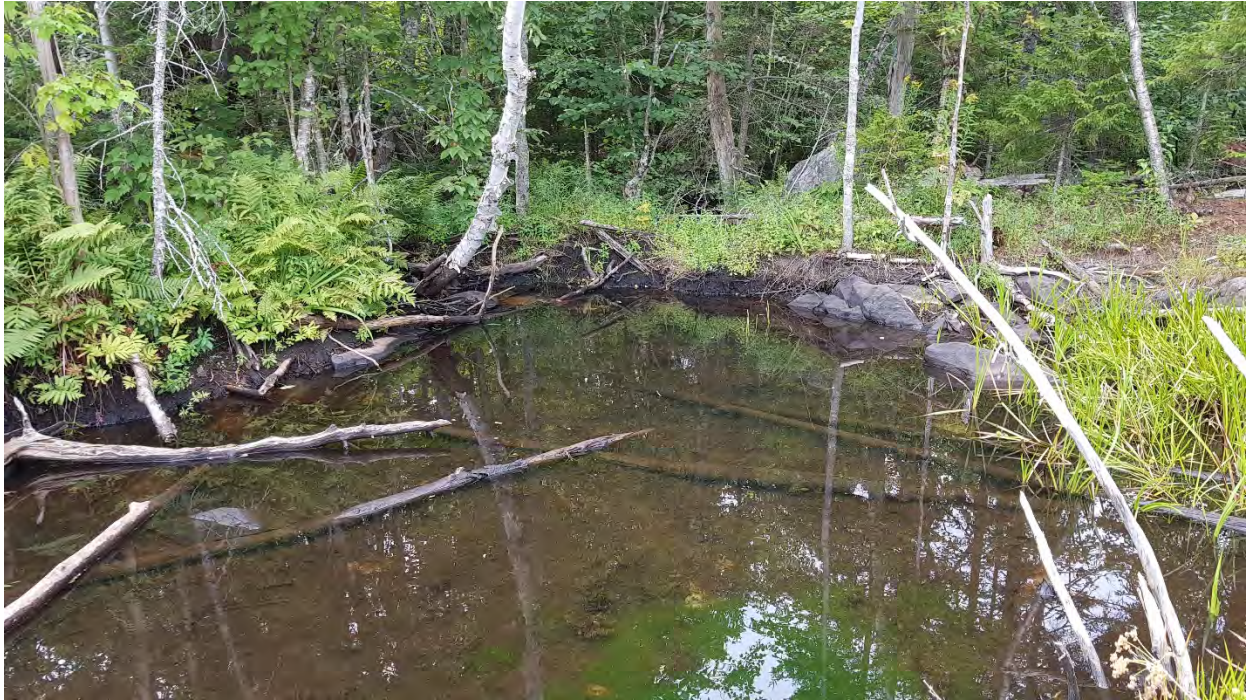
Photo 1. Area 4C – A beaver dam controls water at the outlet of Area 4C.

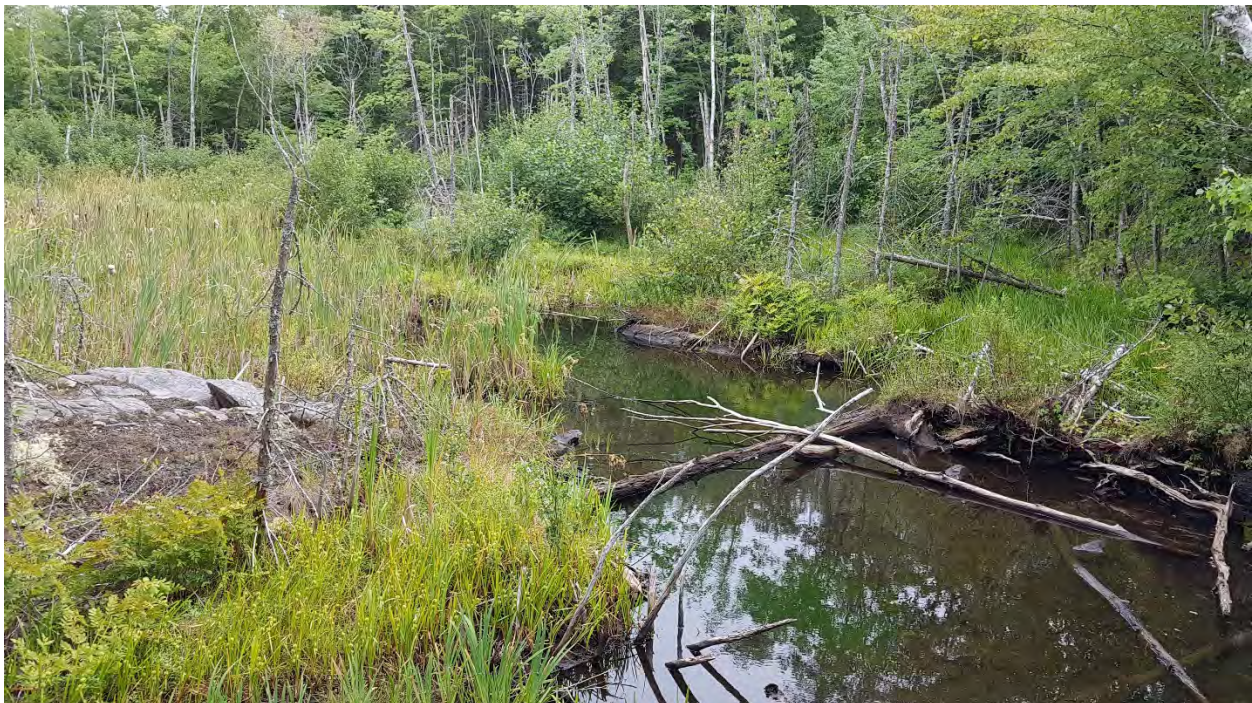
Photo 2. Area 4C – Looking upstream from the location above. There are signs of variable high-water levels, perhaps seasonally.

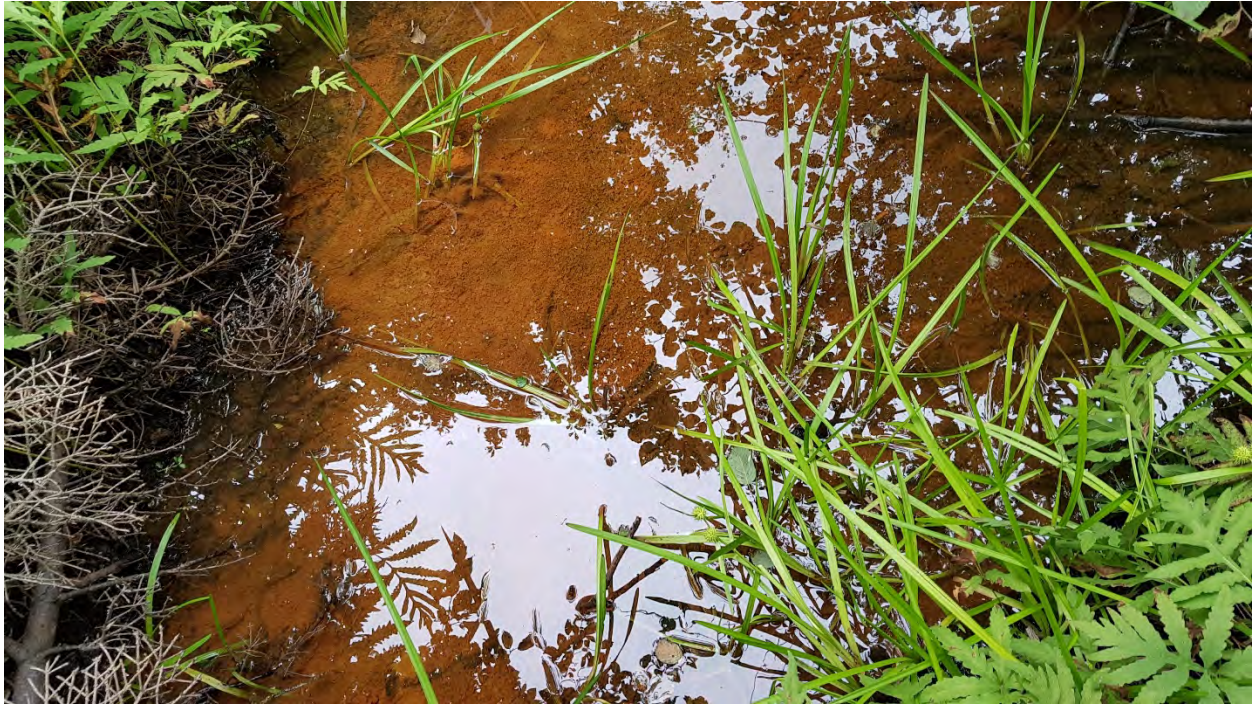
Photo 3. Area 4C – The beaver pond has areas with both orange and green algae.

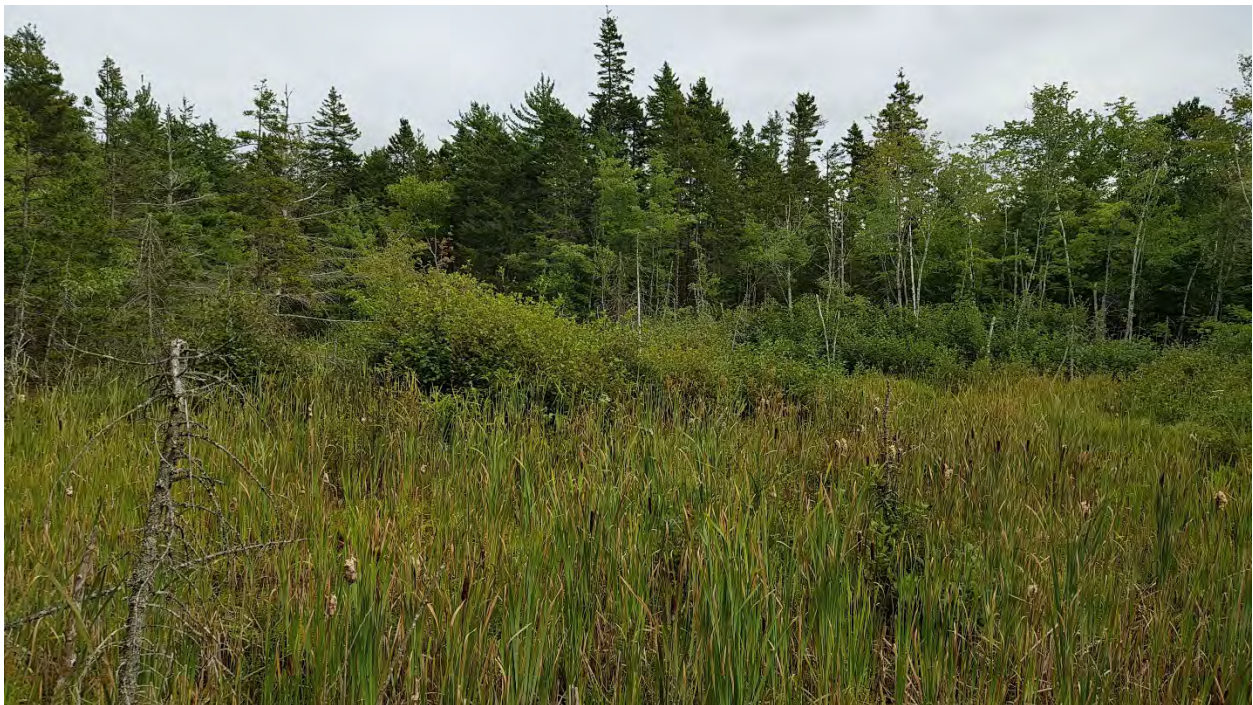
Photo 4. Area 4C – Cattails and rushed dominate the open middle with a fringe of alder shrubs and small coniferous trees (mainly tamarack). There are no indications of historic mining activity.

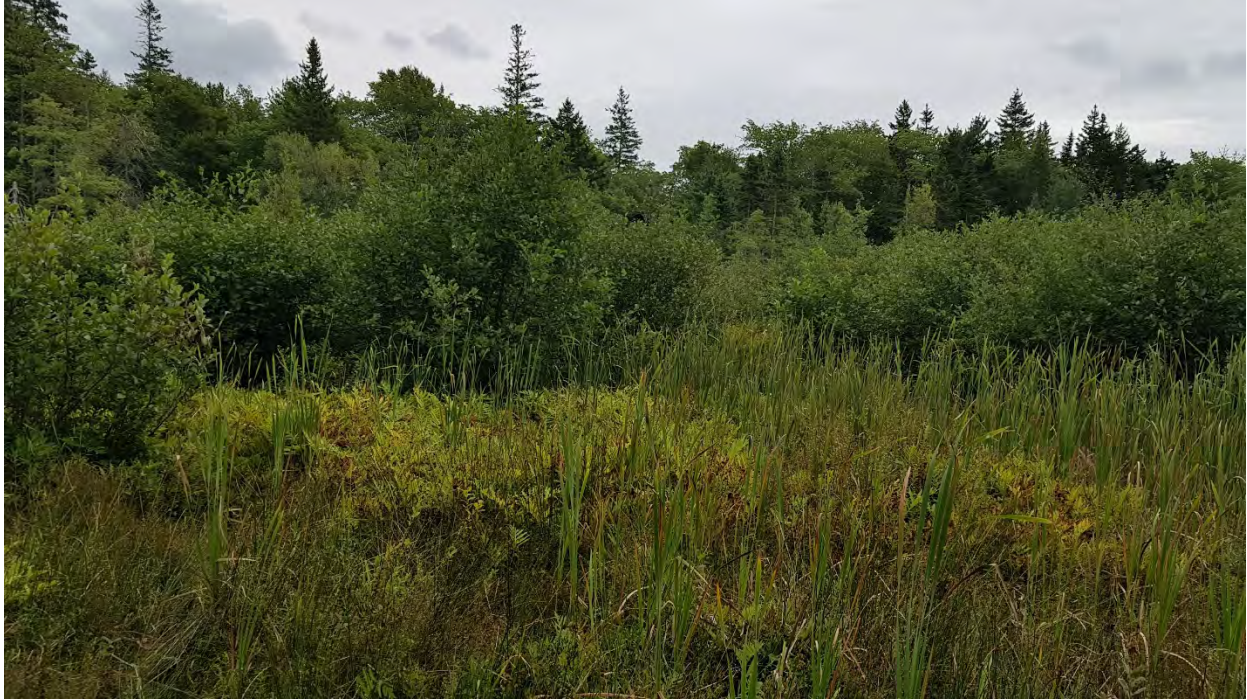
Photo 1. Area 4D – This wetland is at a slightly higher elevation than Area 4C and has no standing water (except perhaps seasonally). The vegetation is a mix of open meadow and tall shrub swamp.

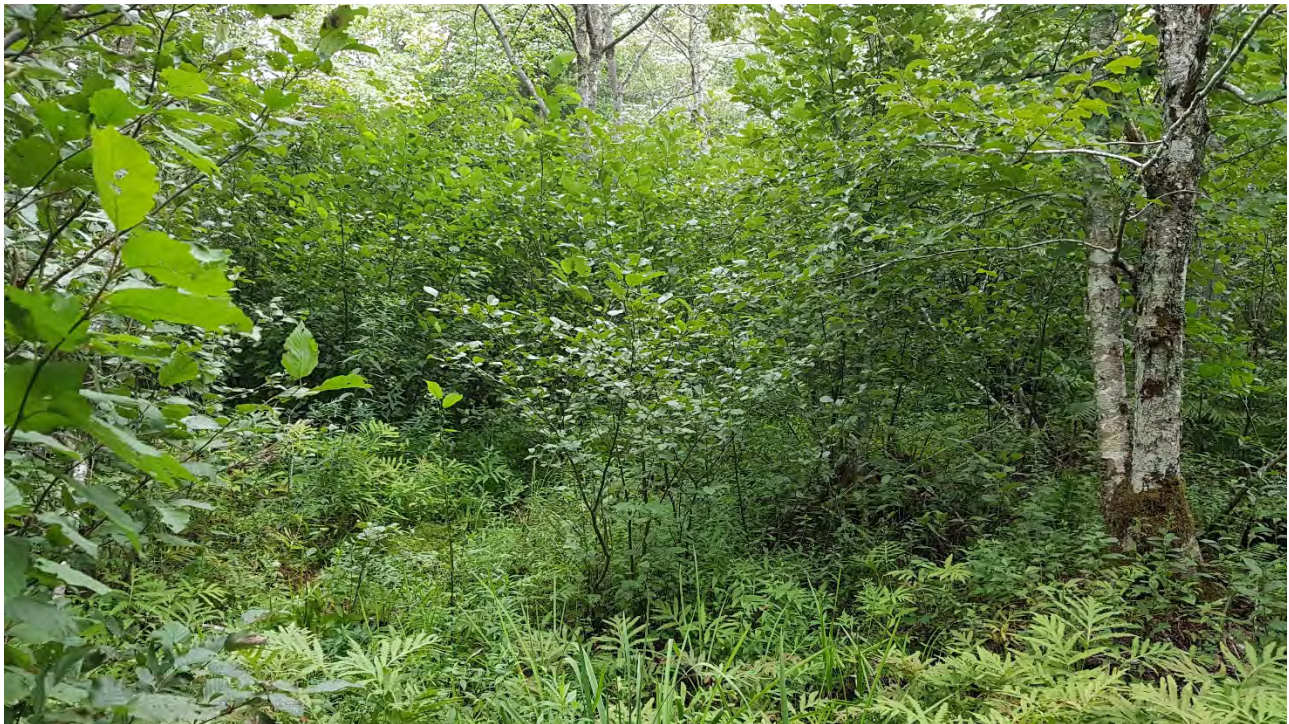
Photo 2. Area 4D – The margin of the wetland is swampy including some trees. There is no indication of historic mining impacts. The soil appears naturally developed with high organics.

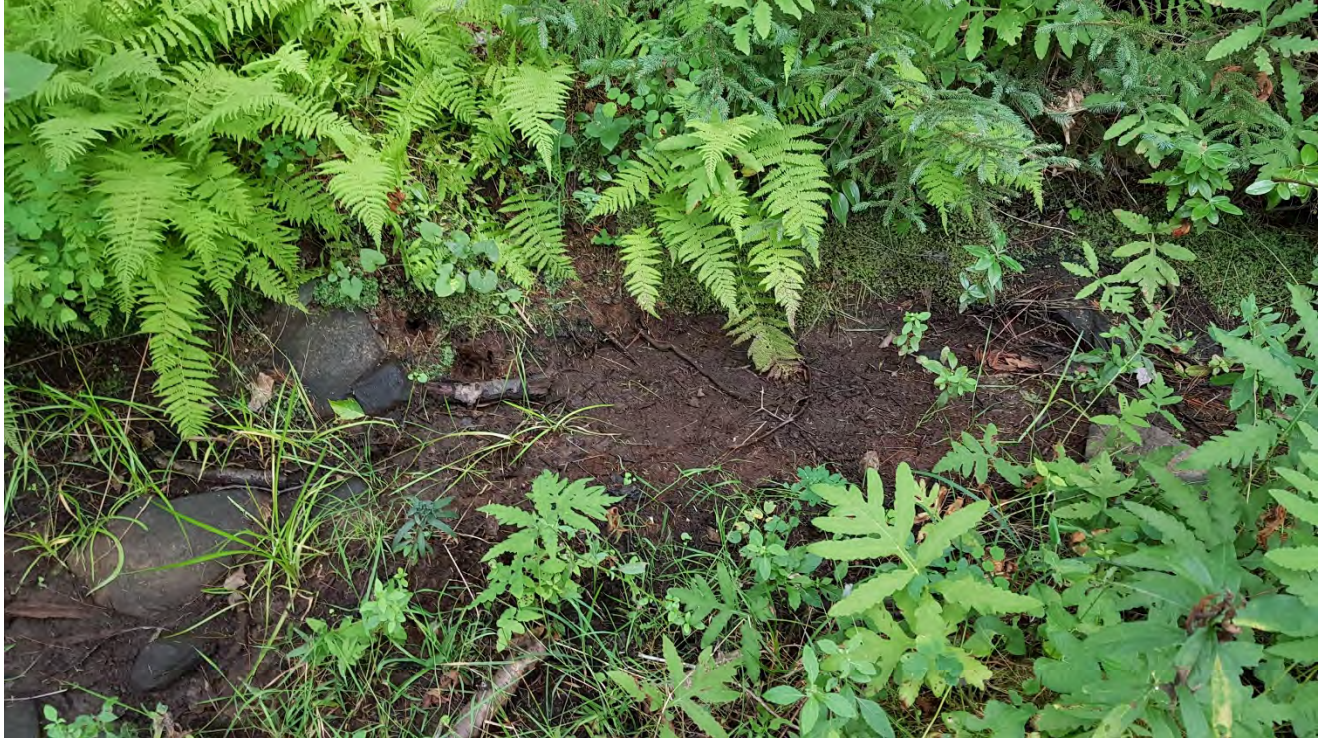
Photo 3. Area 4D – An inlet channel was dry at the time of the visit.

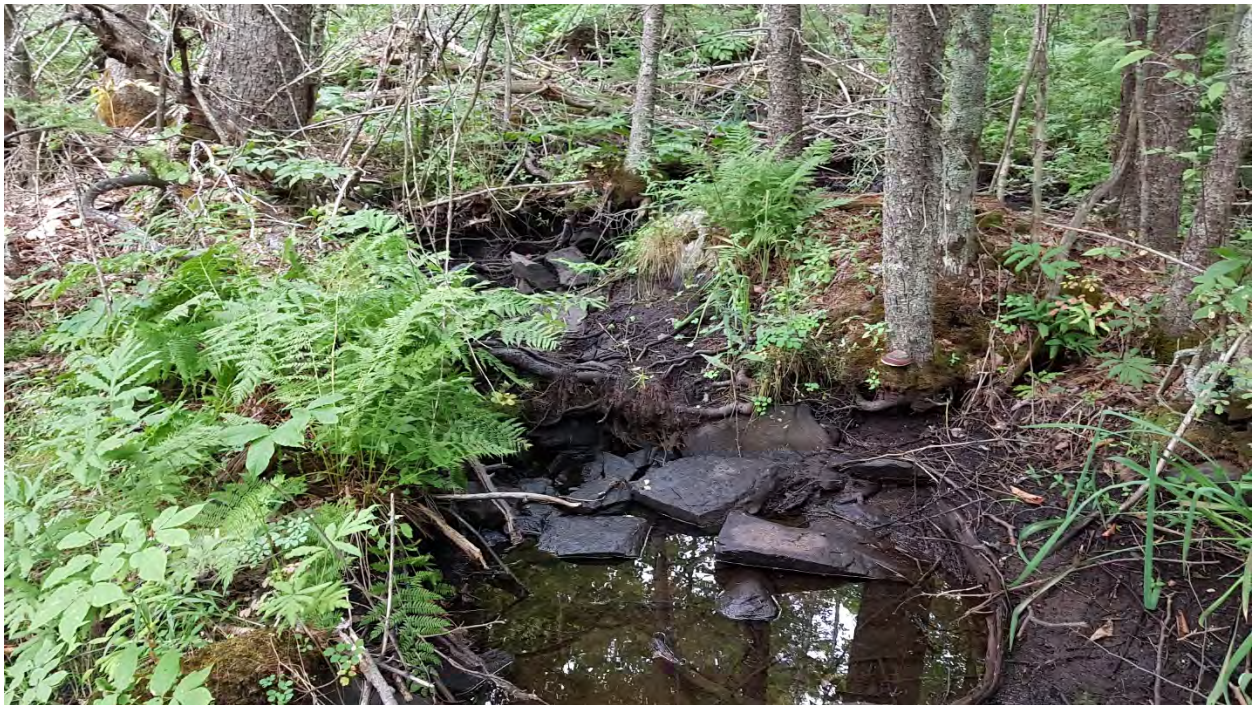
Photo 4. Area 4D – A steep intermittent stream flows from Area 1E via Culvert 1. There are signs of seasonal high-volume flow. The flow infiltrated into the ground before reaching the wetland.

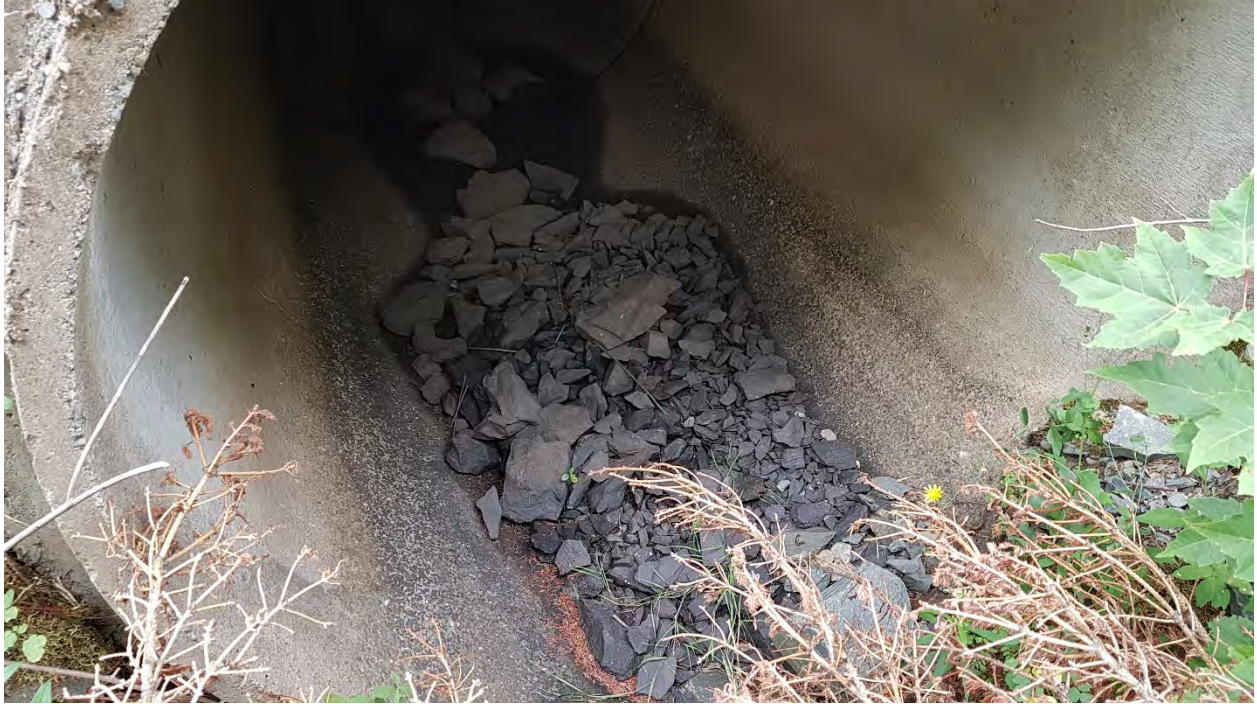
Photo 5. Area 4D – There was no flow in Culvert 1, despite recent rain.

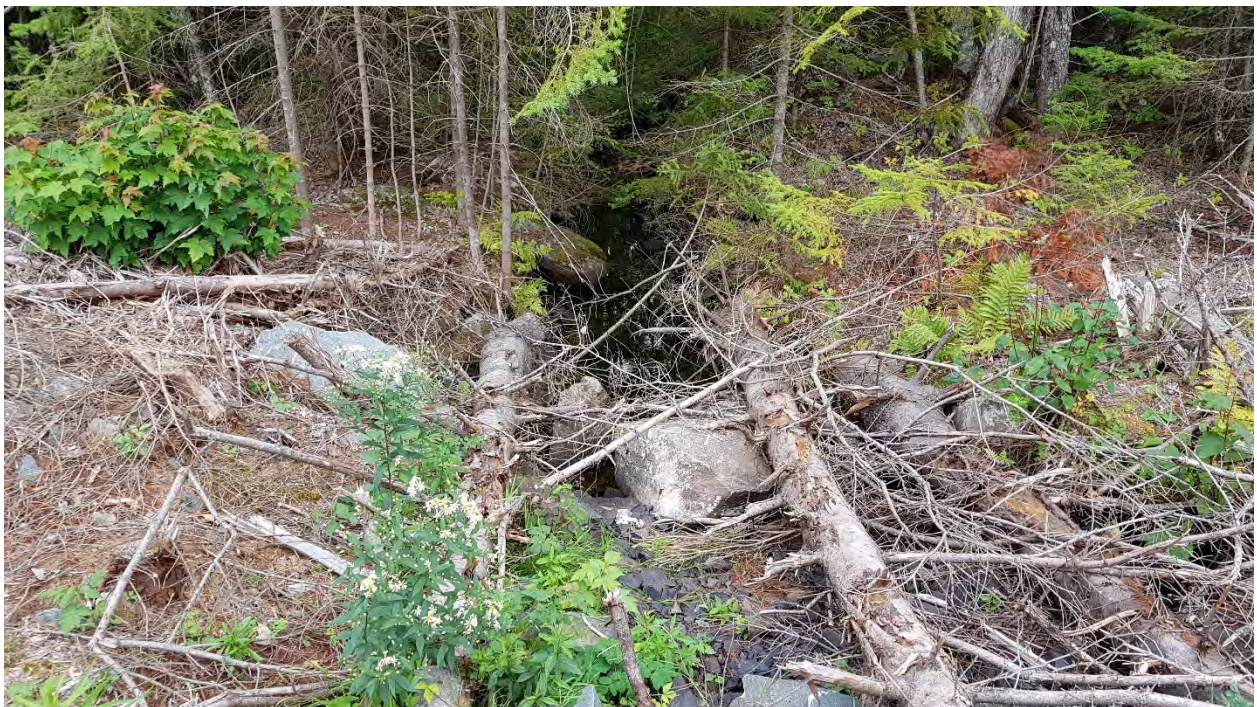
Photo 6. Area 4D – Looking downstream from the culvert above. A small current emanates from the embankment fill several metres downgradient.
